**Airfield Asphalt Pavement Technology Program**

**Final Report AAPTP 05-04      Techniques for Mitigation  
of Reflective Cracks**

Harold L. Von Quintus, P.E., Applied Research Associates (ARA), Inc.

**20 February 2009**

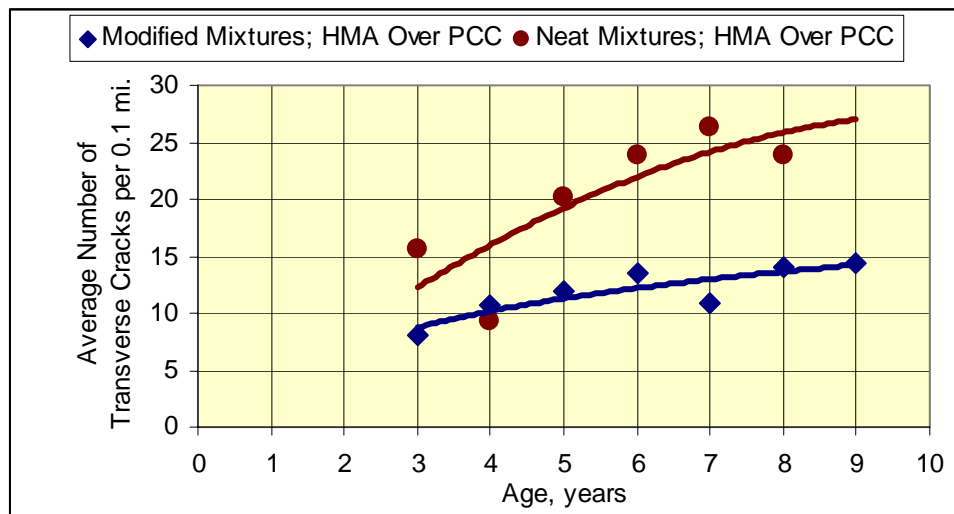
(a) HMA Overlays of Flexible Pavements.

(b) HMA Overlays of Rigid Pavements.

Von Quintus, et al., (2007) evaluated and compared the performance of overlays with conventional-neat mixtures to those with PMA mixtures of existing flexible and rigid pavements. The comparison of field performance clearly showed a substantial benefit (reduced levels of distress) with the use of PMA mixtures. This study, however, did not consider reflective cracking of the overlay—it was based on thermal or transverse cracks, fatigue cracks, rutting and International Roughness Index (IRI).

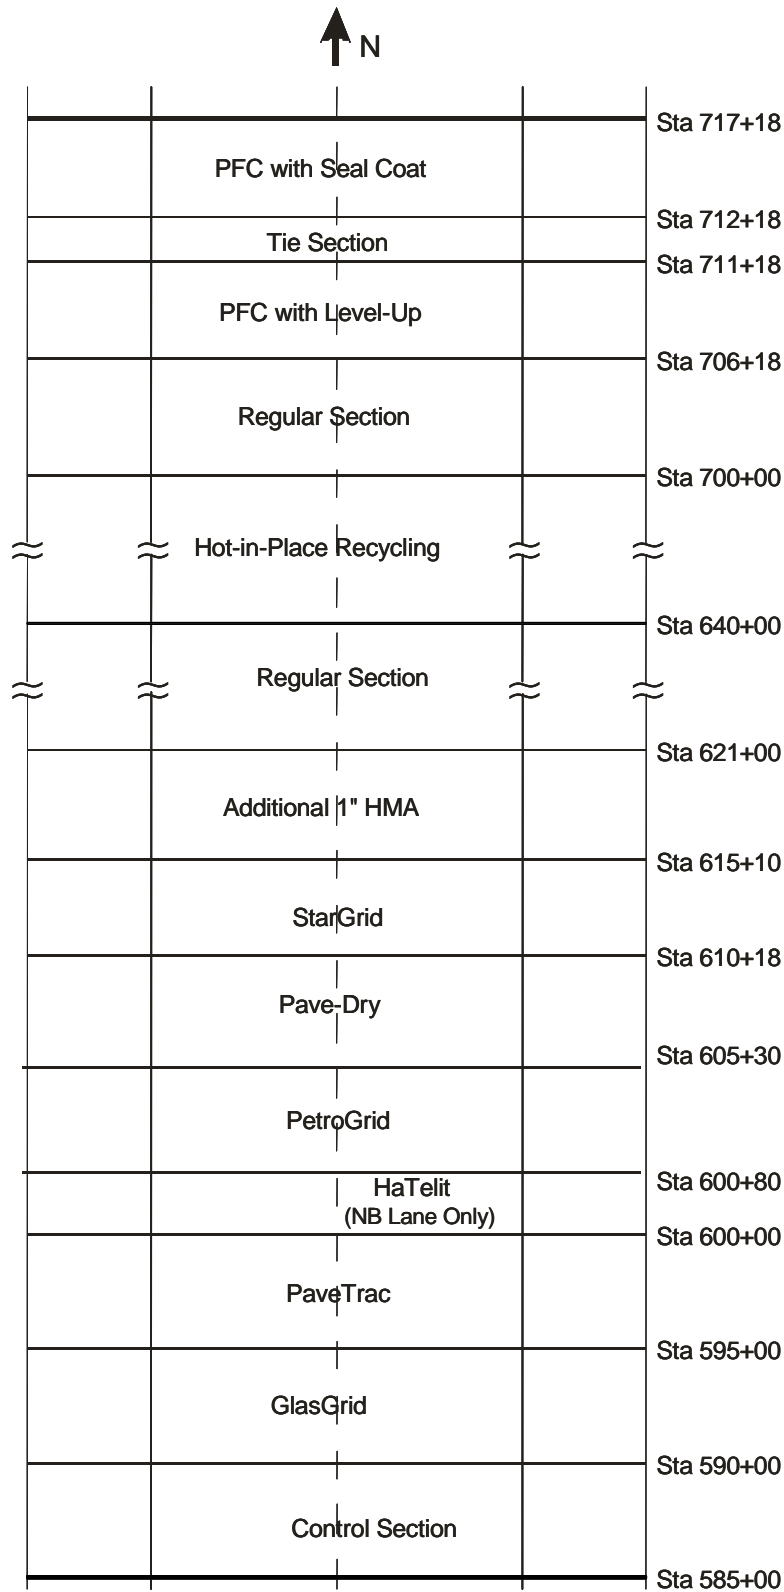
**Figure 13. Plan View of Test Pavement Placed in Amarillo—Amarillo District**

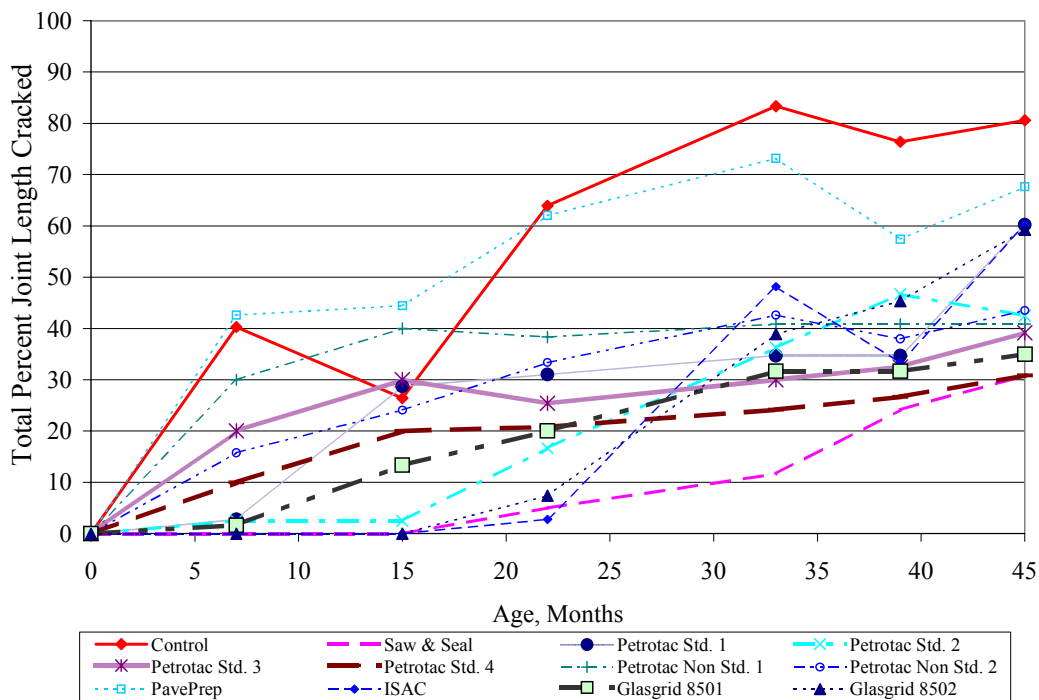
**Figure 14. Time History of Reflection Crack Development as a Percentage of Total Joint Length for the 20-ft Sections (Joint Series 1-12); after Mallela and Von Quintus, 2004**

In summary, the saw and seal crack control strategy is providing the better performance. None of the geogrids or geosynthetics significantly reduced the amount of reflective cracks. The most surprising observation from this experiment was that a significantly lower percentage of reflective cracking was exhibited for nearly all treatment methods for the 20-ft (6 m) test sections rather than the 15-ft (4.6 m) test sections.

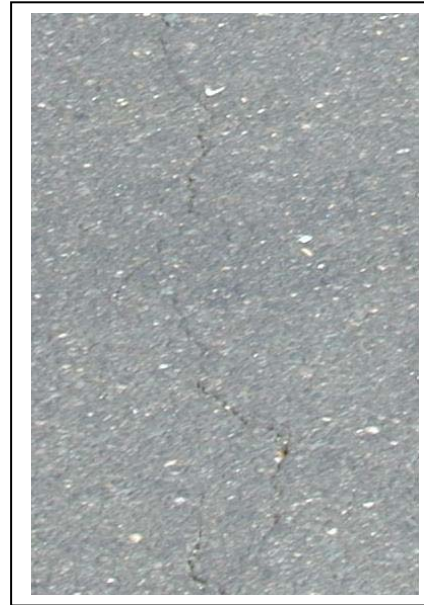
Hairline to Low Severity Reflective Crack—Crack can be seen and extends across paving width.

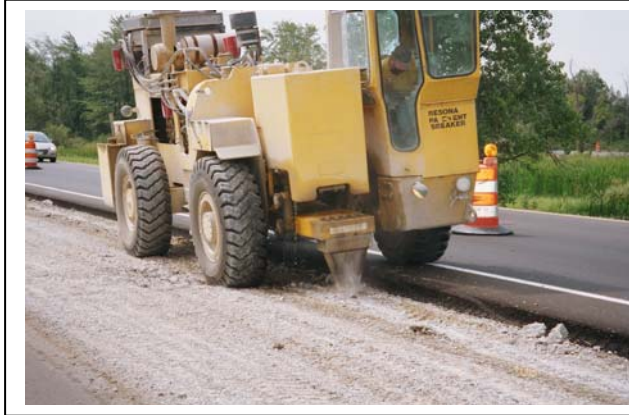
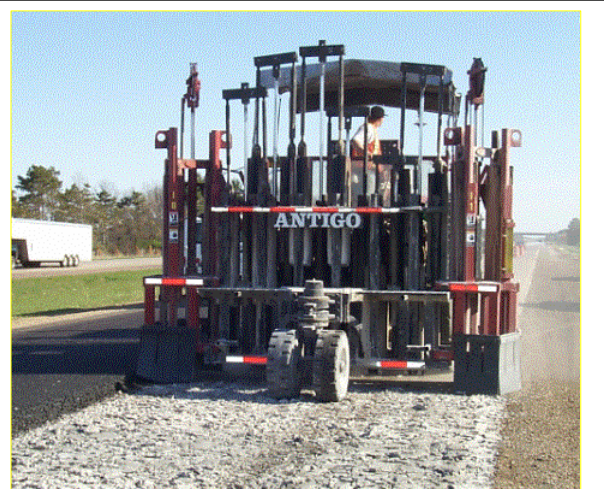
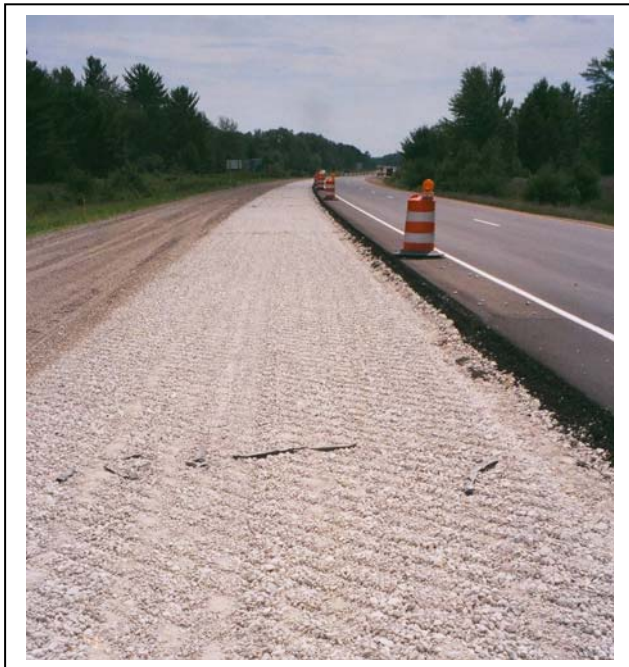
**Figure 19 Equipment Used to Rubblize Deteriorated PCC Slabs**

a. Resonant Frequency Pavement Breaker

b. Multiple-Drop Hammer

c. Compacted Surface of Rubblized PCC Slabs

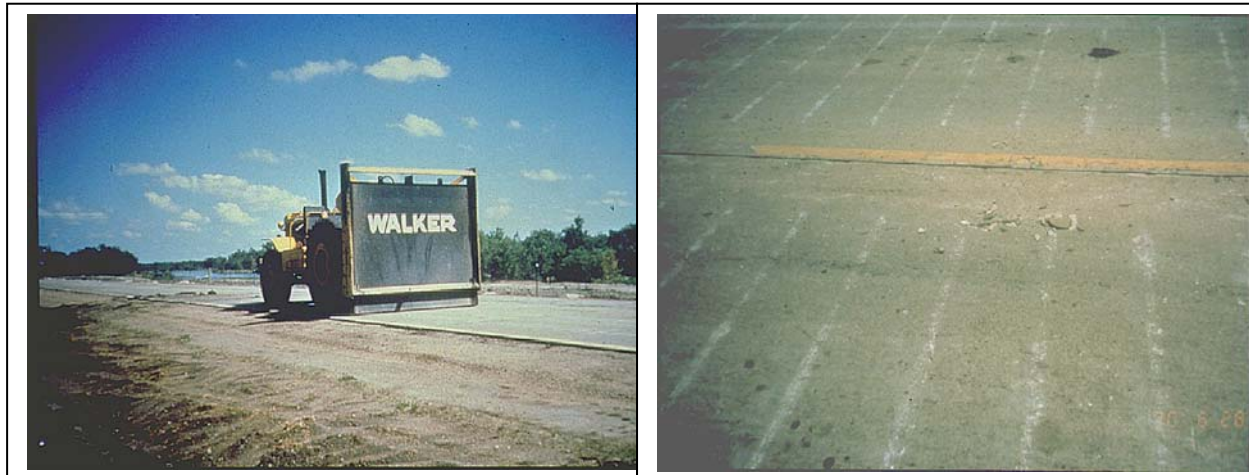
**Figure 20. Crack and Seat or Break and Seat Equipment for Fracturing PCC Slabs**

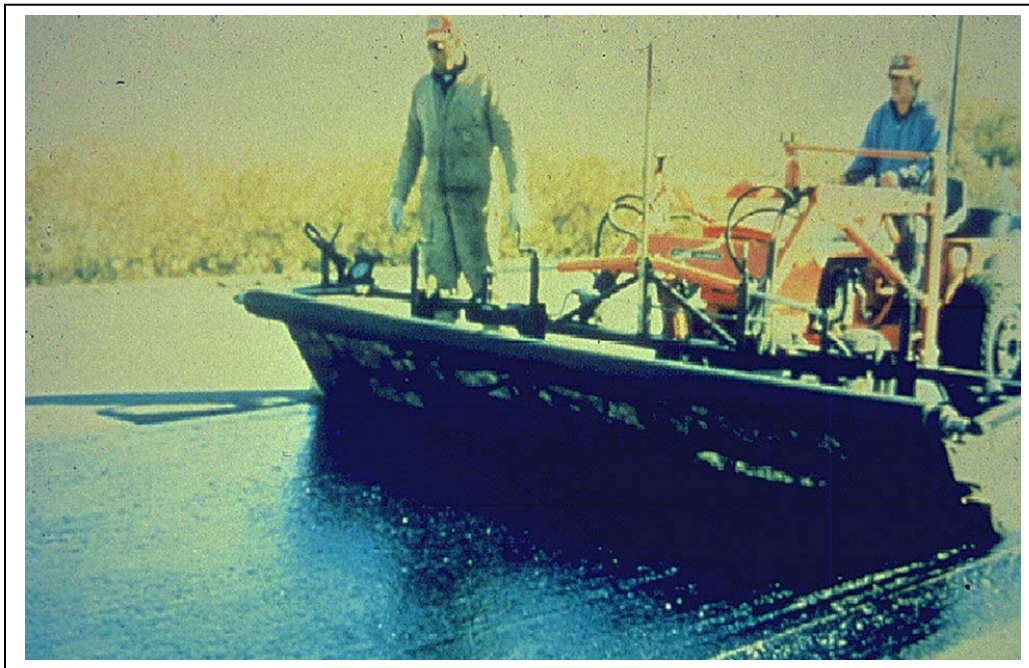
**Figure 21 Geosynthetics Interlayer Used in a Stress/Strain Interlayer**

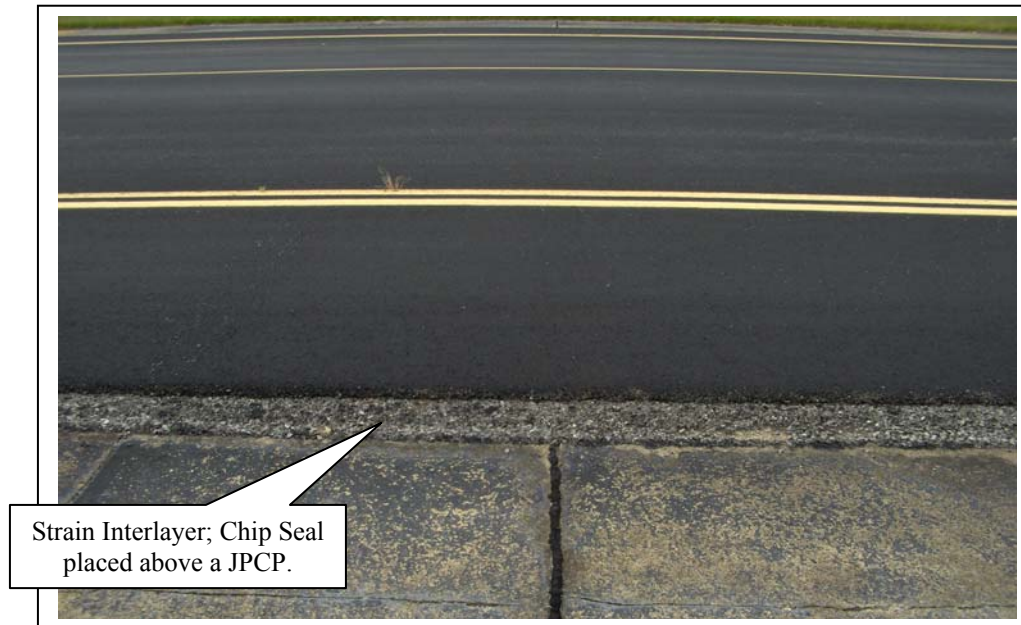
**Figure 22 Stress or Strain Relieving Interlayer Placed Above a JPCP**

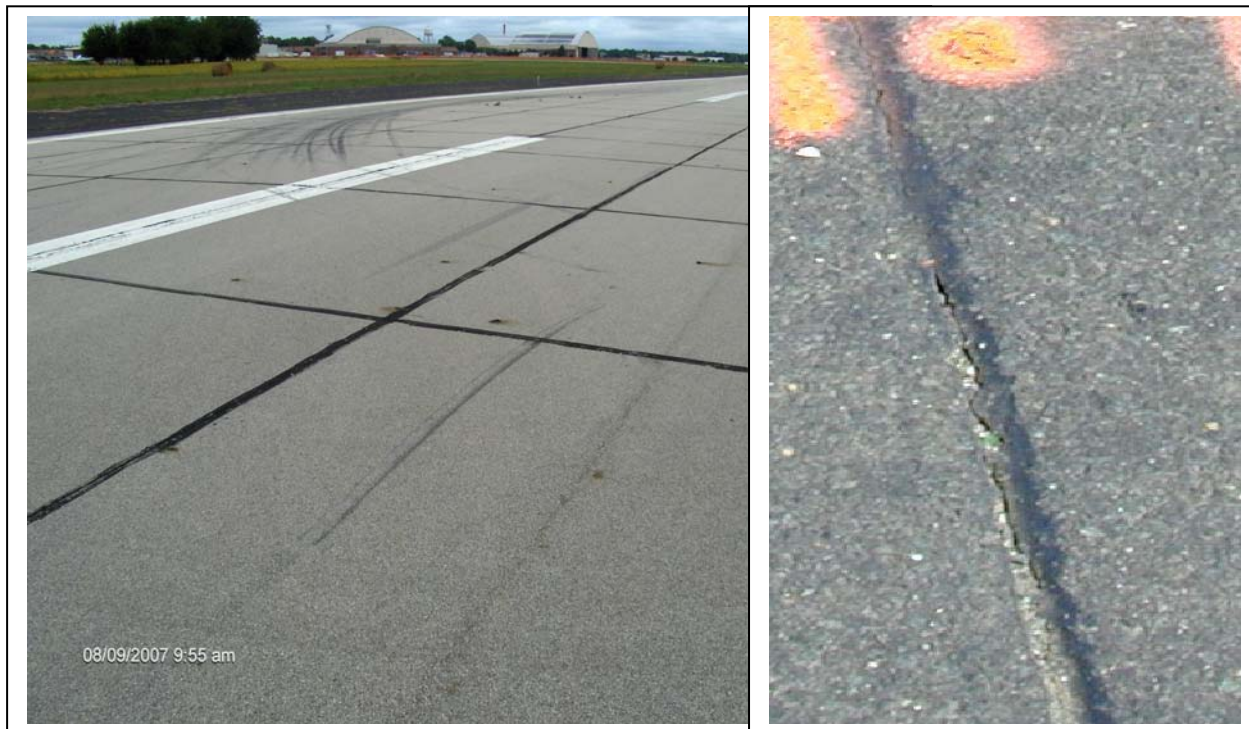
**Figure 23 Saw and Seal Method for Crack Control**

When used under the appropriate conditions, this method has a very high degree of success with a very low risk (figure 23). The one performance issue is that the sawed and sealed joints in the HMA overlay will need to be resealed with time. There is insufficient performance data to determine the period of time between joint reseal applications. However, previous experience suggests that the joints should last for 10+ years, assuming good materials (not susceptible to moisture damage) and good compaction. Airport maintenance should plan or develop a schedule for inspecting the joints over time.

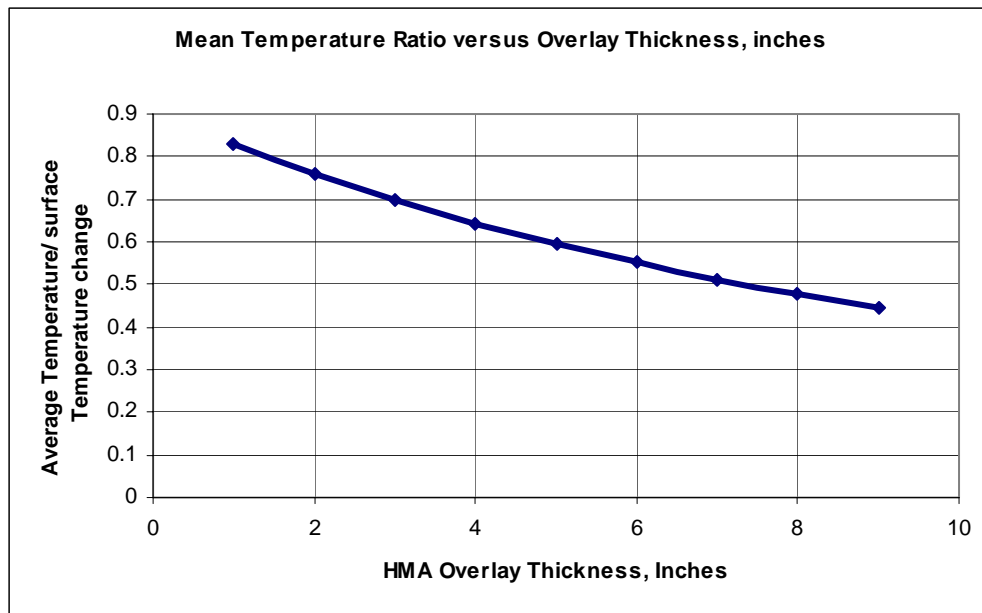
Figure 27. Determine the temperature ratio of the average temperature change in the overlay to the design surface temperature change (Lytton, 2008)

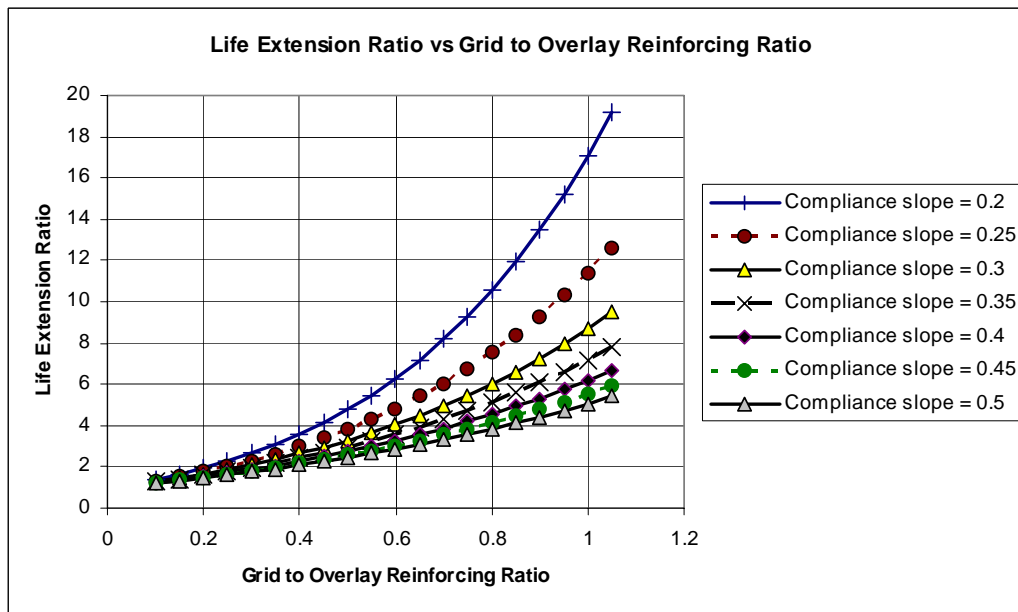
Figure 28. Determination of the Life Extension Ratio for Geogrid Reinforced HMA Overlays

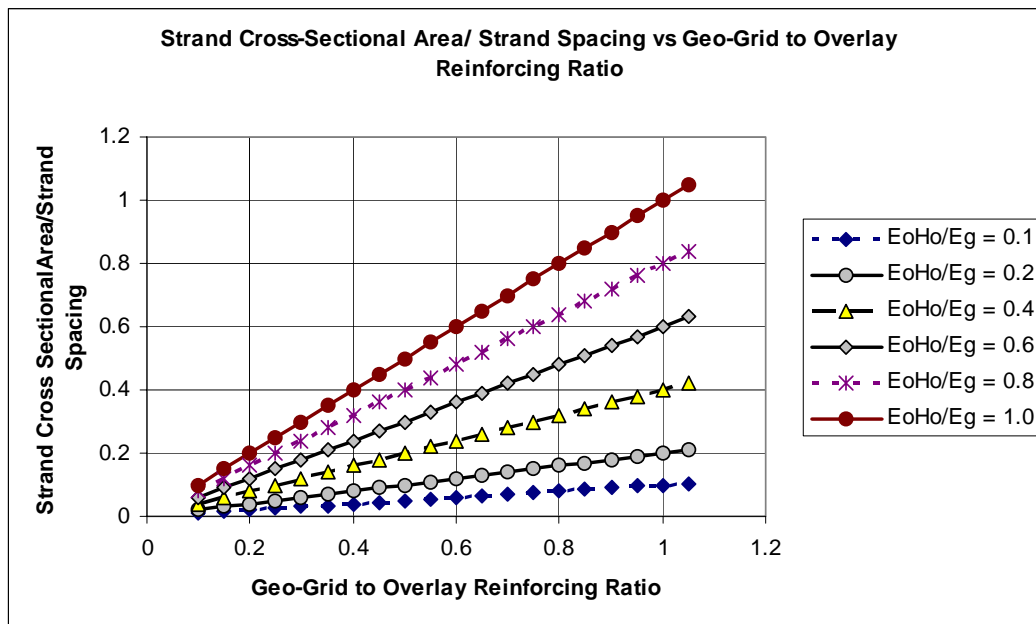
**Figure 29. Determination of Required Ratio of the Geogrid Strand Area to Strand Spacing**

- Step 7—Enter Figure 29 with the same product computed in Step 5 along the horizontal axis and go vertically upward to reach the proper curve for the ratio of overlay stiffness-to-grid material stiffness,  $E_o H_o / E_g$ , and then from this point, go horizontally to find the required ratio of the geogrid strand area,  $a$ , to its strain spacing,  $s$ . If the  $a/s$  ratio is not provided by the trial geogrid selected in Step 5, then assume another trial geogrid and repeat steps 5 through 7 until a satisfactory geogrid is found.

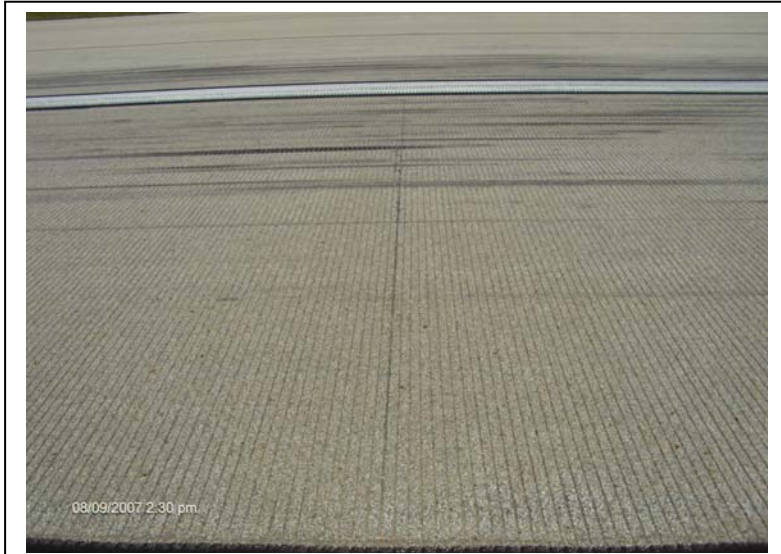
Willard Airport – PavePrep Section

After a planned PCC overlay did not work, a 1.5-inch HMA overlay was placed on runway 14L/32R in late 1998 so that the runway was available during the winter months. In 1999, ISAC (23,134 ft) or Pavement (23,134 ft) was placed on the transverse joints (95% had reflected through), then a nominal 6.5" asphalt overlay was placed. The pavements that intersect this runway offer transition overlays and provide control sections. The thin HMA overlays at this airport leave little chance for most, if not all joints to reflect through at some point. It should also be noted that the Pavement material was installed directly on the PCC, instead of between lifts of the overlay as recommended by the manufacture.

- Some transverse joints have low severity ( $\leq \frac{1}{4}$  inch wide) cracks.
- More transverse joints have cracks in the portion of the runway that was extended in 1974. Construction records indicate 20- 21 inches PCC.
- Fewer transverse joints have cracks in the original portion of the runway which also contains 20- 21 inches PCC, but was constructed as two lifts, one in 1948, the second in 1974

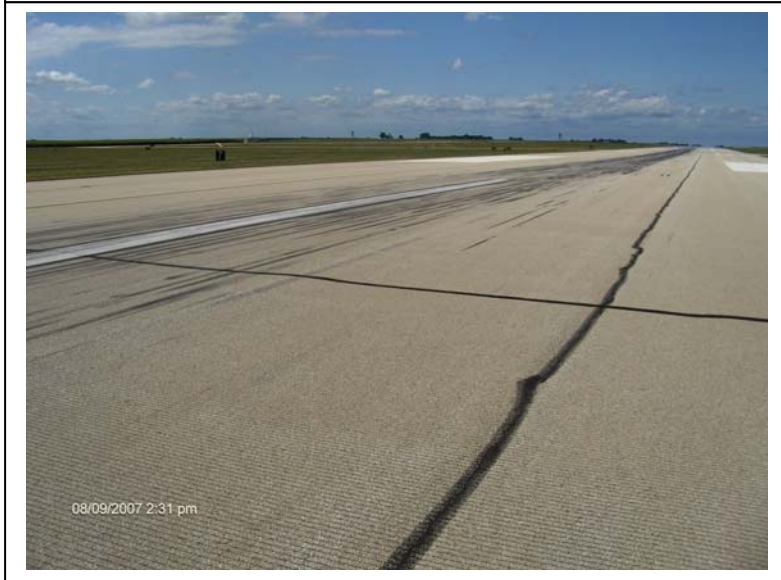
Willard Airport – ISAC Section

- Less cracking overall compared to the Pavement section
- Transverse cracks are low severity

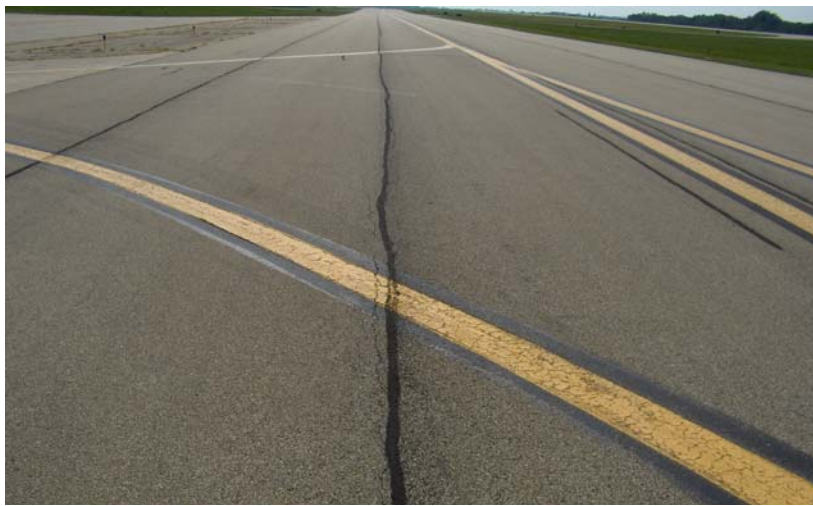
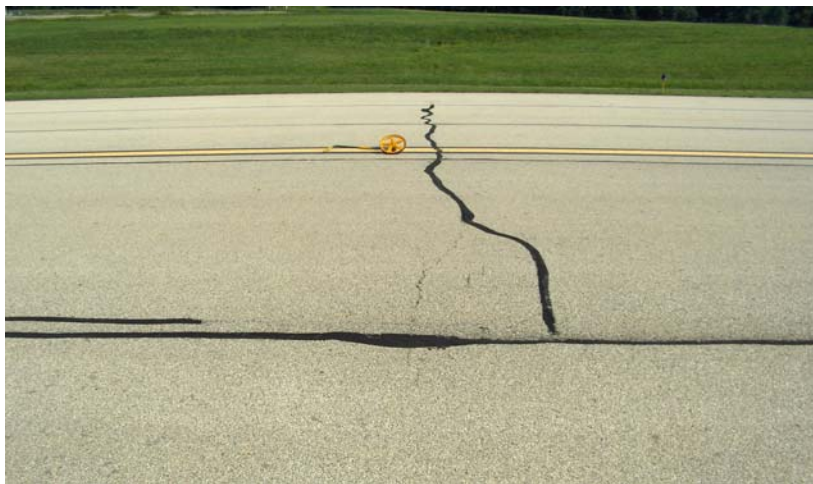
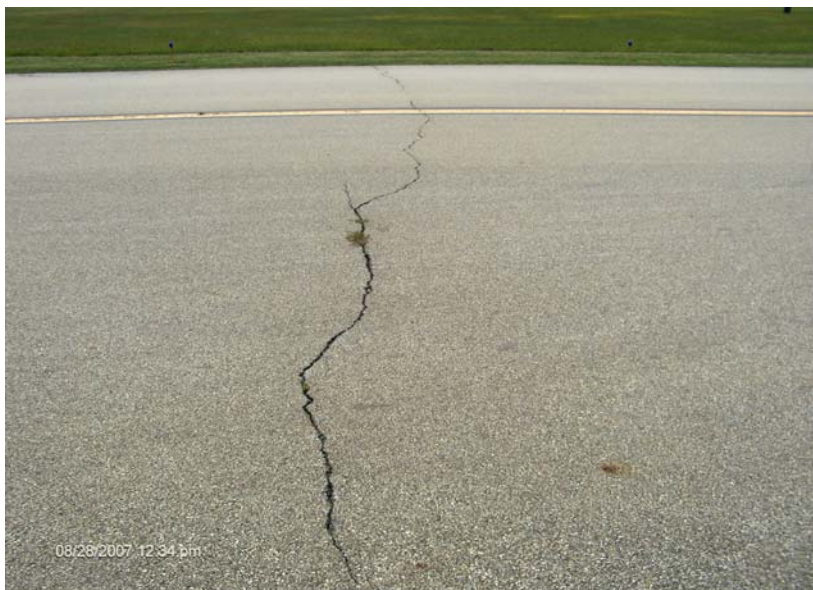
Peoria Regional Airport –  
Control Section

Peoria Regional Airport –  
Glasgrid Section

Peoria Regional Airport –  
Strain Relieving Interlayer  
Section

The techniques used in Sections 2 and 3 appear to ultimately allow reflective cracks to develop, but at more manageable state (crack width is  $< 1/4$ ") and perhaps at a slower rate compared to a pavement with no pre-overlay repairs.

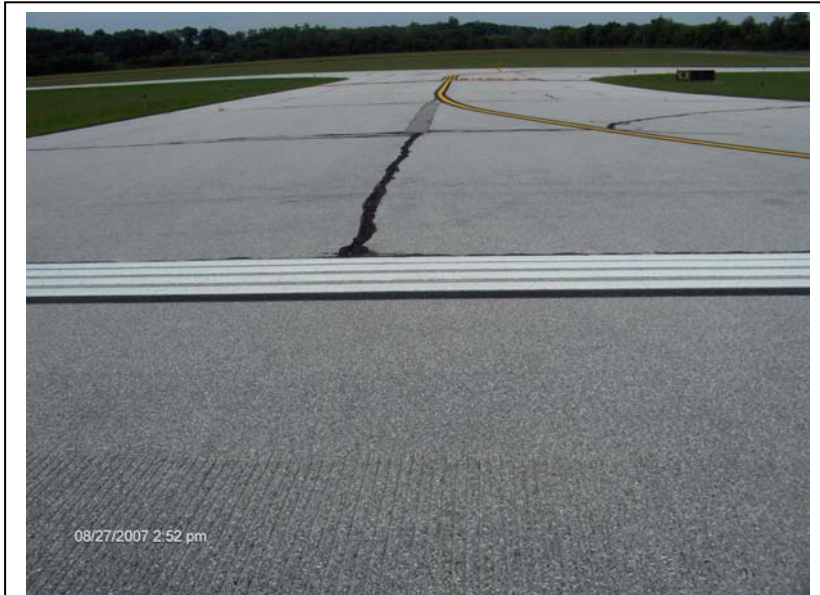
Purdue University Airport –  
PavePrep Section with 4-inch  
P-401 Overlay for Taxiway  
Rehabilitation.

It appears the combination of the pulverization of the old asphalt surface and placing saw cuts at 100' intervals has virtually eliminated the occurrence of transverse cracking on this pavement. The majority of the longitudinal cracking is occurring at paving lane seams as expected for original or overlaid asphalt pavements.

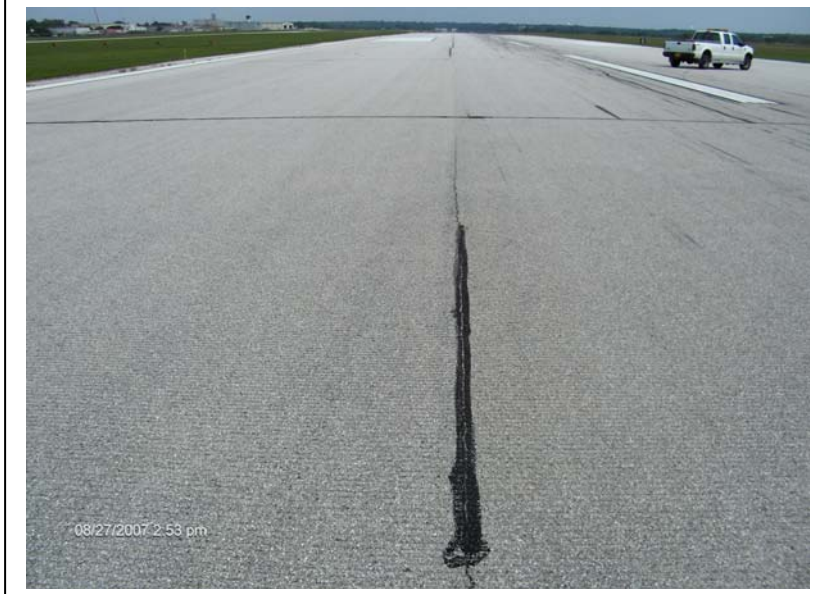
Purdue University Airport –  
Full-Depth Reclamation for  
Runway Rehabilitation.

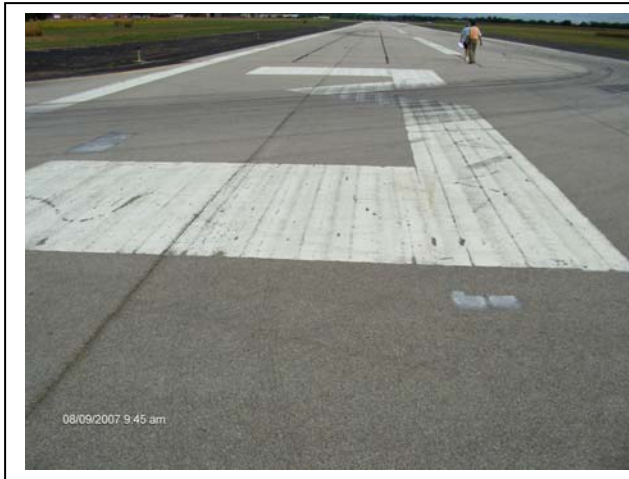
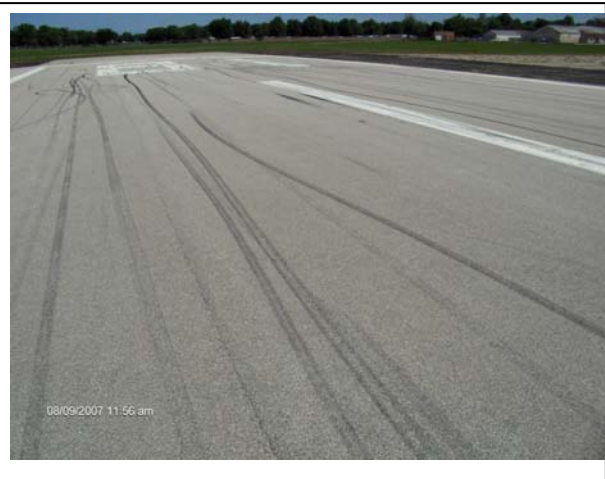
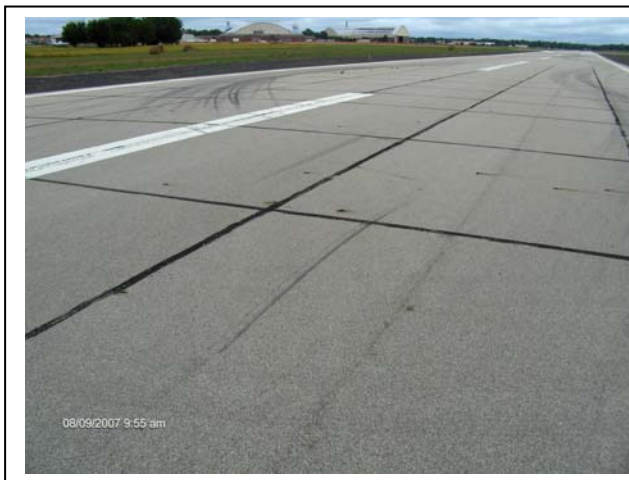
Rantoul Airport – Control Section

Rantoul Airport – Rubblized Section

Rantoul Airport – Saw and Seal Section

Rantoul Airport – ISAC Section; After Saw & Seal Section

roughness, more so in the 18” and 9” sections. It appears that the smaller sized rubblization technique will add benefit to the final product based on the overall condition of the asphalt so far.
