NCAT Report 06-04

Forensic Investigation of a Rich-Bottom Pavement

December 2006

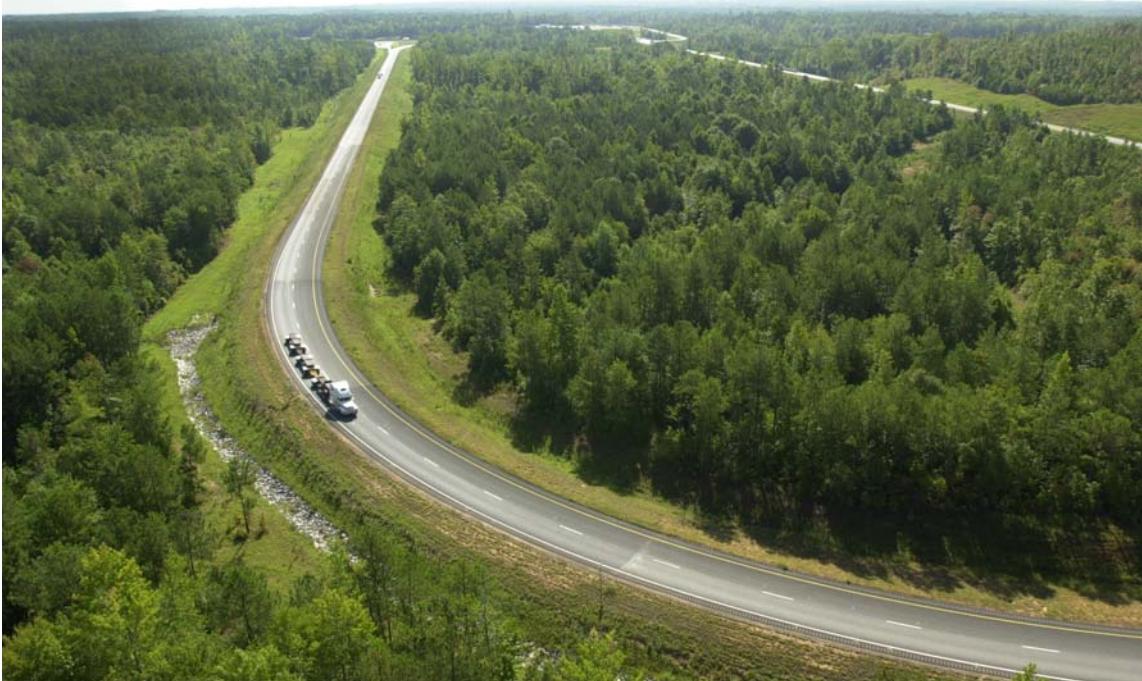
Figure 1.2 NCAT Test Track.

In 2003, the National Center for Asphalt Technology (NCAT) rebuilt the original 1.7 mile Test Track, seen in Figure 1.2, in Opelika, Alabama. The track is an accelerated loading facility where the pavement is subjected to approximately 10 million ESALs in two and a half years. Included in this new study were eight 200 ft structural test sections to investigate mechanistic-empirical pavement design and analysis concepts. All eight sections were built upon an improved roadbed and 6 inches of crushed aggregate base course. The differences in the 8 sections were the thicknesses and designs of the HMA layers as indicated in Figure 1.3.

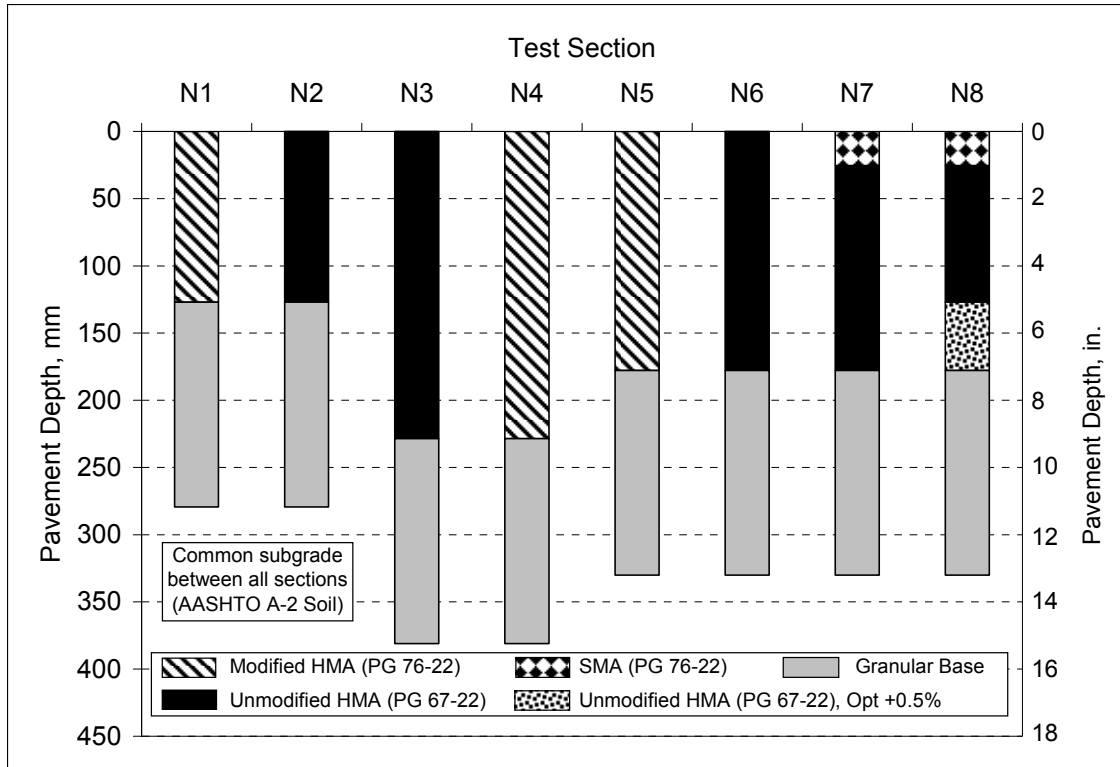
Figure 1.3 Structural Study Cross Sections (Priest and Timm, 2005).

Sections N7 and N8 are the two sections of particular interest to this report due to their similarities. As can be seen, each HMA layer was 7 inches thick comprised of a 1 inch SMA layer at the top of the pavement. The only difference in the two sections was the 2 inch rich bottom layer as the bottom lift in N8 where the additional asphalt decreased total air voids by almost 2 percent. Figure 1.4 and Table 1.1 give properties for the mixes used in the construction of N7 and N8. In both of these sections, strain gauges were built into the pavement structure at the bottom and on top of lift four.

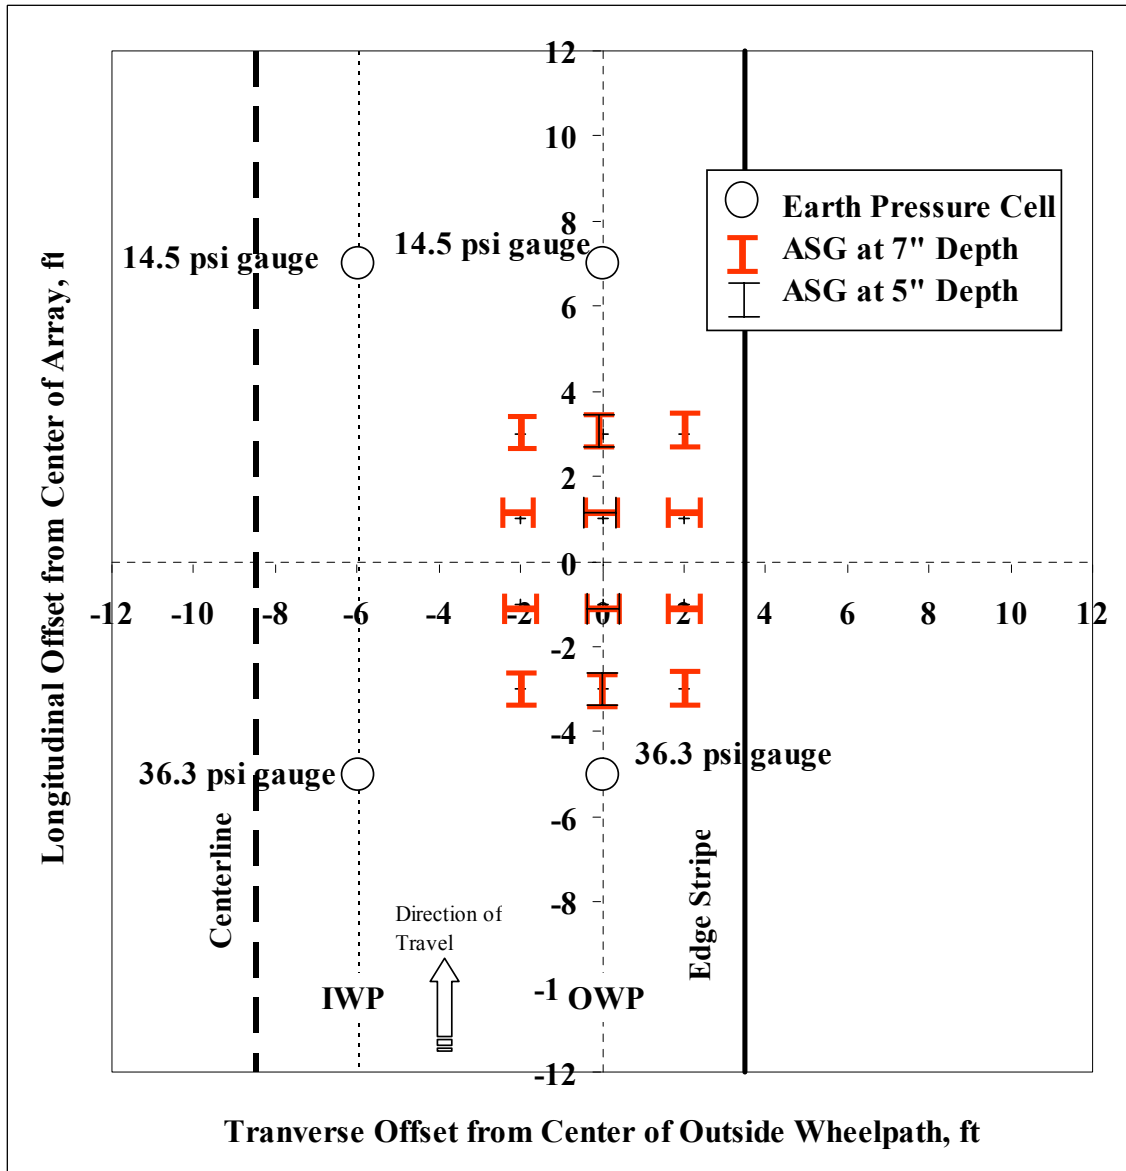
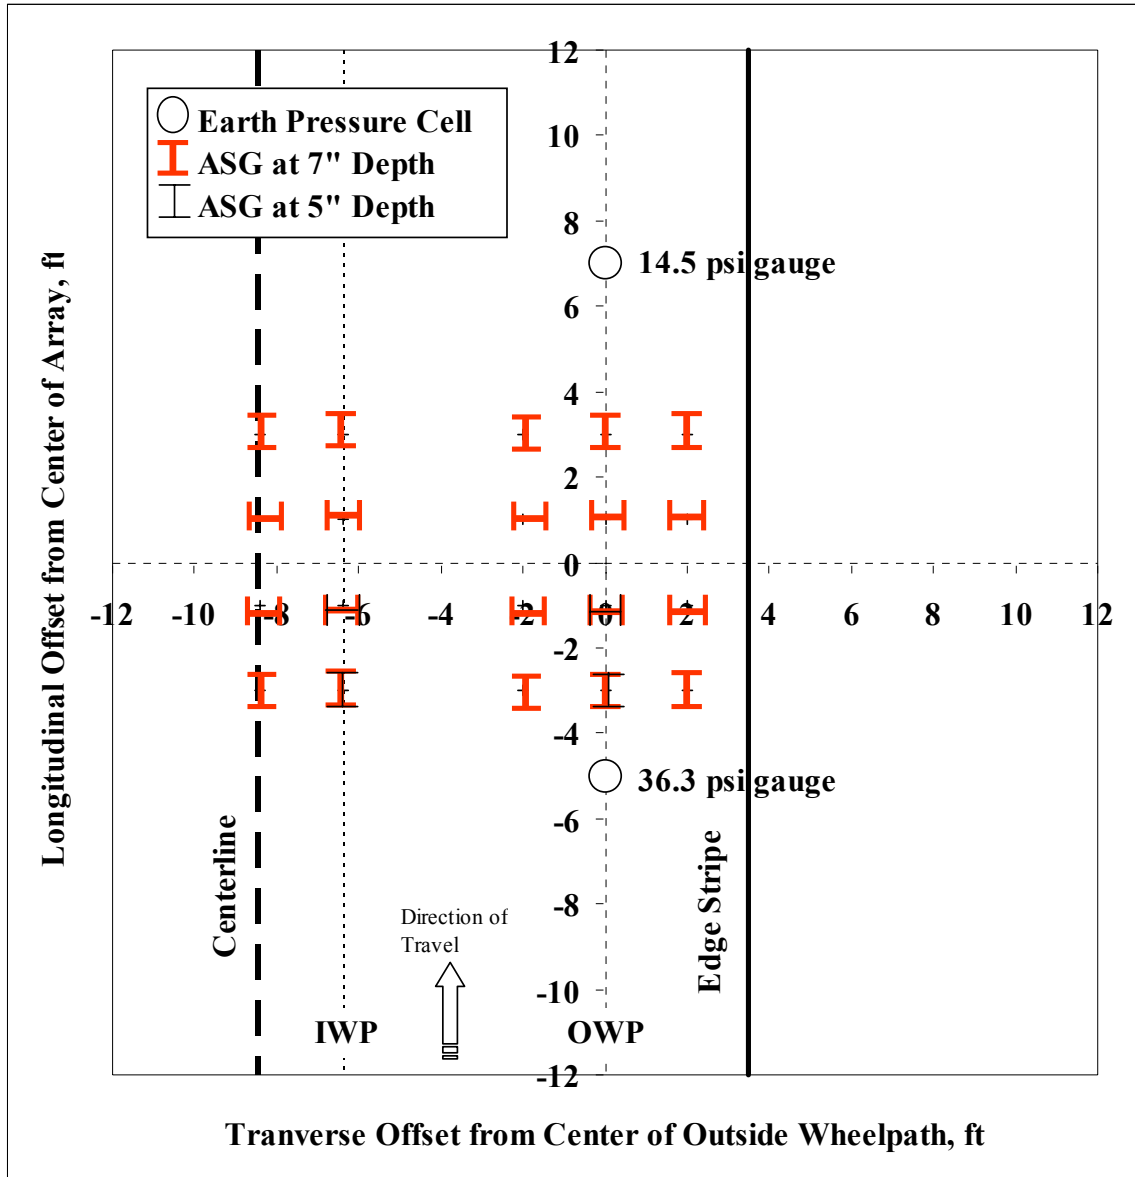
Figure 2.1 N7 Gauge Arrangement (Timm *et al.*, 2004).

The strain gauges were installed in two different layers in the locations marked in Figures 2.1 and 2.2. One set of gauges was at a depth of 7 inches, corresponding to the HMA and base interface. The second set of gauges was built into the pavement at a depth of 5 inches. In N8, this was the interface between the rich-bottom layer and the regular HMA structure.

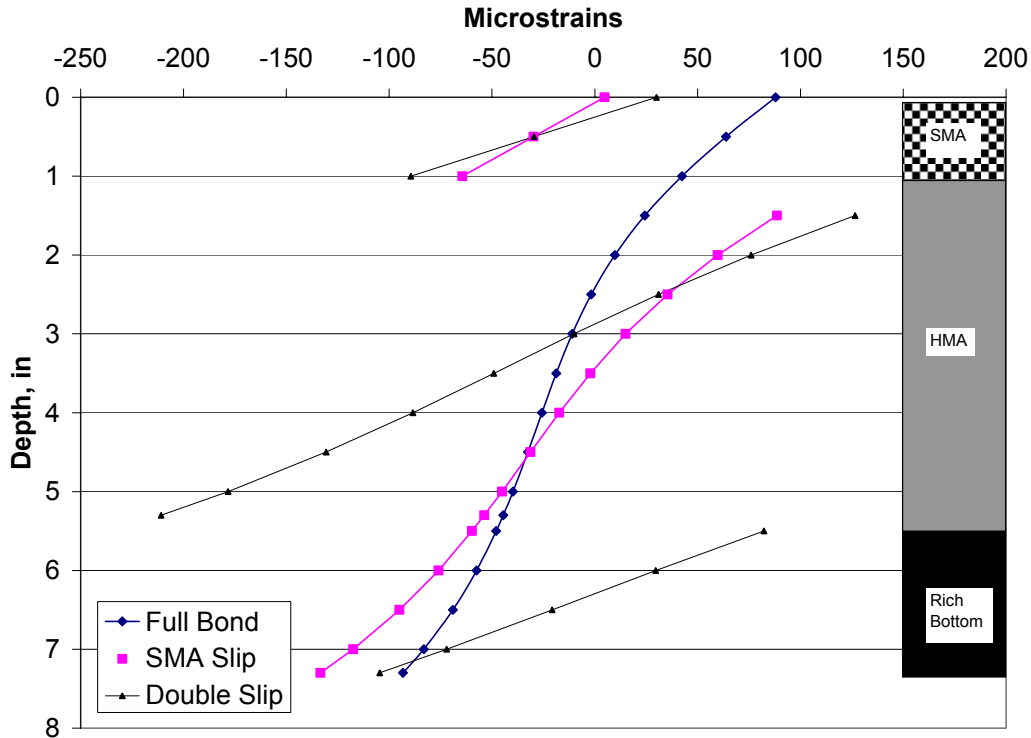
Figure 2.9 Theoretical Strain Profile of 7.3 inch Pavement.

Next, in order to present the data in a useful form, a ratio of the strains, 7.3 inch (bottom) to 5.3 inch (lift), was calculated for both of the bond conditions. At full-bond, the strains produced a ratio of 2.078. If debonding were to occur at the SMA layer, the ratio of the two strains would be 2.48. The double slip incurs a ratio of 0.496.

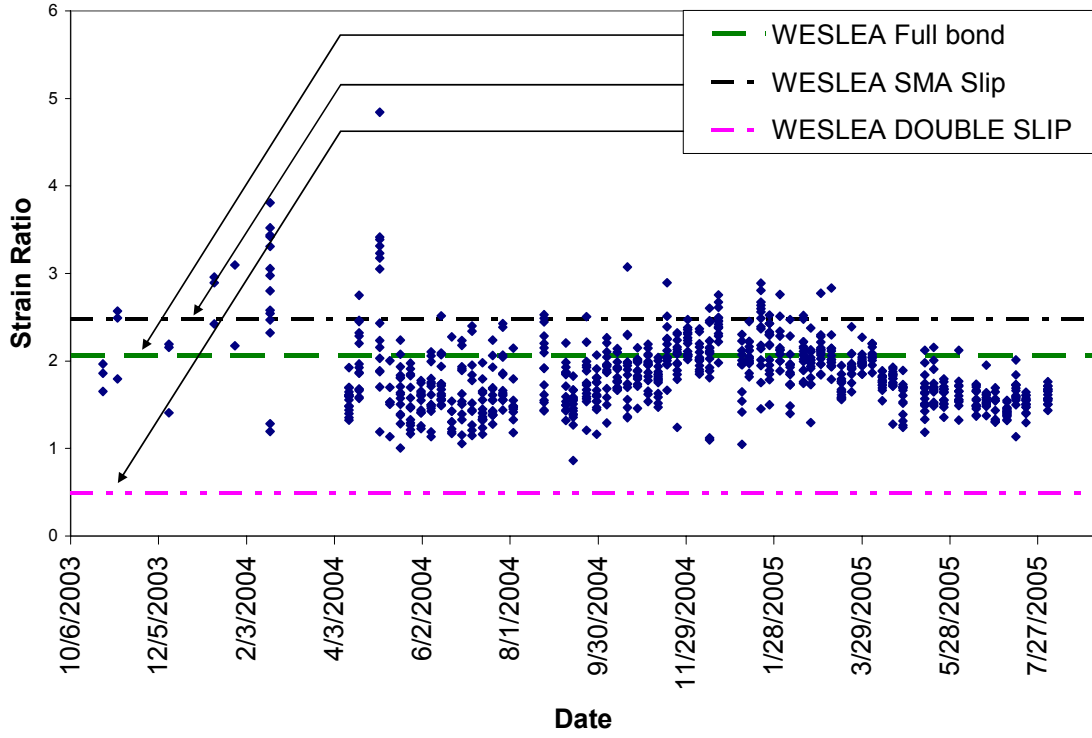
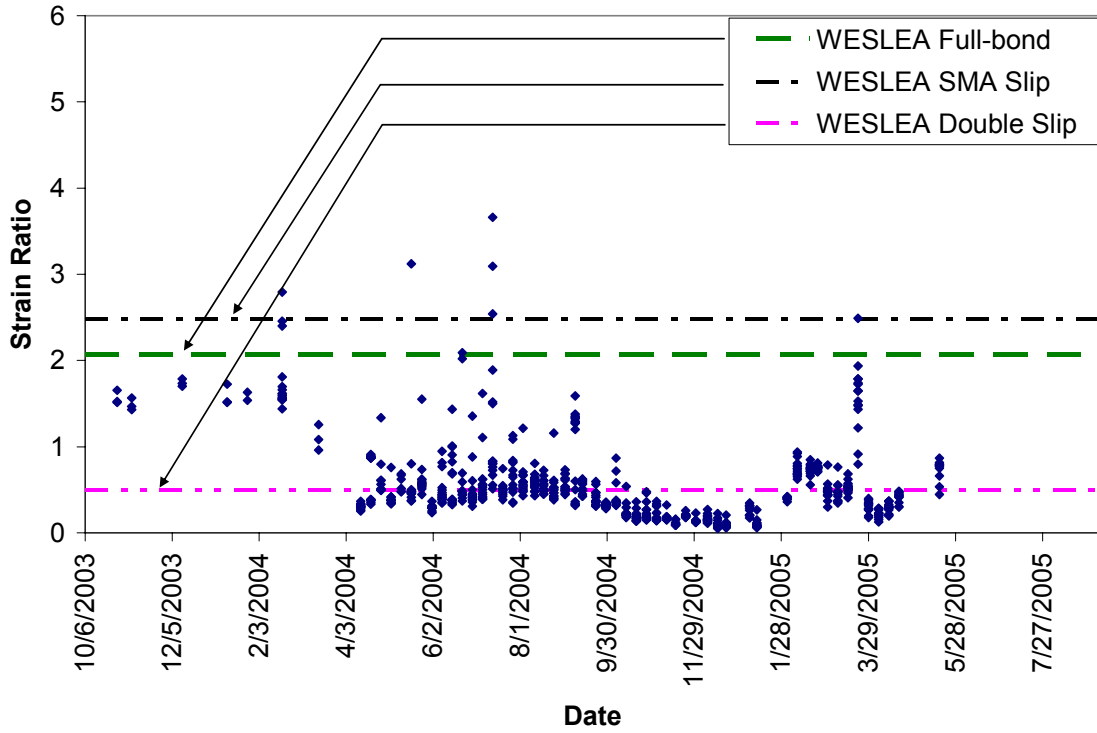
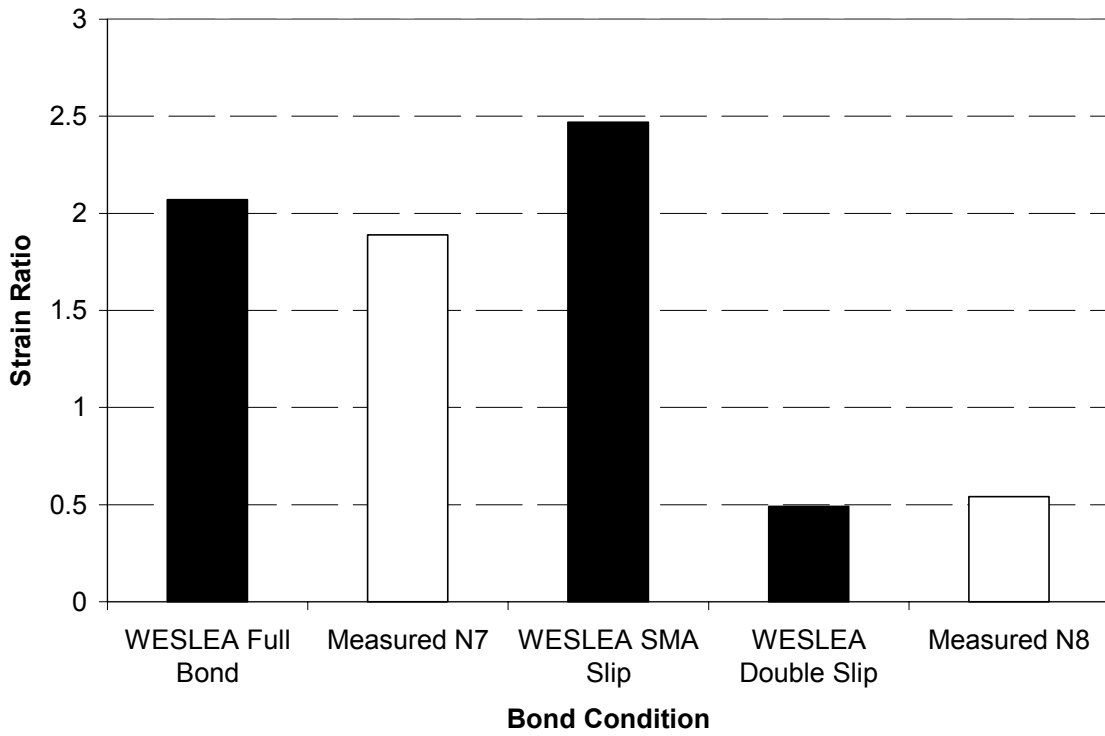
All of the measured strain values were averaged by truck for each day, and ratios were calculated as done for the WESLEA analysis. Ratios were calculated for both N7 and N8 in the outside wheelpath. The ratios were then plotted over time with the WESLEA averages superimposed in Figures 2.10 and 2.11. Inspection of these figures shows that the strain ratios for N7 compare favorably to WESLEA ratio for full-bond, as summarized in Figure 2.12. The measured average ratio for N7 was 1.84. The strain ratios for N8 graphically relate to the WESLEA double slippage ratios. The measured average strain ratio for N8 was 0.542 compared to the WESLEA value of 0.496. If the ratio for N8 is taken from the date when the 5 inch depth strain first surpassed that of the 7 inch strain, the average ratio is 0.49. This analysis supports the idea that debonding occurred in N8 while N7 remained fully bonded. Neither of the values is similar to the SMA slippage only ratio of 2.48.

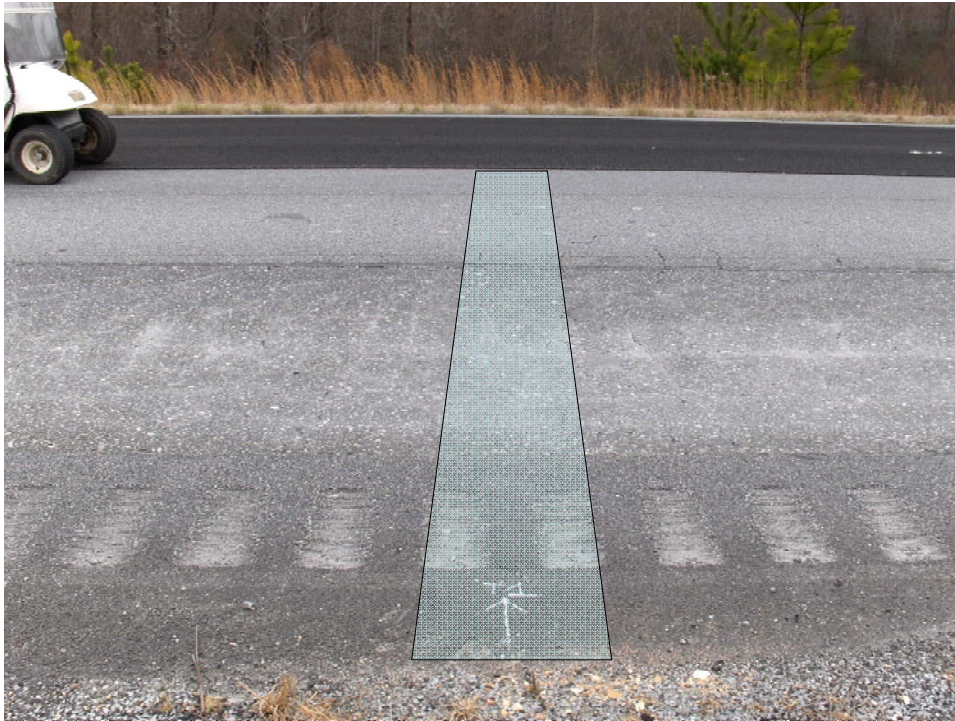
Figure 3.1 Location of Trench 1.

Trench 1 (Figure 3.1) was cut through the middle of the gauge array. This location had heavy fatigue cracking, and base material pumping from the cracks could be seen.

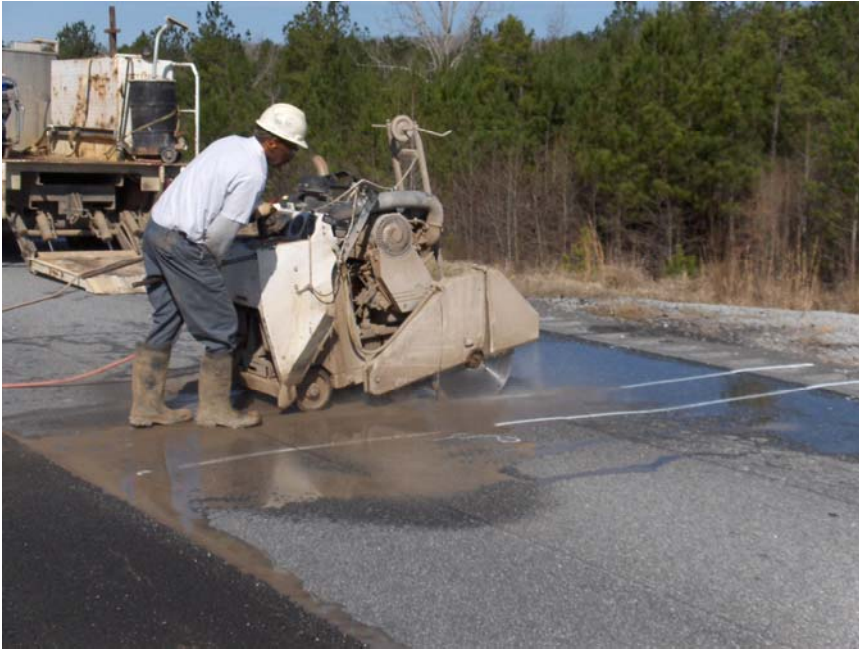
Figure 3.5 Cutting Trench 1.

On March 14, 2006, the three trenches were cut and ran transversely across the pavement from the outside edge to the centerline in locations shown in Figure 3.4. The trenches were cut, as seen in Figure 3.5, to a depth just below the HMA layer to enable inspection

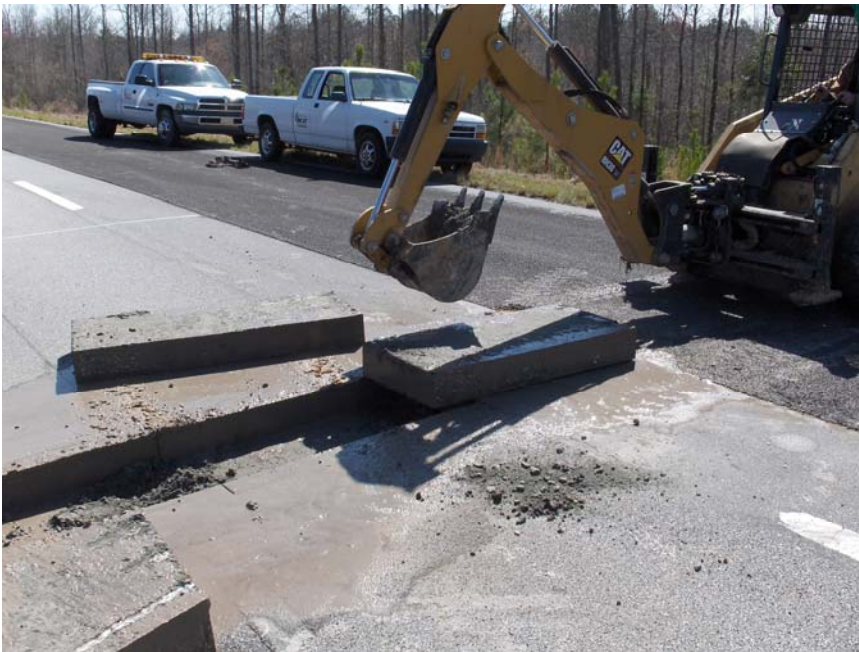
of the bottom of the rich-bottom layer. Once the trenches were cut, a backhoe was used to remove the asphalt in slabs (Figure 3.6). Upon removal of the slabs in Trench 1, the presence of debonding was physically confirmed at the SMA/HMA interface, Figure 3.7.

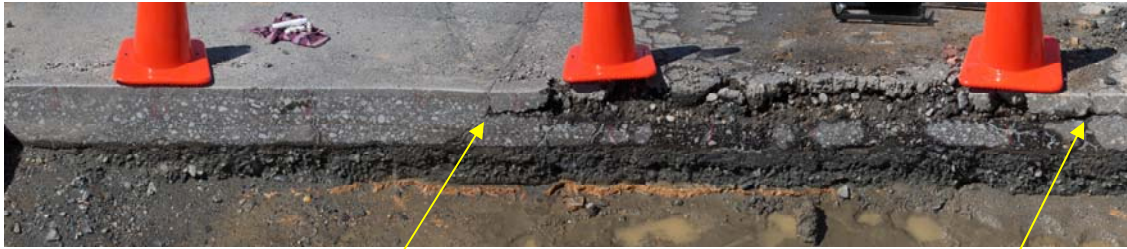
Figure 3.8 Trench 1 West Face.

Trench 1 is shown in Figure 3.8. Trench 1 was the location where the heaviest fatigue cracking existed, specifically along the outside wheelpath. The lower layers of the pavement structure showed the heaviest fatigue damage, as well.

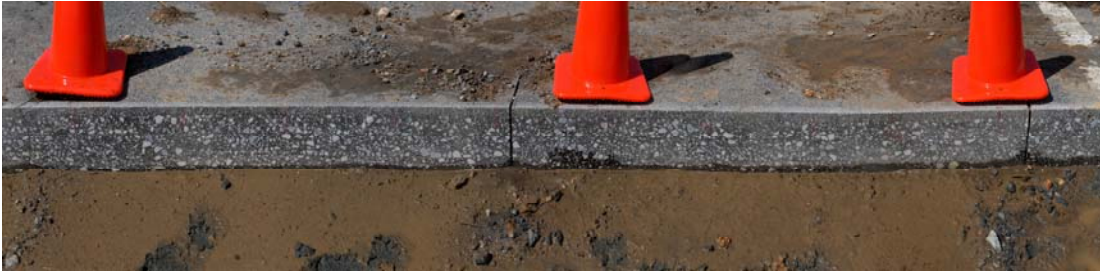
Figure 3.11 Trench 3 West Face.

Trench three, shown in Figure 3.11, was cut in a location just inside N8 where virtually no surface damage had been observed. The crack mapping investigation provided evidence that the interior of the pavement had not been damaged either. The SMA, HMA, and rich bottom layers were still bonded and free of fatigue cracking.

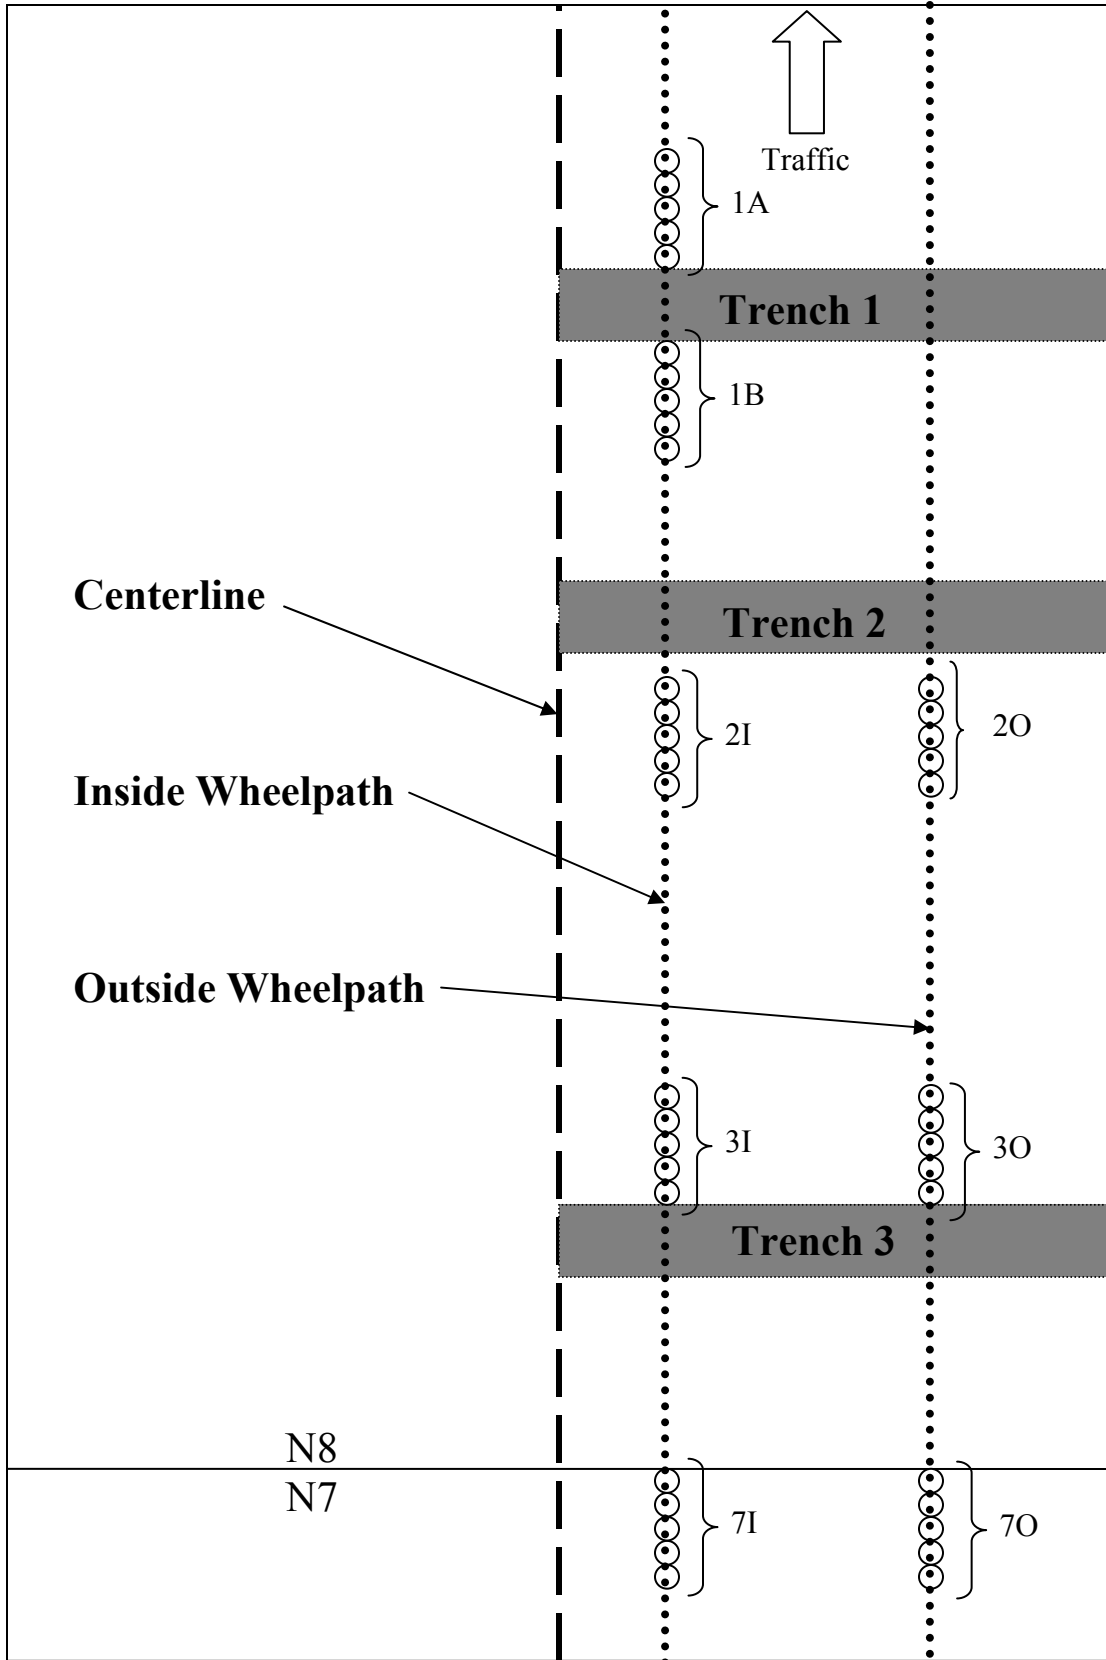
Figure 4.1 Core and Trench Locations.

In order to pursue this analysis procedure, forty 6 inch diameter cores were taken that could be tested for bond strength. Ten cores were taken near each trench, and ten control cores were taken from N7 as shown in Figure 4.1. Five cores came from each wheelpath with the exception of Trench 1. The extent of the fatigue damage at Trench 1 made it physically impossible to remove a core intact; therefore, five cores were taken downstream (relative to the direction of traffic) and five were taken upstream of the trench location in the inside wheelpath. The core groupings for trench 1 were labeled "A" and "B" corresponding to after and before the trench, respectively.

Bond strength tests were run on all 40 cores at the 1 inch depth and 5 inch depths. The strength results are found in Appendix B while their summary statistics are found in Table 4.1 and Figure 4.9. Figure 4.1 can again be referred to for core locations.

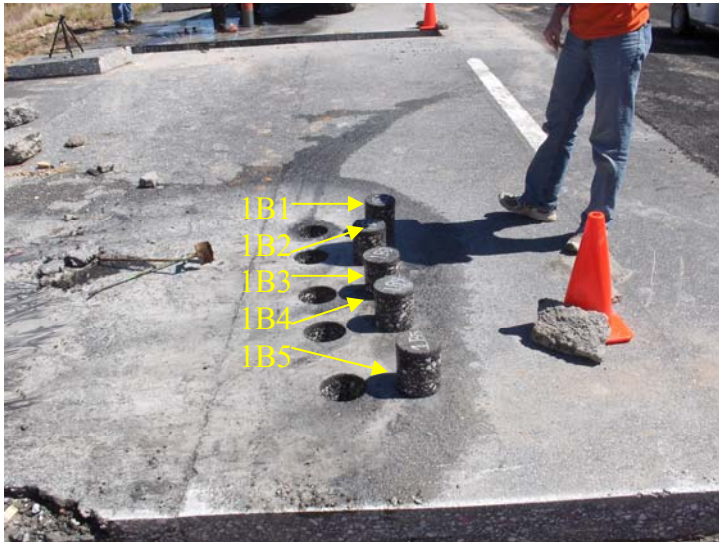
Figure 4.2 Cores Taken Before Trench 1.

The cores were labeled by trench, wheelpath location, and longitudinal location from 1 to 5. Those labeled 1 were furthest downstream of the trench location as can be seen in Figures 4.2 and 4.3. Upon completion of the coring process, the cores were transported back to the NCAT laboratory for bond strength testing using a simple shear apparatus in a Marshall load frame.

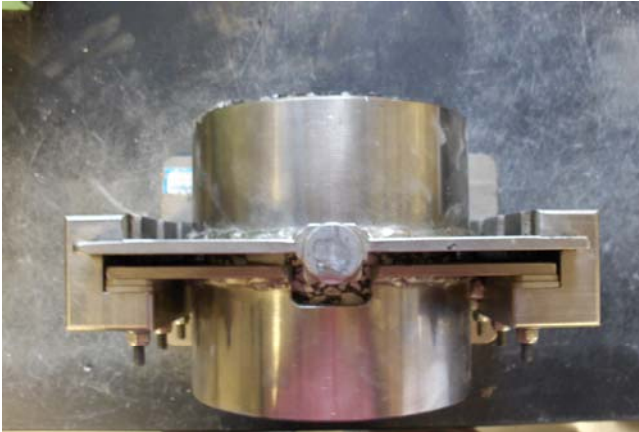
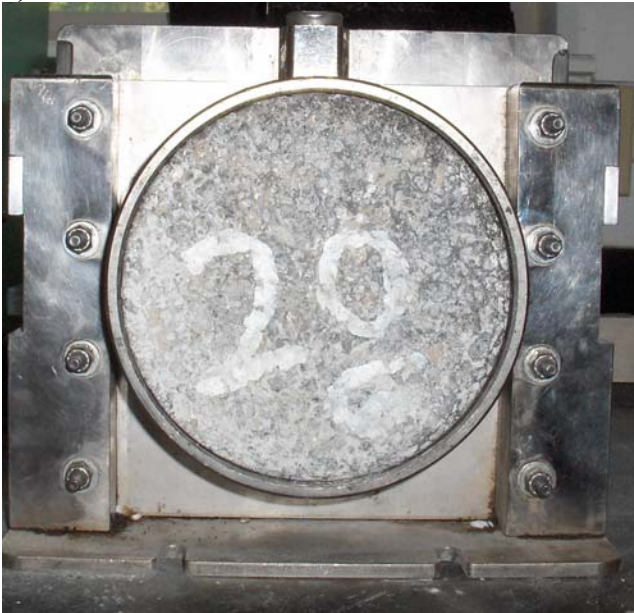
Figure 4.4 Core Fitted in Shear Collar.

Bond strength testing was conducted at the NCAT laboratory. In order to test for bond strength, the 6 inch cores were loaded into a fitted collar (Figure 4.4). This collar applied a shear force to a desired portion of the core while holding the rest of the core fixed (Figure 4.5). A Marshall Pine Recording Test Press, shown in Figure 4.6, was used to apply the shear force on the sample as specified by ALDOT's draft test method entitled the *Standard Test Method for Determining the Bond Strength Between Layers of an*

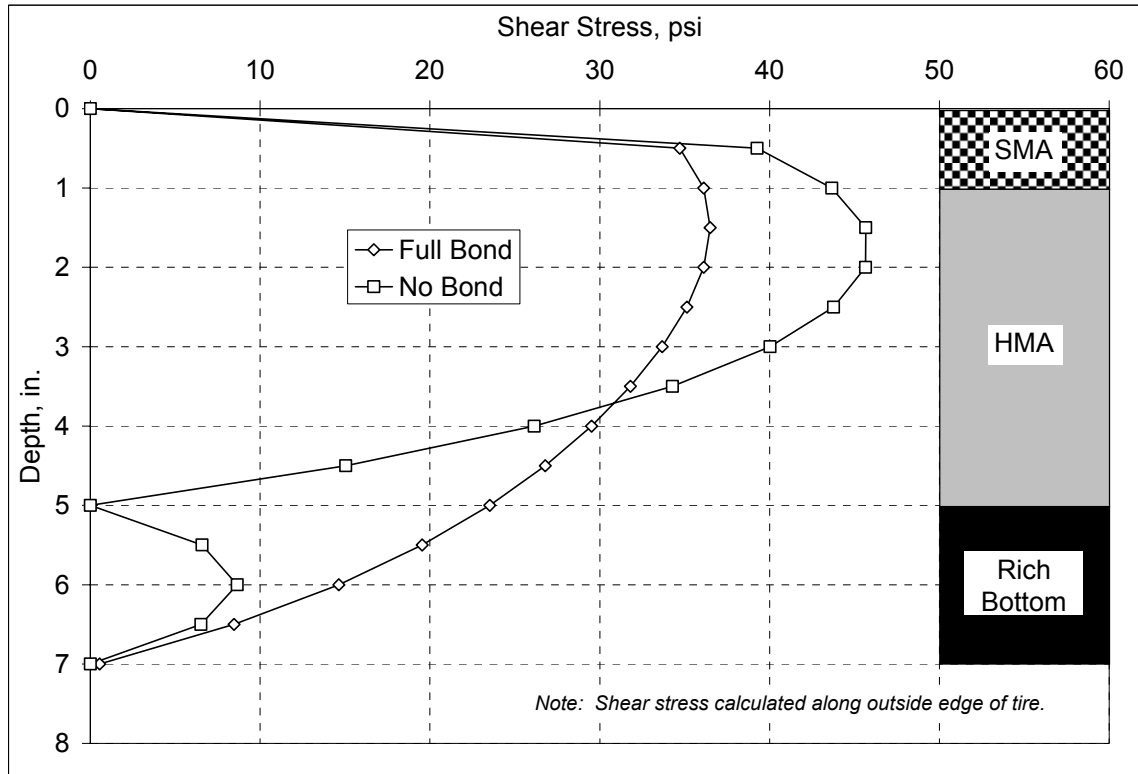
Figure 4.8 WESLEA Shear Study Results.

along the outside wall of the tire. This analysis (Figure 4.8) showed that the highest levels of shear would be concentrated just below the SMA layer of the pavement while lower shear stresses occurred at the HMA/Rich-bottom interface. This means that the bond strength between the SMA and HMA is critical. It is also important to note that the simulation lacking full bond resulted in the rich-bottom acting independently of the upper HMA layers.

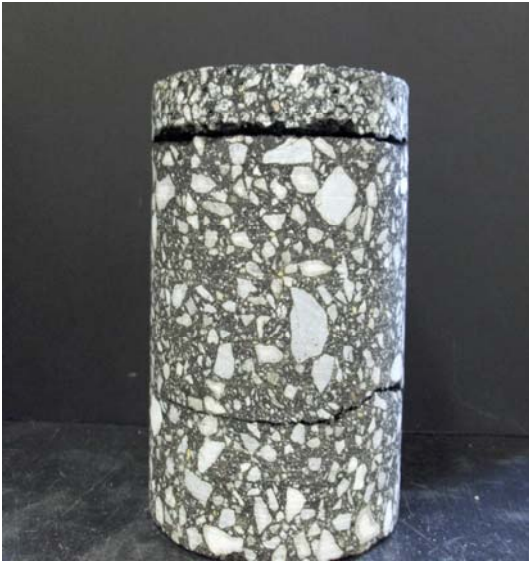
Figures 4.10 Core 1A1.

The cores from Trench 1 failed as expected. Figures 4.10 and 4.11 show the clean break exposing the rich black asphalt when the cores from Trench 1 were sheared. Cores from Trench 2 failed differently as shown in Figures 4.12 and 4.13. When shearing the 1” SMA layer from the core, many of the cores sheared at another location between 0.5 to 1 inch below the SMA interface. At a depth of 1 inch, the exposed surface was a rich black color. However, at the second break, the core was feeble and gray (Figure 4.14). Upon further inspection of the core, small cracks were seen in its base. The gray color could be the presence of fines that were ground from the pavement structure due to the debonding of the upper layers. Another effect of the shear loading was crack propagation throughout the top layer of SMA that was being sheared off (Figure 4.15).

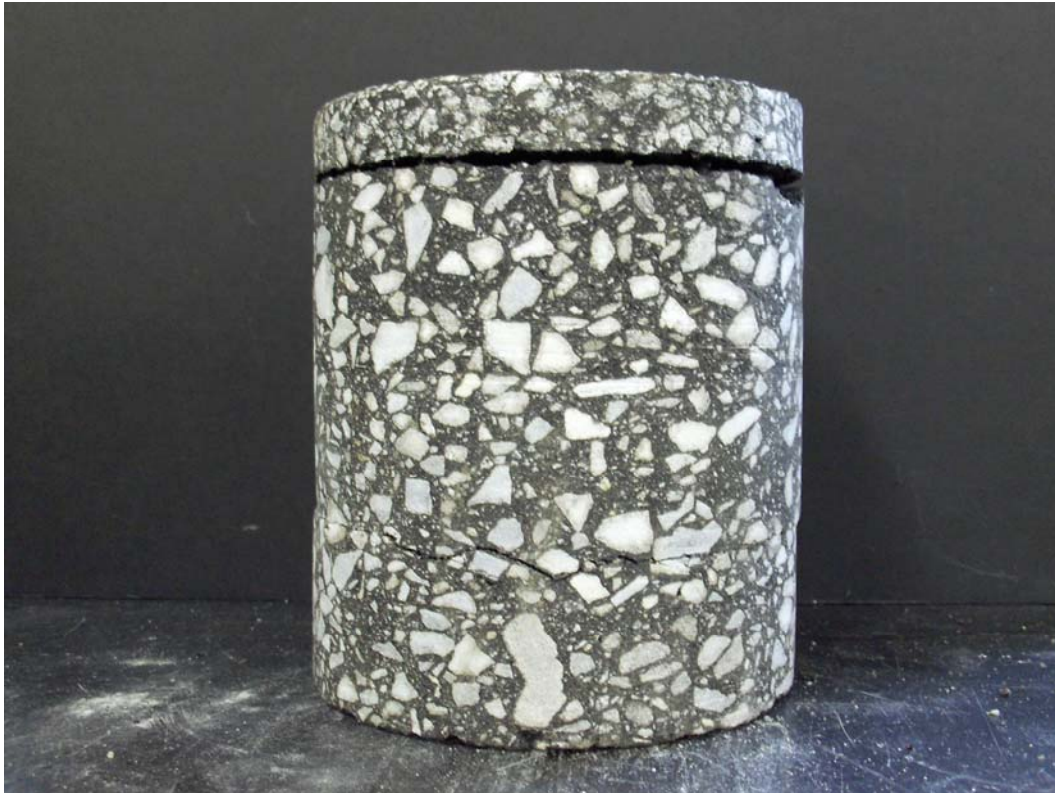
Figure 4.16 Core from N7.

along lift interfaces at both depths, the failure at the 5 inches depth of N7 was different. The top sheared off along the SMA interface, but instead of having a clean break along the lift at 5 inches, the failure line occurred more along the edges of the aggregates. In many cases, the bottom portion of N7's samples did not even shear off completely, but rather just shifted out of position slightly. This is shown in Figure 4.16.
