**NCAT Report No. 12-04**

**REFINEMENT OF THE BOND  
STRENGTH PROCEDURE AND  
INVESTIGATION OF A  
SPECIFICATION**

**Nam H. Tran  
Richard Willis  
Grant Julian**

**June 2012**

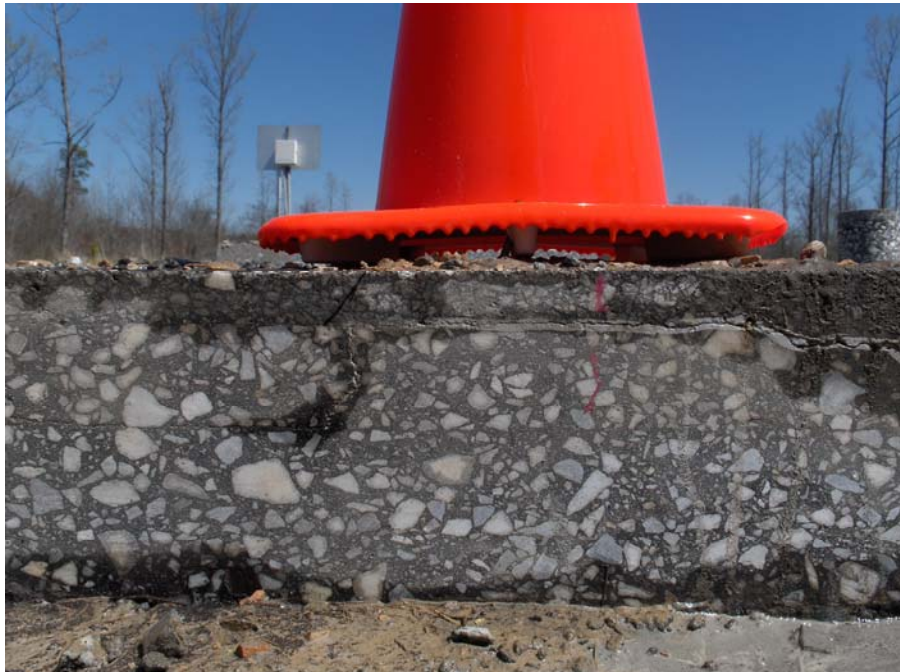
**FIGURE 1 Delamination in HMA Pavement (11).**

When bonded AC pavement layers lose adhesion and separate (FIGURE 1), the overall stiffness of the pavement decreases, inciting the development of pavement distresses (6, 7, 8). The pavement structure can be extensively damaged as cracking courses its way through multiple layers of the structure (FIGURE 2) (11).

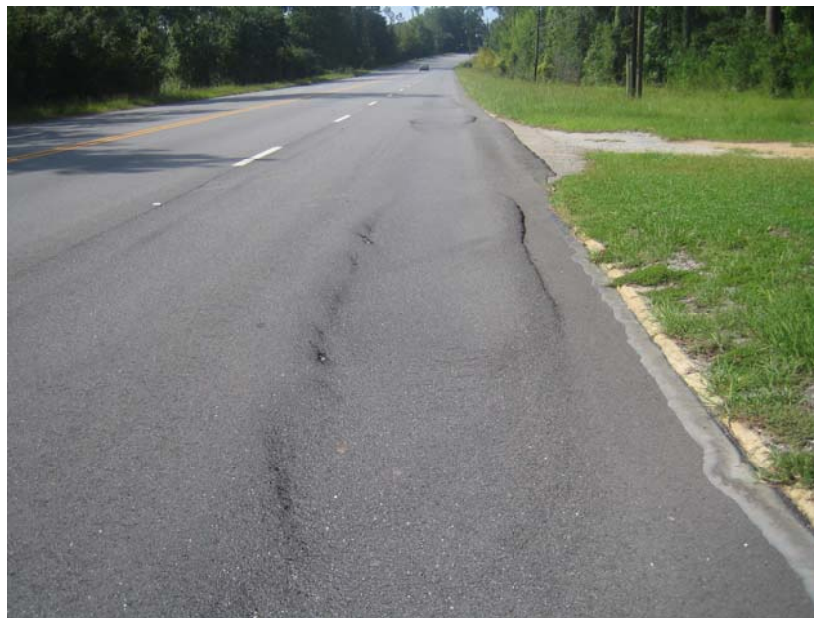
**FIGURE 3 Slippage Failure Due to Inadequate Bond.**

Another form of distress associated with the lack of bond is slippage cracking (FIGURE 3). Slippage cracking typically indicates an inadequate bond between an asphalt wearing course and its underlying layer. This distress is developed in areas where braking, accelerating, or turning wheels move and deform the surface of the AC structure (5, 6). Slippage cracks are typically half-moon shaped cracks with two ends pointing at the direction of traffic (FIGURE 4).

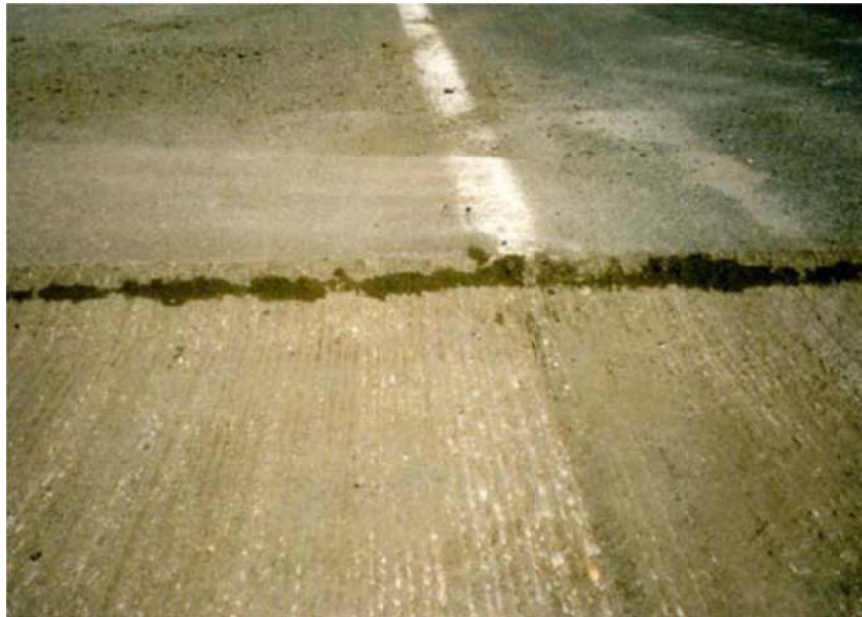
**FIGURE 5 Moisture Present at Delaminated Interface between HMA Layers (12).**

Debonding can be especially rapid if water is forced along the lift boundary (FIGURE 5) by hydrostatic pressure induced by trafficking (12).

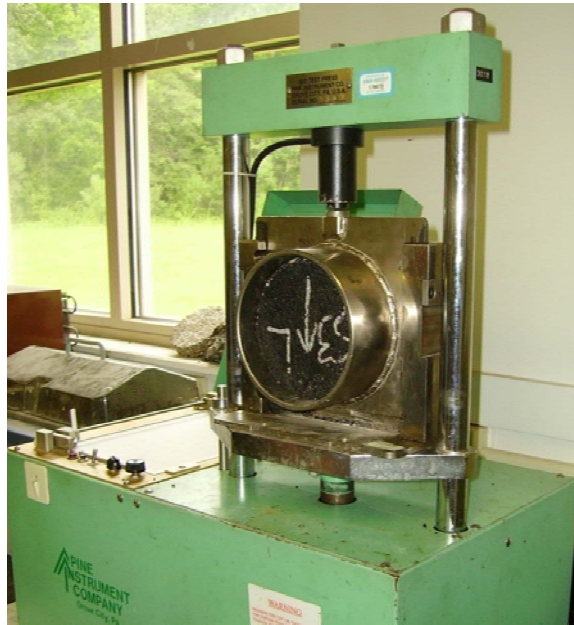
**FIGURE 14 Bond Strength Testing Apparatus.**

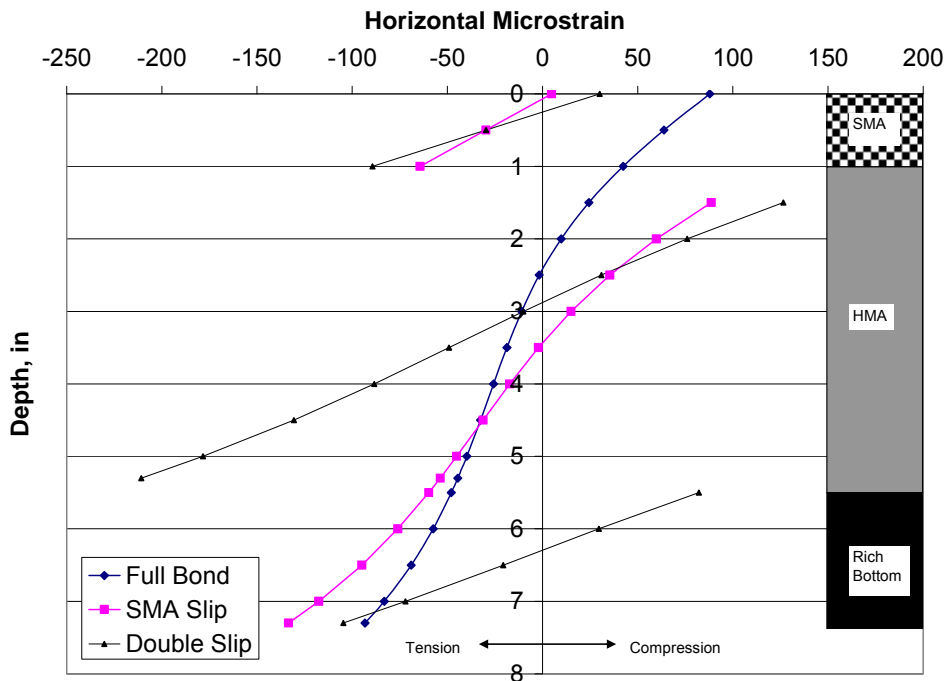
**FIGURE 15 Theoretical Strain Profile of Debonded Pavement (II).**

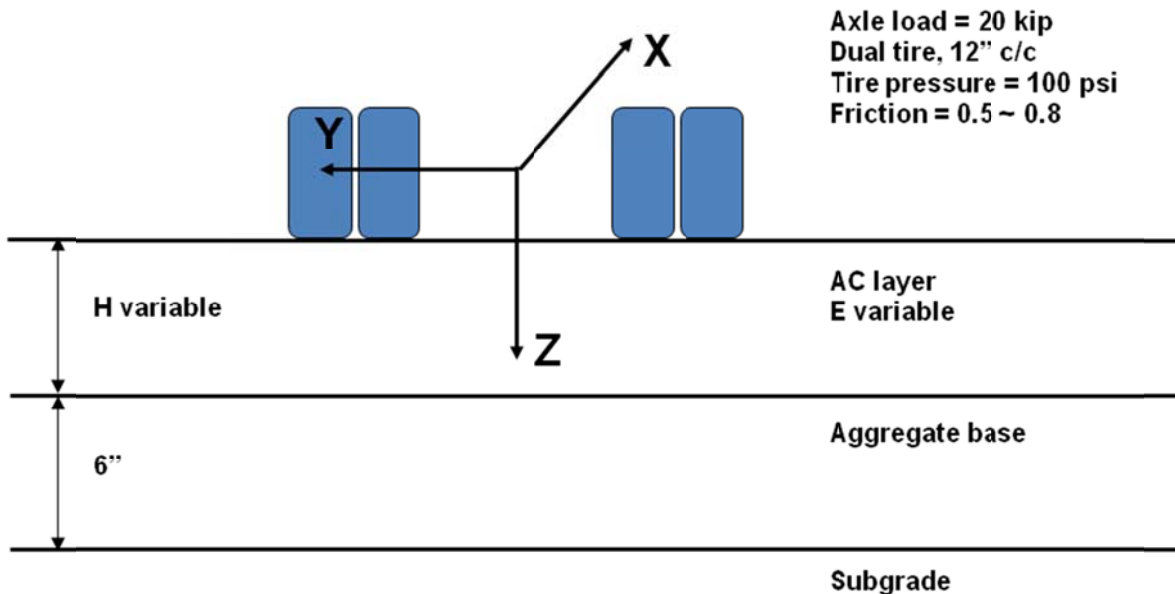
**FIGURE 17 Pavement Structure for BISAR Analysis.**

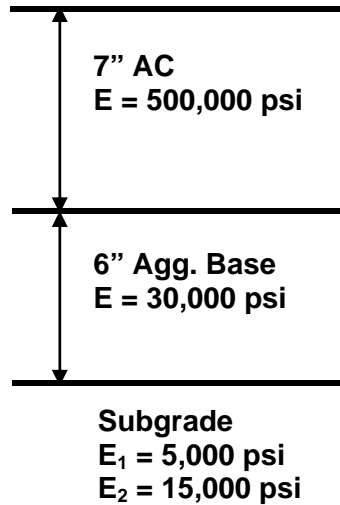
**FIGURE 18 Pavement Cross-Section for Evaluating Effect of Subgrade Stiffness.**

**Effect of Subgrade Stiffness.** A simulated pavement cross-section (FIGURE 18) was created in BISAR to investigate the effects of subgrade stiffness on shear stresses in the top 2 in. of an asphalt pavement structure. The AC was assumed to have a thickness of 7 in. and stiffness of 500,000 psi. Six inches of 30,000 psi of granular base materials were placed below the AC. Two subgrade stiffnesses, including 5,000 psi and 15,000 psi, were investigated in the analysis. Shear stresses were determined in BISAR at the surface of the pavement and at depths of 0.25, 0.5, 0.75, 1.0, 1.25, 1.5, 1.75, and 2.0 in. under the center and edge of the tire.

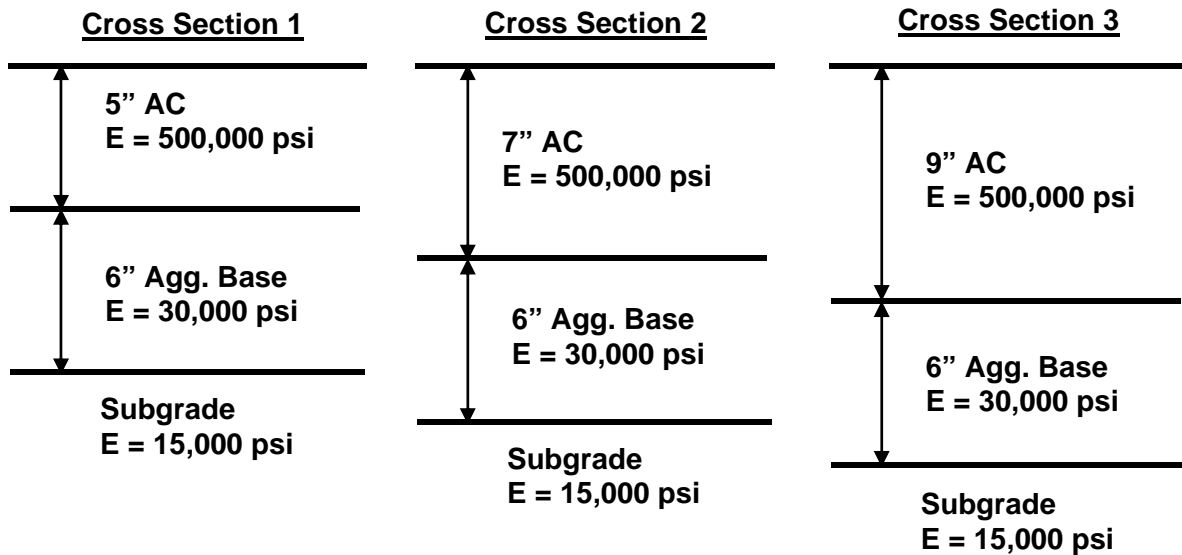
**FIGURE 20 Pavement Cross-Sections for Evaluating Effect of AC Total Thickness.**

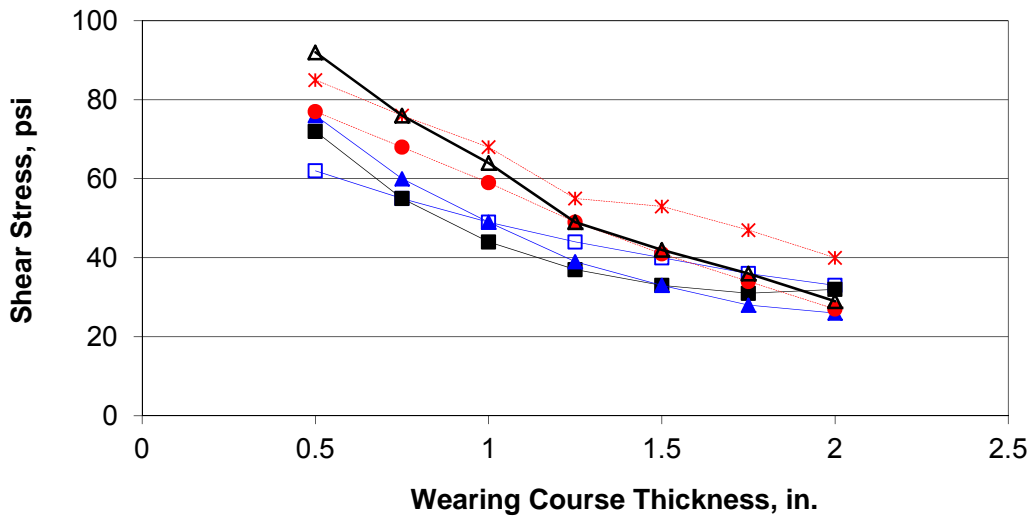
(a) Under the Center of the Tire

(b) Under the Edge of the Tire

FIGURE 23 illustrates critical shear stresses under the center and edge of the tire due to seasonal variation of stiffnesses of asphalt layers. A further analysis of modeling results showed that when the stiffness of the wearing course was different from that of the underlying layer, the shear stress at the interface increased. This was the case whether the underlying materials were softer or stiffer than the wearing course. Reducing the underlying AC stiffness increased the shear stresses in the top 1 inch of the pavement. Below a depth of 1 inch, a shear stress reduction was typically seen when compared to a pavement of constant stiffness. In all cases, increasing the underlying AC stiffness increased the shear stresses at the layer interfaces.

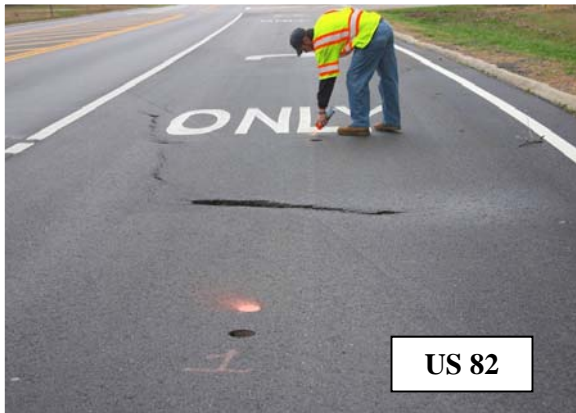
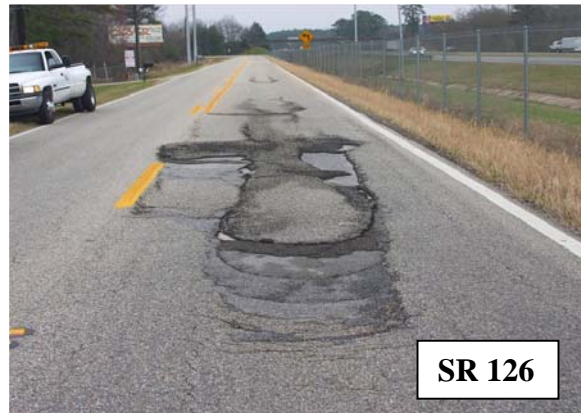
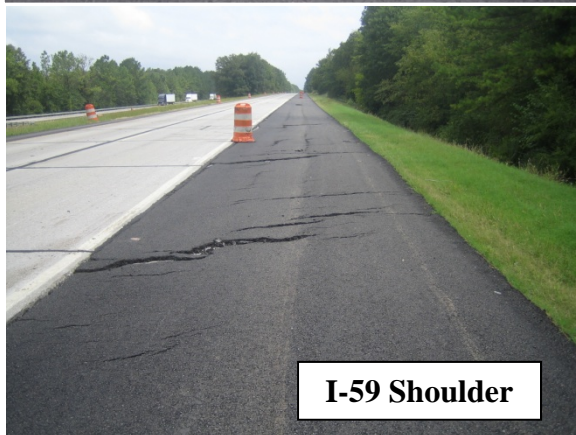
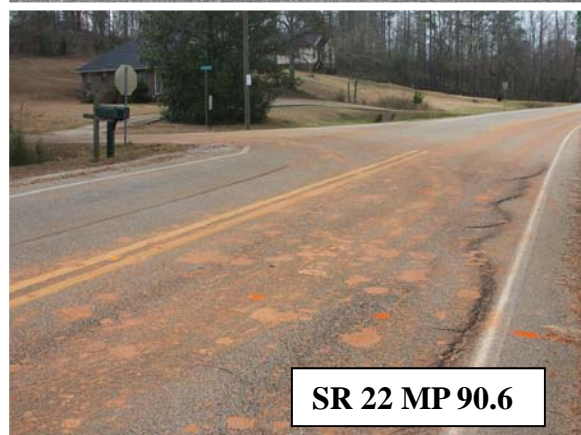
**FIGURE 25 Some Pavement Sections Showing Slippage Failures Evaluated in this Study.**

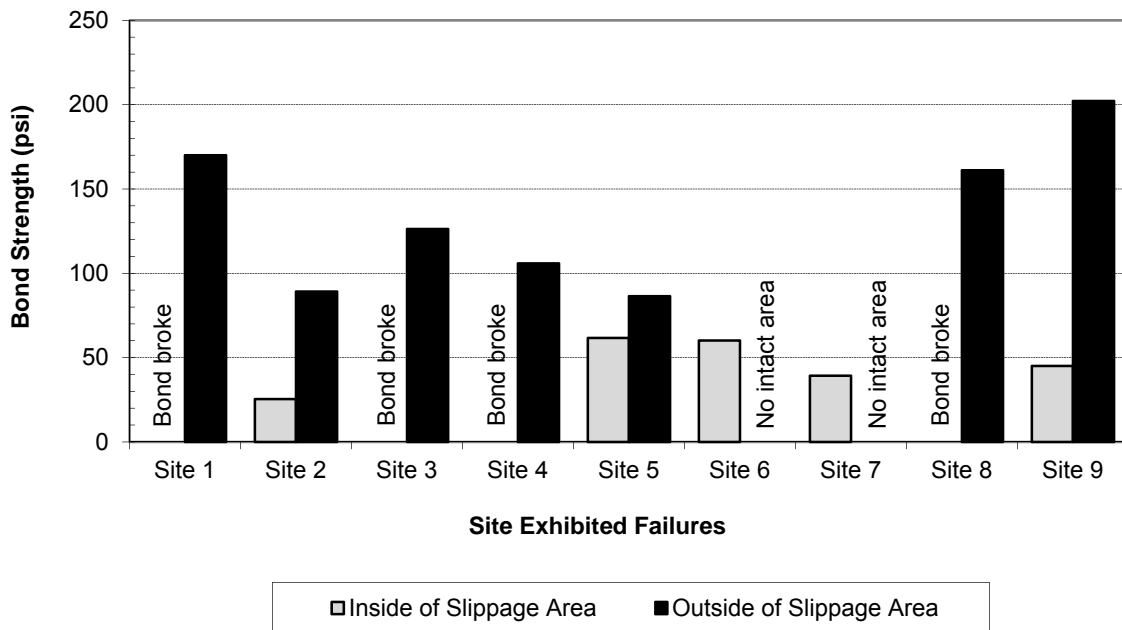
**FIGURE 26 Interface Bond Strength for Nine Sites Showing Slippage Failures.**

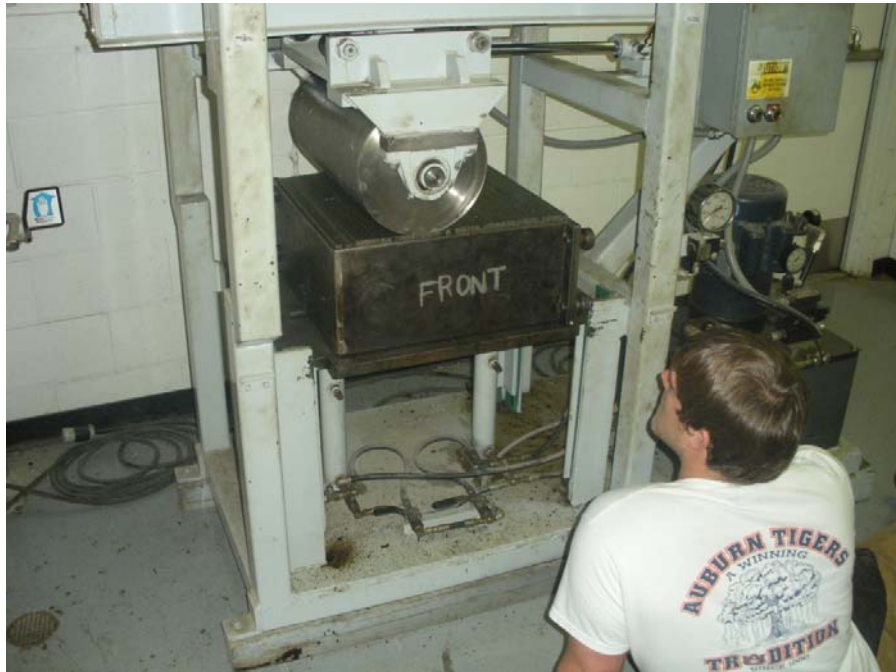
**FIGURE 27 Kneading Compactor for Compacting Lab Slabs.**

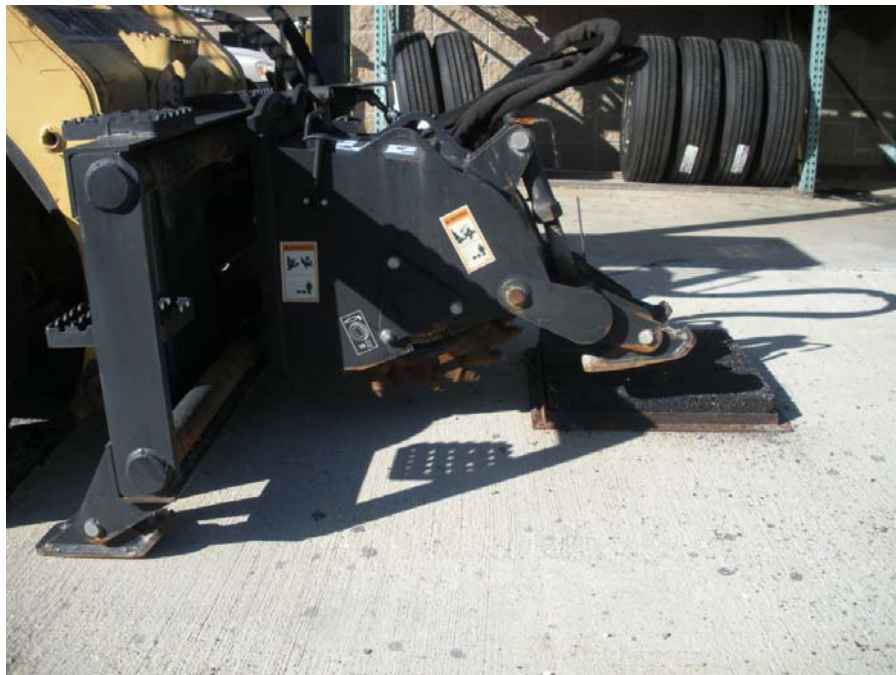
**FIGURE 28 Attachment with Two Milling Drums for Milling and Micro-Milling Slabs.**

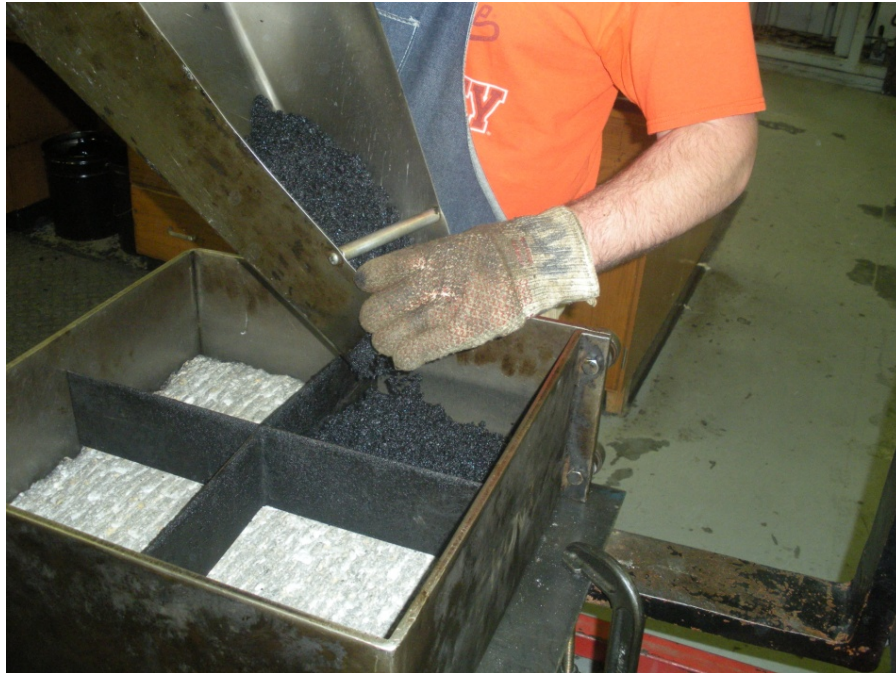
**FIGURE 29 Compacting Top Layer on Non-Tacked Milled Underlying Layer Surface.**

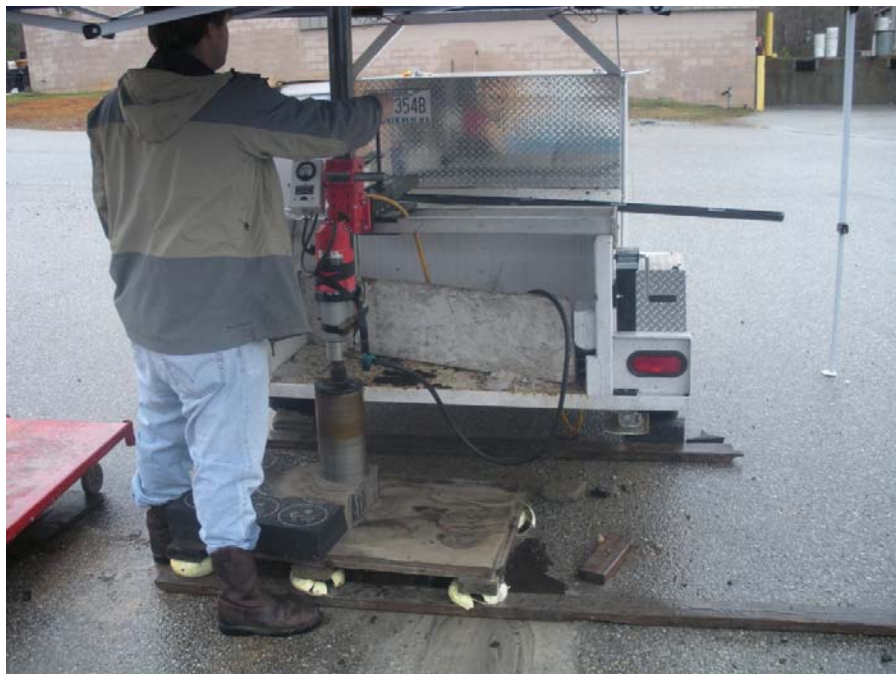
**FIGURE 30 Cutting Cores from Slab.**

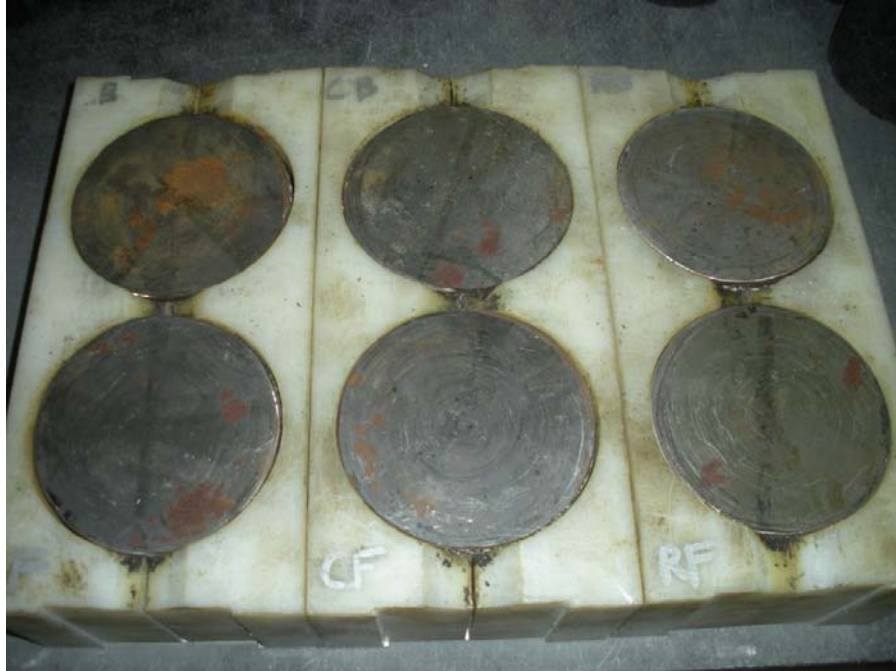
**FIGURE 31 150-mm Steel Plates Placed on Specimens to Avoid Rutting in APA Testing.**

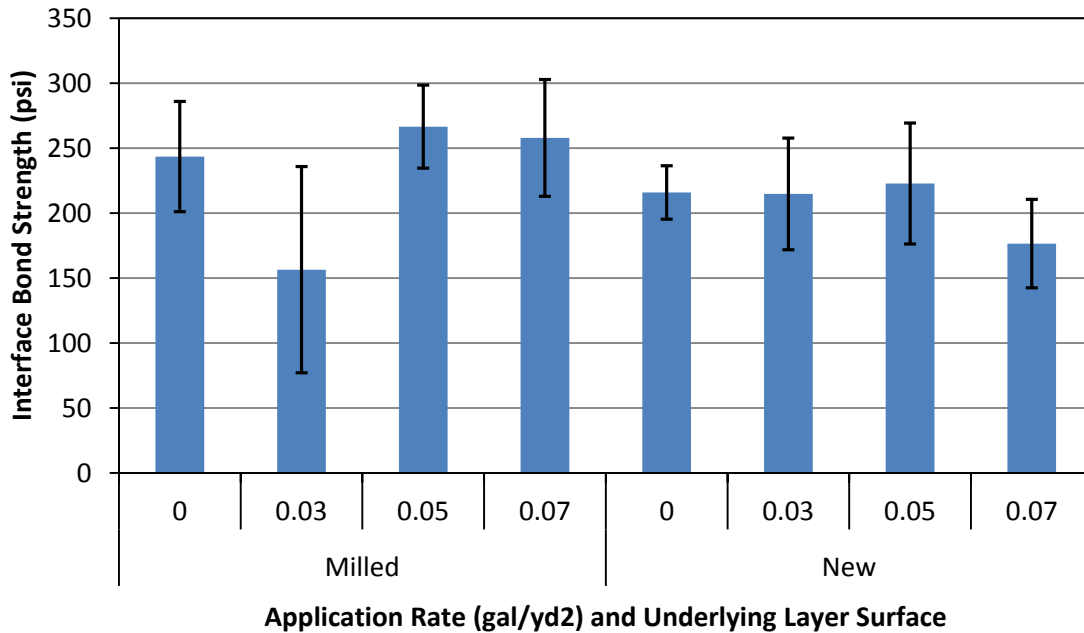
**FIGURE 35 Effect of Application Rate and Surface Condition on PG 67-22 Bond Strength.**

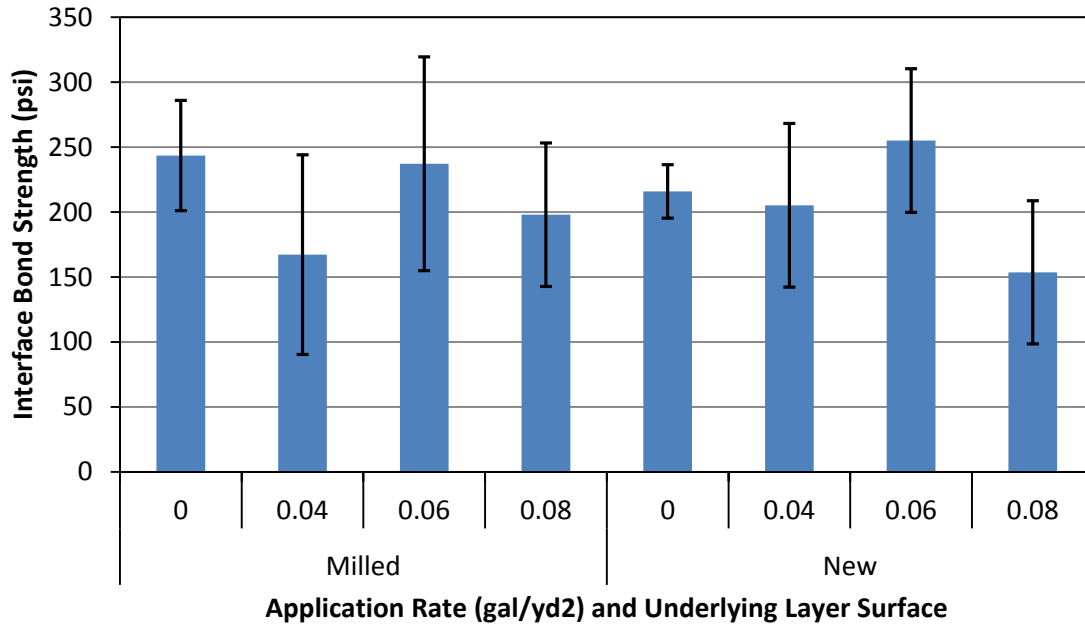
**FIGURE 36 Effect of Application Rate and Surface on NTSS-1HM Bond Strength.**

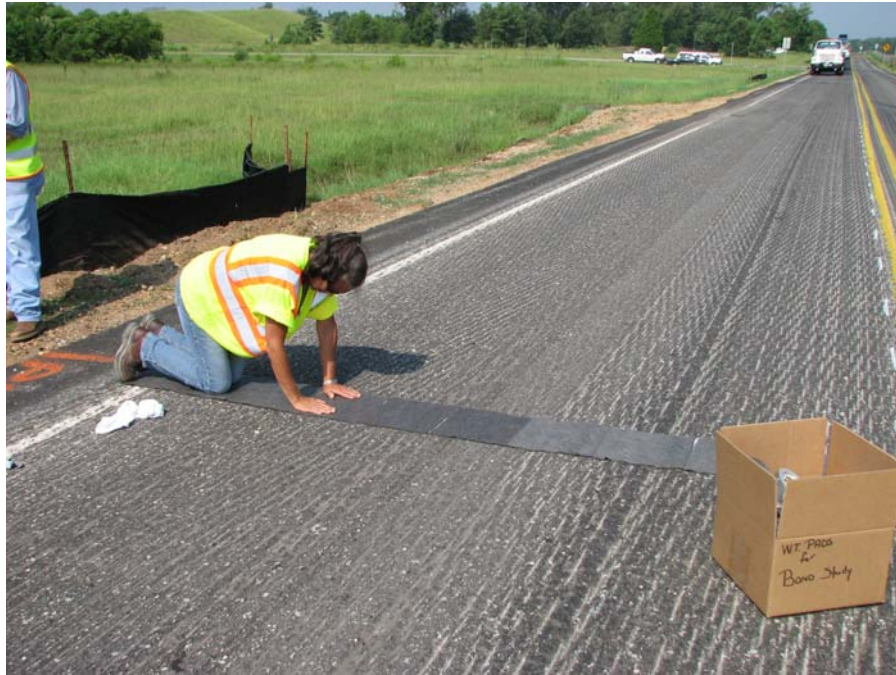
**FIGURE 41** Installing Geotextile Pads for Measuring Application Rate.

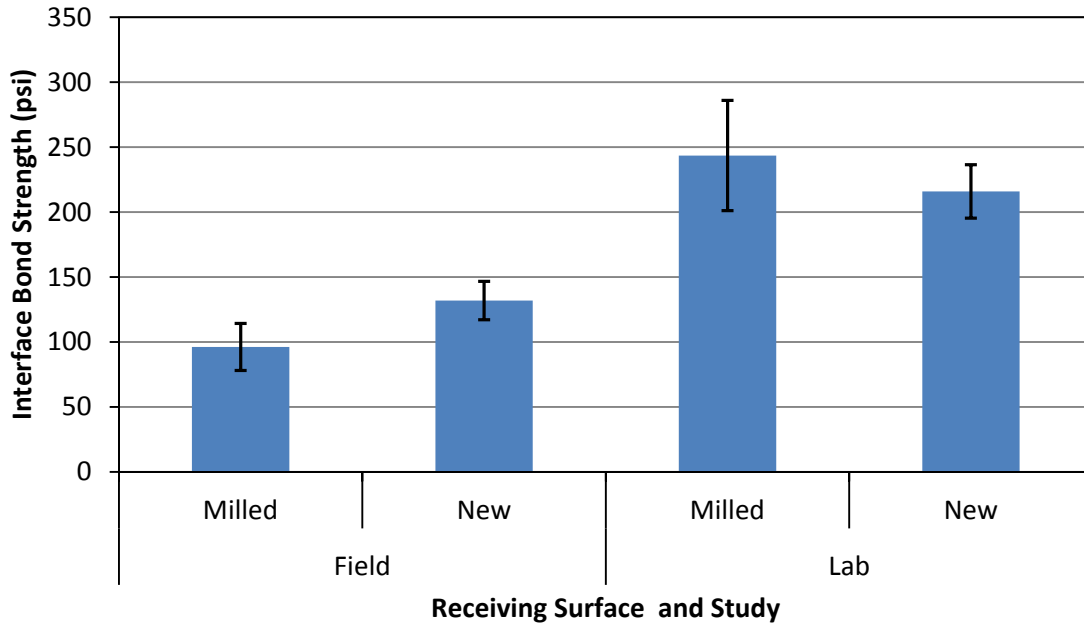
**FIGURE 43 Comparing Lab and Field Results for Non-Tack Surfaces.**

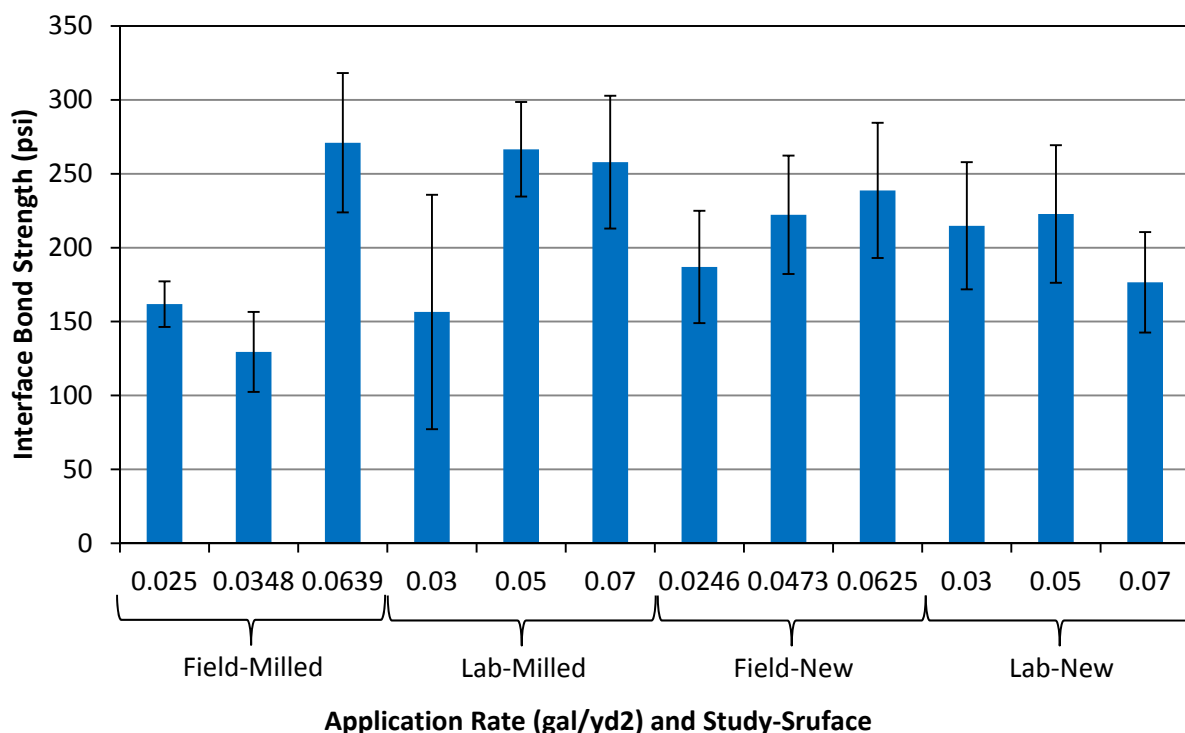
**FIGURE 45 Comparing Lab and Field Results for PG 67-22 Tack Coat.**

FIGURE 45 compares the bond strength results determined from the laboratory and field studies for the PG 67-22 tack coat. It should be noted that the field application rates did not match those used in the laboratory study exactly. However, there was a good agreement between the laboratory and field study results. The minimum and maximum application rates (0.03 and 0.07 gal/yd<sup>2</sup>) specified in the ALDOT specification appear to be reasonable for the new surface. However, the application rates for the milled surface should be higher; based on the test results, it is recommended that the minimum and maximum application rates be 0.05 and 0.09 gal/yd<sup>2</sup>, respectively.

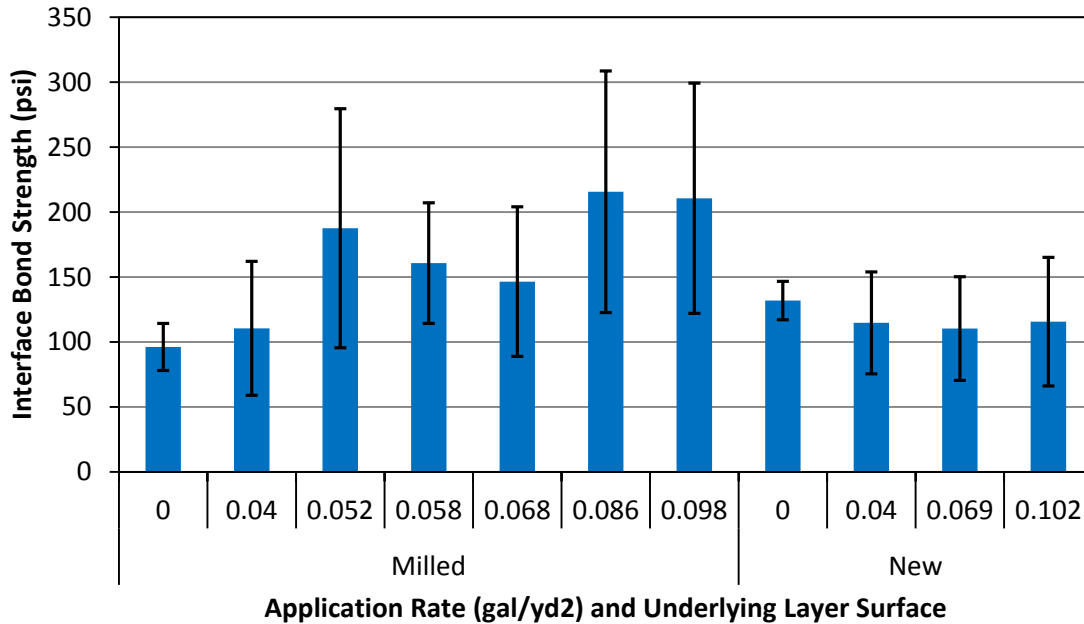
**FIGURE 48 Analysis of Field Results for CQS-1H Tack Coat.**

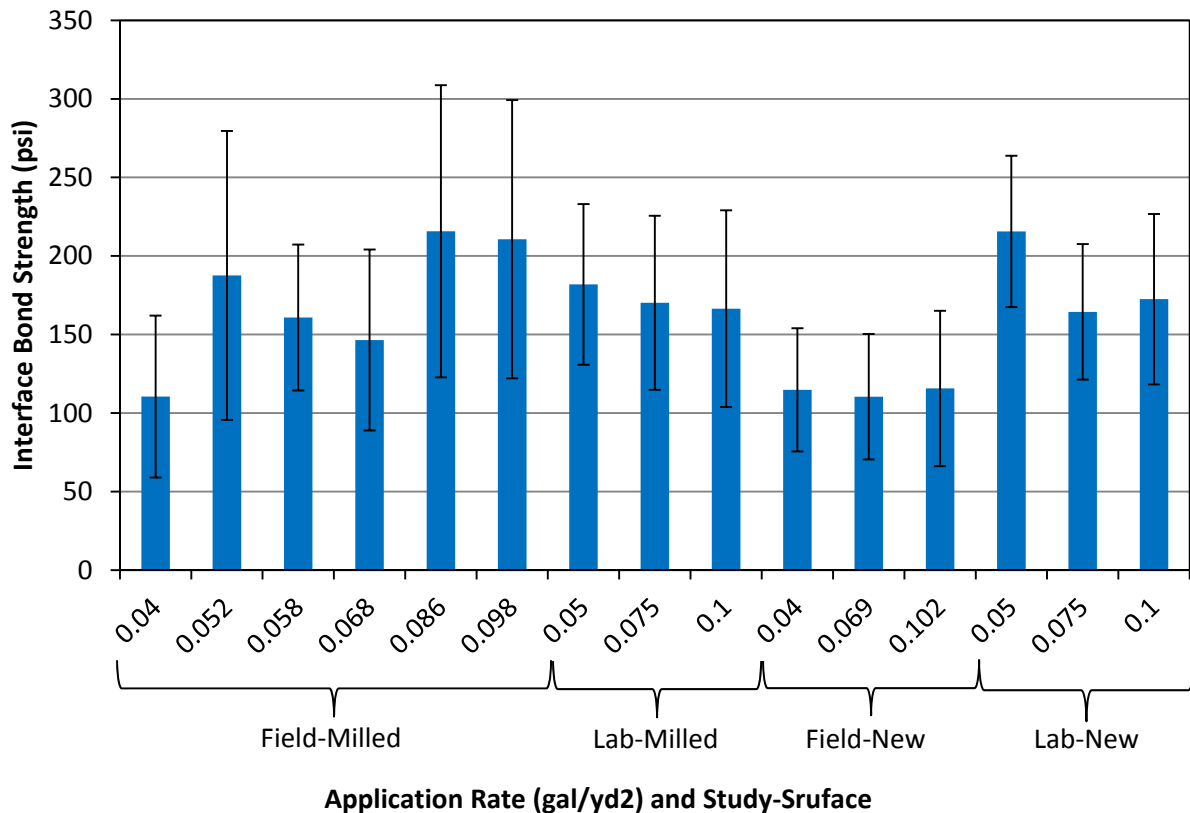
**FIGURE 49 Comparing Lab and Field Results for CQS-1H Tack Coat.**

FIGURE 49 compares the bond strength results determined from the laboratory and field studies for the CQS-1H tack coat. There was a good agreement between the laboratory and field study results for the milled surfaces. However, for the new surfaces, the laboratory study results appeared to be higher than the field study results. The minimum and maximum application rates (0.05 and 0.1 gal/yd<sup>2</sup>) specified in the ALDOT specification seem to be reasonable for both the new and milled surfaces.

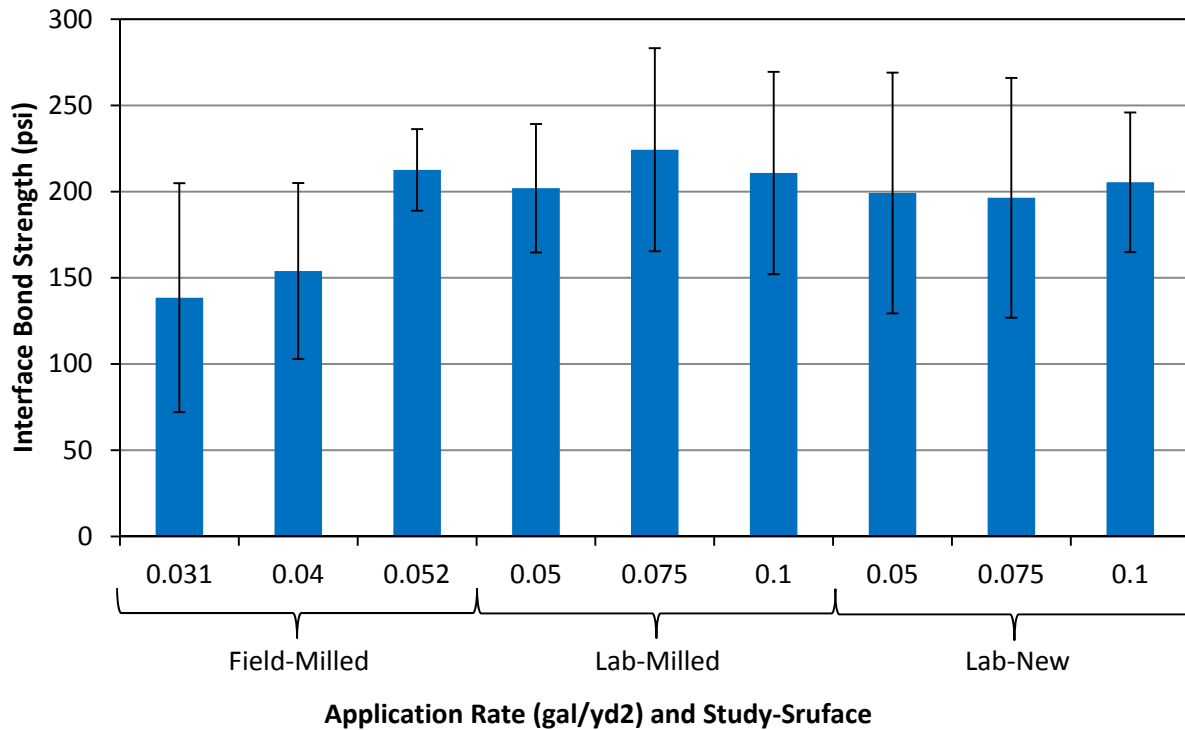
**FIGURE 51 Comparing Lab and Field Results for CRS-2 Tack Coat.**

FIGURE 51 compares the bond strength results determined from the laboratory and field studies for the CRS-2 tack coat. The field bond strength obtained at 0.052 gal/yd<sup>2</sup> appeared to agree with the laboratory study results. Based on the limited field results, the minimum and maximum application rates (0.05 and 0.1 gal/yd<sup>2</sup>) specified in the ALDOT specification seem to be reasonable for both the new and milled surfaces.
