NCAT Report 97-01

PERFORMANCE OF STONE MATRIX ASPHALT PAVING MIXTURES (SMA) MIXTURES IN THE UNITED STATES

January 1997

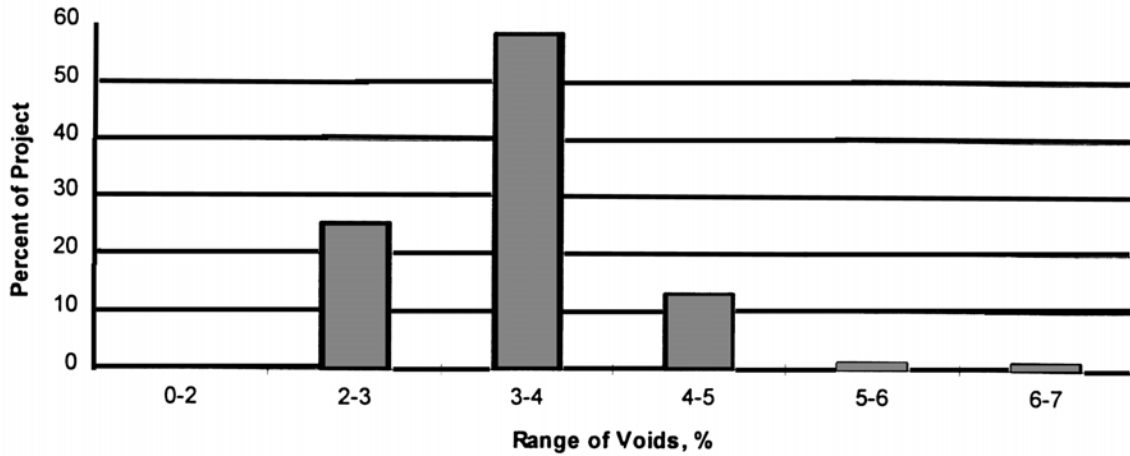
Figure 3. Range of Design Air Voids Used for Design of SMA Mixture

Total Number of Projects: 105, Data used for this plot is from 75 Projects.
Average: 3.7%, Standard Deviation: 0.65%

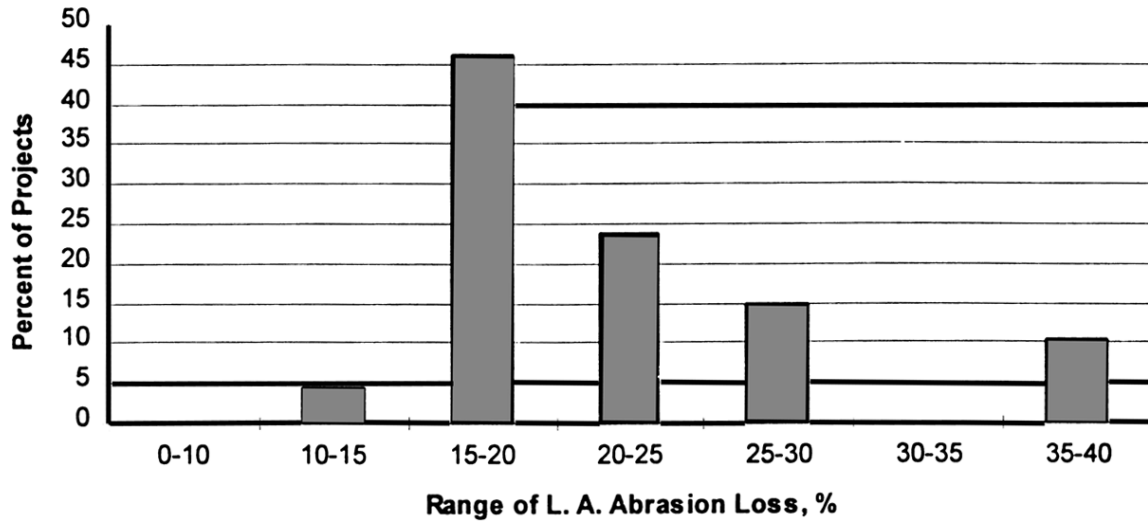
Figure 5. Distribution of L.A. Abrasion Values Used for the SMA Projects

To date, SMA projects have been designed using all crushed aggregate. This requirement is probably one major reason that SMA mixtures tend to provide good performance. The L.A. abrasion of the aggregate, on the average, is lower than that used for dense mixtures. Eighty-five percent of the projects have had L.A. abrasion values below 30 (Figure 5).

Total Number of Projects: 105, Data used for this plot is from 67 Projects.

Average: 22.5 %, Standard Deviation: 6.60 %

- C Approximately 85 percent of the projects used an aggregate meeting the recommended Los Angeles Abrasion requirement of 30 percent. No problem was observed in the SMA mixtures that could be contributed to L. A. abrasion.

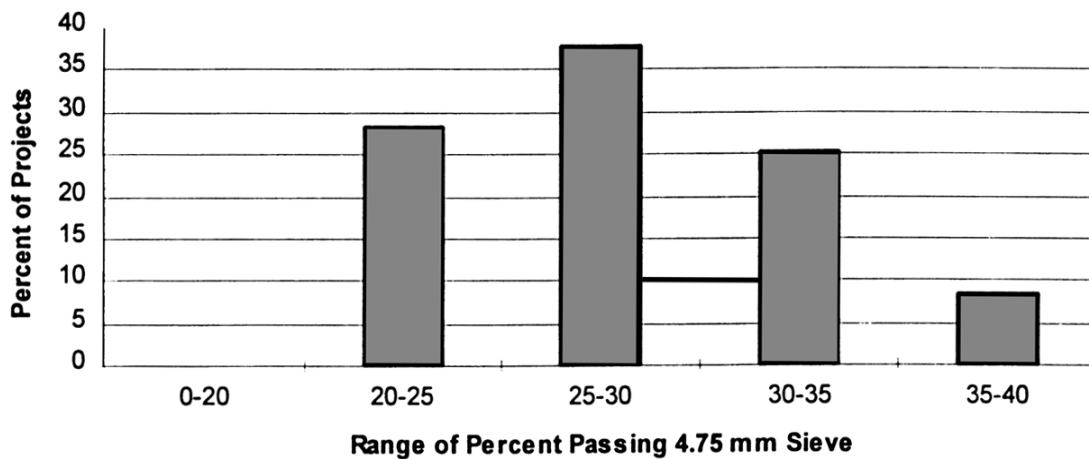
Figure 6. Distribution of Percentage Passing the 4.75 mm Sieve During Mix Design

SMA mixtures have been designed approximately 90-95 percent of the time to have 20- 35 percent of the material passing the 4.75 mm sieve and to have 7-11 percent passing the 0.075 mm sieve (Figure 6 and 7). During production, the measured gradation is similar to the mix design for the material passing 4.75 mm (Figure 8), but the percentage between 7 and 11 percent is less (80 percent) in the case of material passing the 0.075 mm sieve (Figure 9).

Total Number of Projects: 105, Data used for this plot is from 95 Projects

Average: 28.8%, Standard Deviation: 4.12%

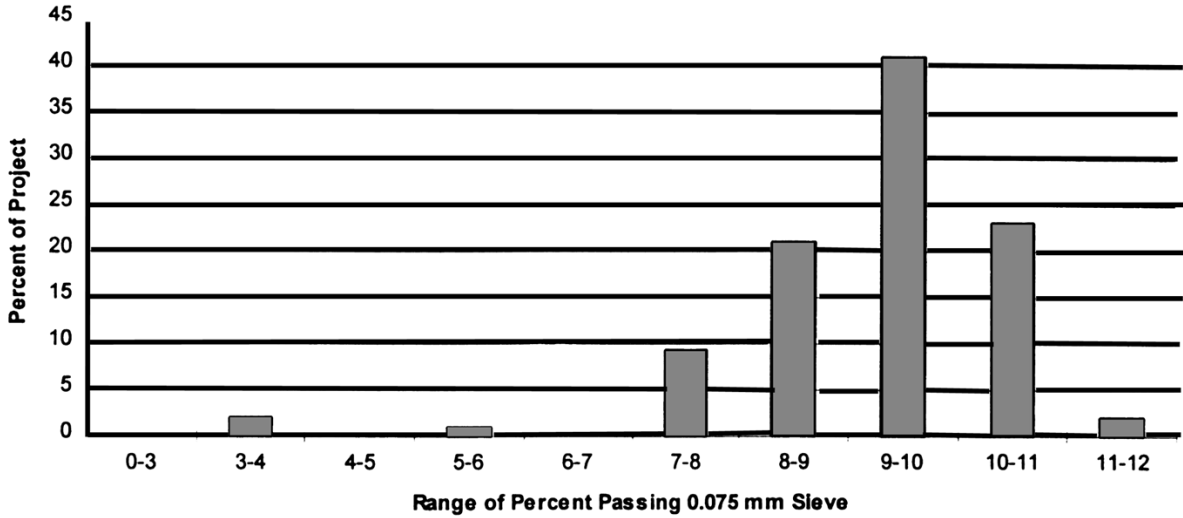
Figure 7. Distribution of Percentage Passing the 0.075 mm Sieve During Mix Design

Total Number of Projects: 105, Data used for this plot is from 95 Projects

Average: 9.3%, Standard Deviation: 1.19%

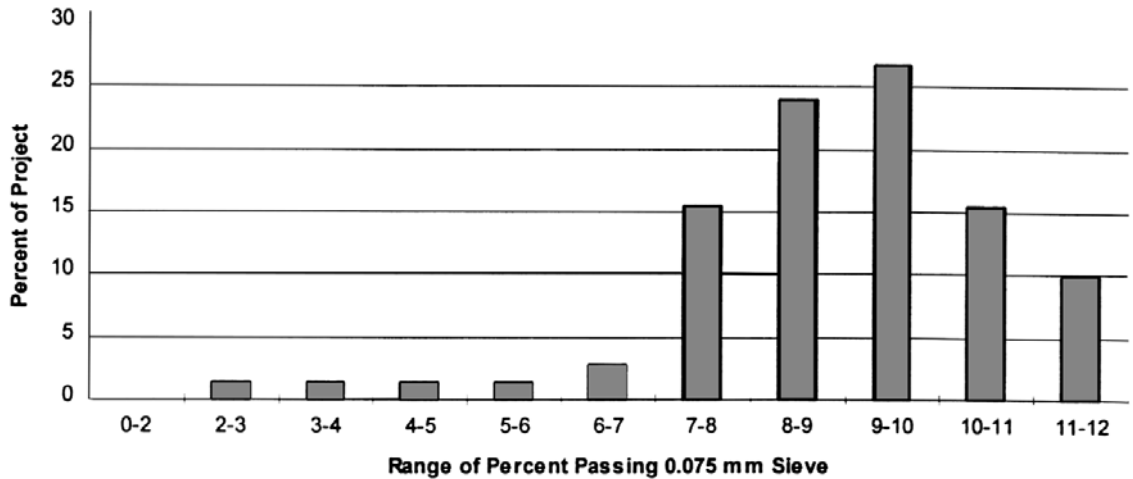
Figure 9. Distribution of Percentage Passing the 0.075 mm Sieve During Construction

Total Number of Projects: 105, Data used for this plot is from 71 Projects

Average: 8.9%, Standard Deviation: 1.71%

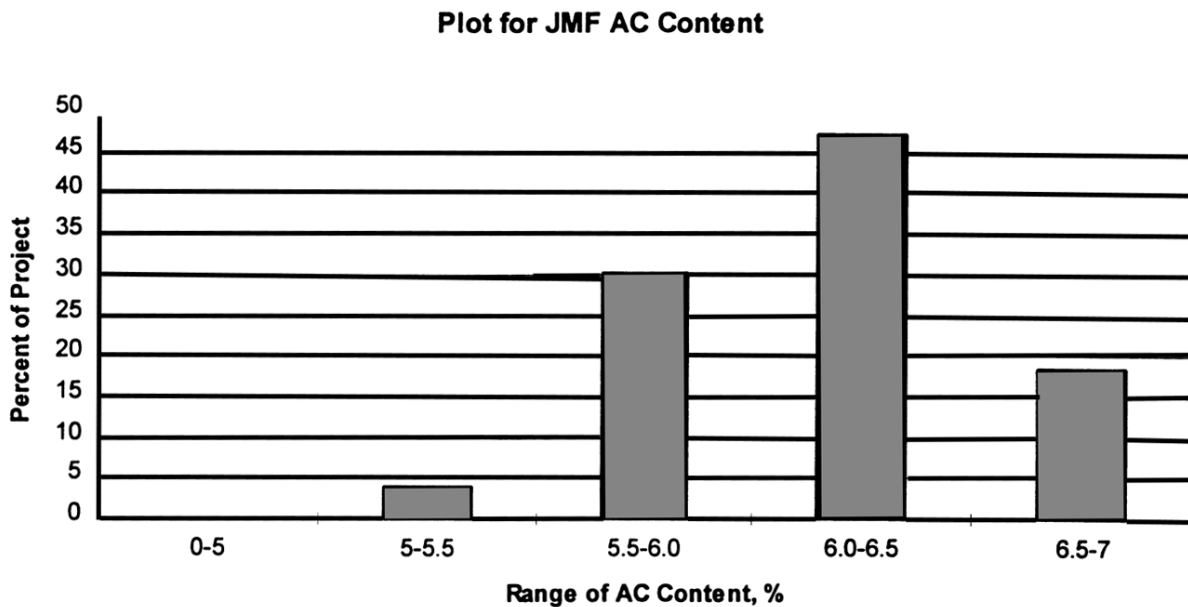
Figure 13. Range of Mix Design Optimum Asphalt Content

Total Number of Projects: 105, Data used for this plot is from 75 Projects

Average: 6.2%, Standard Deviation: 0.34%

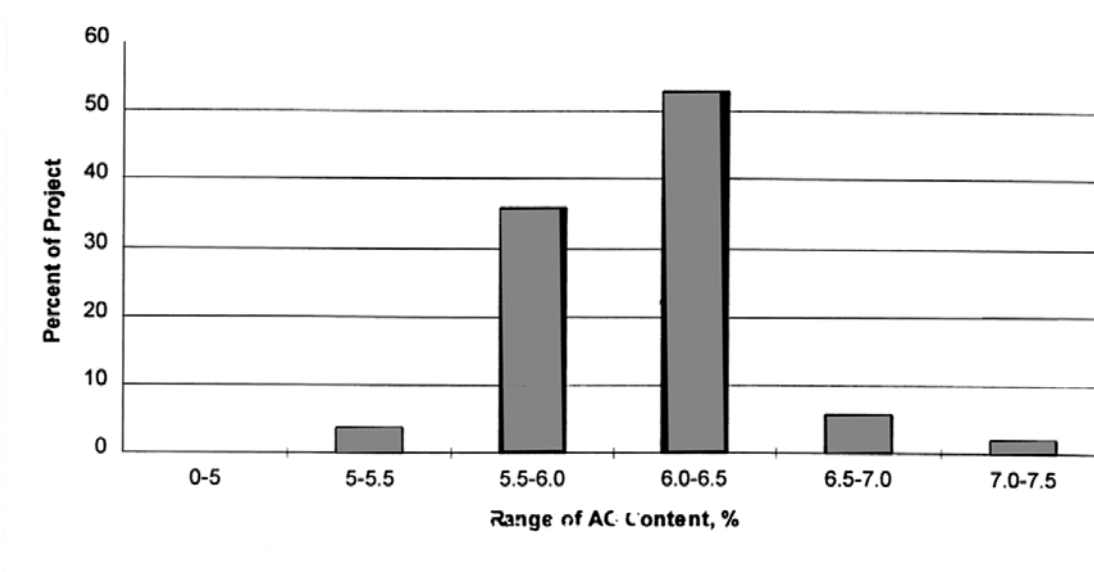
Figure 14. Range of Production Asphalt Content

Typically for SMA mixtures, the asphalt content should be at least 6.0 percent by weight. However, when a limit is established for minimum VMA, a minimum asphalt content does not need to be specified. For the projects investigated, the minimum recommended asphalt content of 6.0 percent was exceeded approximately 60 percent of the time (Figure 13). For production, approximately 50 percent of the projects exceeded the 6.0 percent minimum recommended AC content (Figure 14).

Total Number of Projects: 105, Data used for this plot is from 53 Projects
Average: 6.1%, Standard Deviation: 0.33%

- C Approximately 60 percent of the projects exceeded 6.0 percent asphalt content during production. The minimum recommended requirement of 6.0 percent asphalt content should not be met at the expense of low air voids.

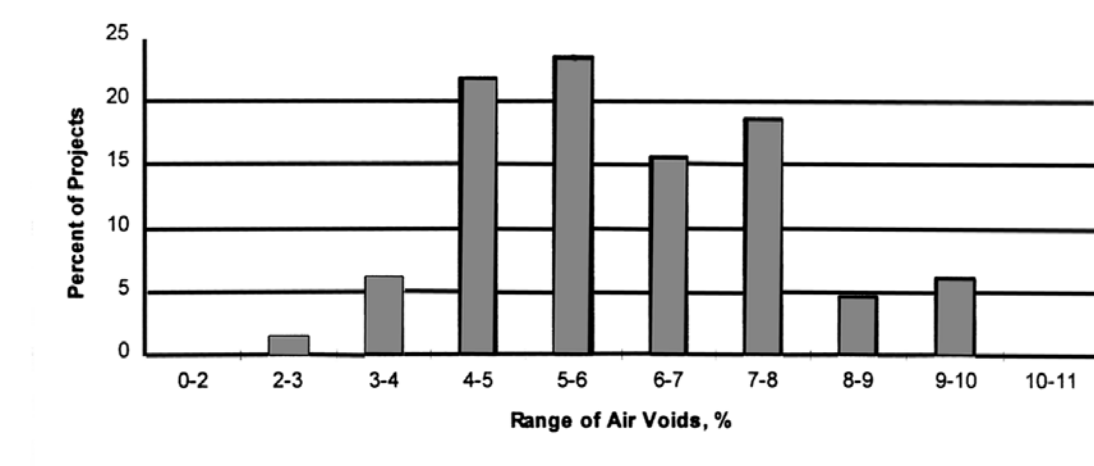
Figure 15. Distribution of Initial In-Place Air Voids

Typically SMA mixtures should be compacted on the roadway to 5-7 percent air voids. However, there are a significant amount of projects that have been constructed with in-place air voids above 7 percent (approximately 25%) and below 5 percent (approximately 30%). A summary of this information is provided in Figure 15. SMA mixtures can be difficult to compact for contractors that have not had much experience with these types of mixtures. The mixes have a high coarse aggregate content, all crushed material, and relatively stiff binders. This combination makes the mixes more difficult to work but with experience they can be placed and properly compacted.

Total Number of Projects: 105, Data used for this plot is from 64 Projects.
Average: 6.1%, Standard Deviation: 1.76%

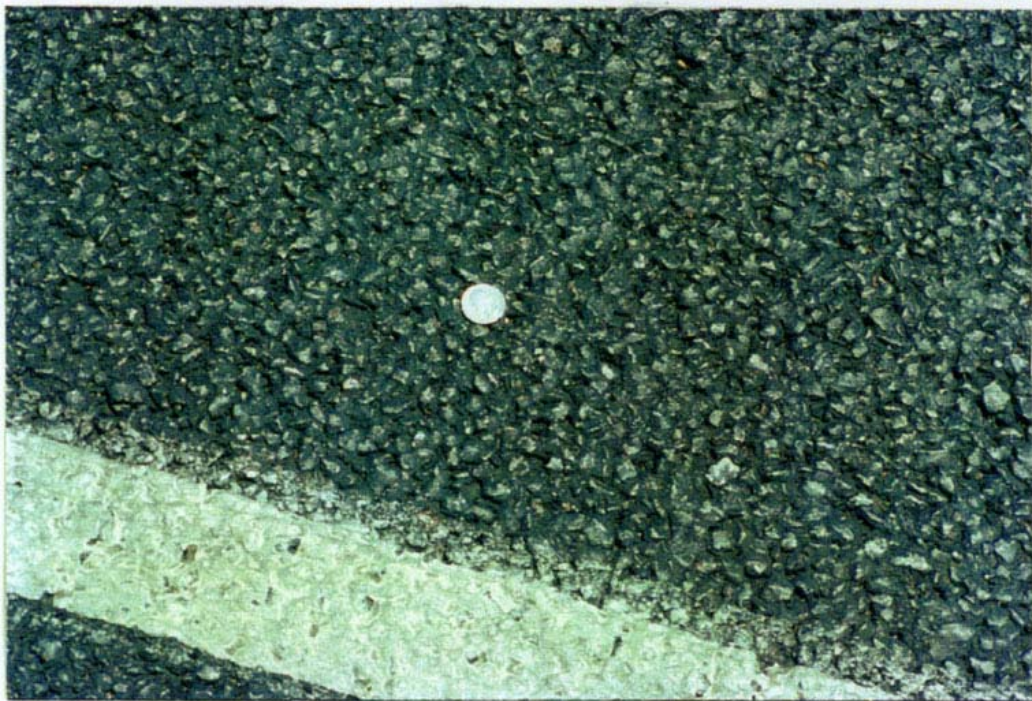
The pavement surface was inspected to evaluate uniformity. In general the SMA mixtures had good uniformity. The coarse aggregate surface texture (Figure 16) appears to be good and tends to help keep surface water below the pavement-tire interface. There were no obvious signs of excessive coarse aggregate segregating from the mix. Some of the pavements inspected had some localized fat spots (Figure 17). These fat spots can vary from a few centimeters in diameter to a few hundred meters long in a few cases. In most cases, the small fat spots were no problem at all. In a few cases where those spots were large they had to be removed and replaced to ensure adequate pavement friction characteristics. Many of the SMAs that used modifiers had small spots about 50 mm in diameter where the modified binder built up on the screed of the paver and then came off at some point and was rolled into the pavement (Figure 18). These small spots do not cause any performance problems.

Figure 16. Close-Up Showing Coarse Aggregate Surface Texture

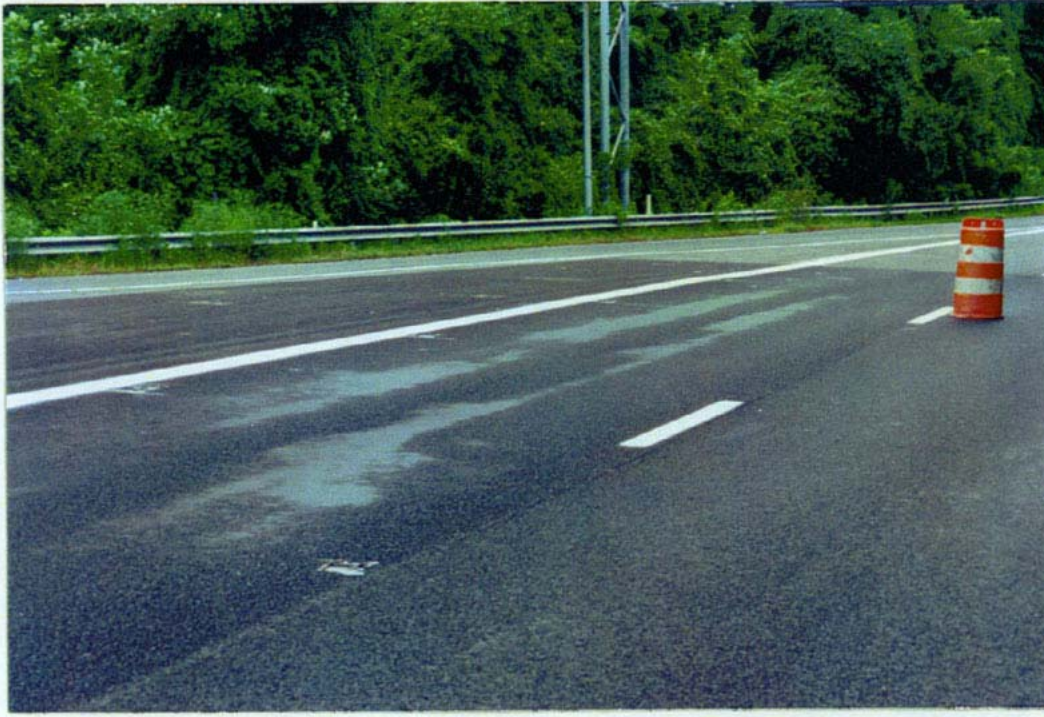
The fat spots can be caused by many things: insufficient fibers, high asphalt content, low coarse aggregate content, excessive temperature, and excessive moisture. Fibers are used in SMA mixtures to prevent draindown of the asphalt cement. If the fiber feed does not work properly, then the fiber content may be too low resulting in a potential for draindown. There is no good way to determine the amount of fibers in a mixture and sometimes feeding problems tend to result in lower fiber content. If the fibers get wet, they are very difficult, if not impossible, to properly feed. If the fibers quit feeding for a few seconds, a fat spot due to draindown will almost certainly occur. If polymers are being used as the stabilizer, failure to get the proper amount of polymer in the mixture can also cause draindown.

Figure 17. Localized Fat Spot

A high asphalt content can cause fat spots in SMA mixtures just as it does in dense mixtures. Compaction of mixes with high asphalt content tends to result in low voids. These mixtures with high asphalt content tend to flush during compaction resulting in fat spots.

Moisture in the mixture or in the existing surface being overlaid can cause fat spots. The moisture vaporizes at high temperatures during construction and will tend to remove the asphalt binder from the aggregate particles. When this happens, the excess asphalt binder tends to migrate to the surface under traffic resulting in a fat spot.

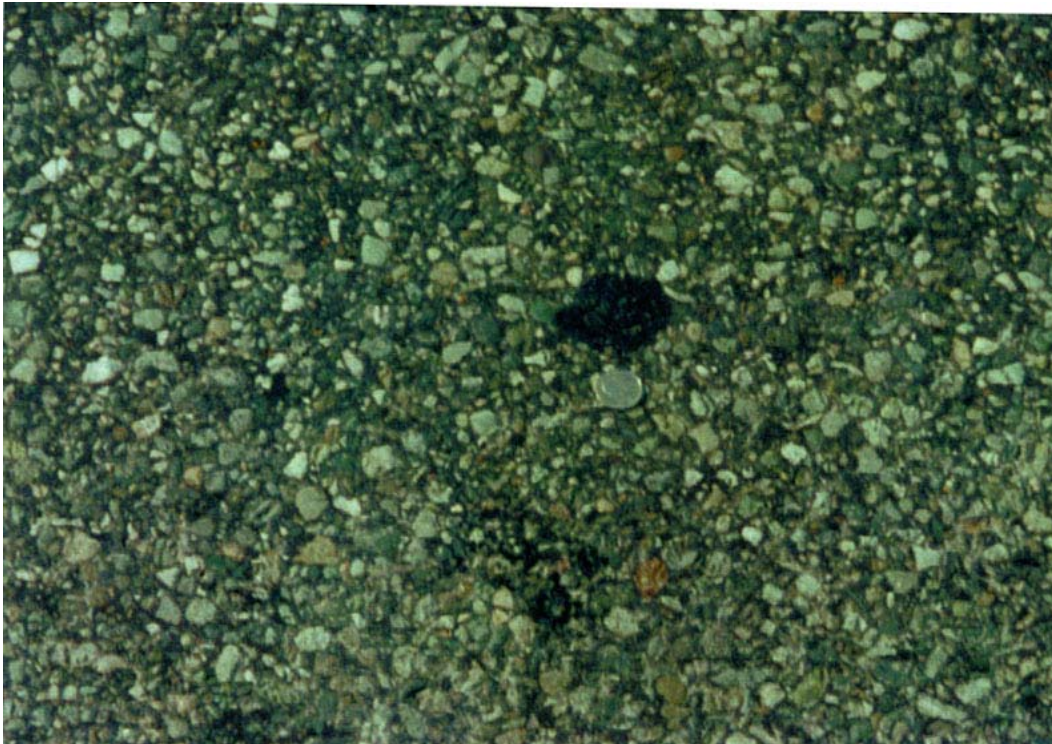
Figure 18. Small Blemish Caused by Build Up of Mortar on Screed

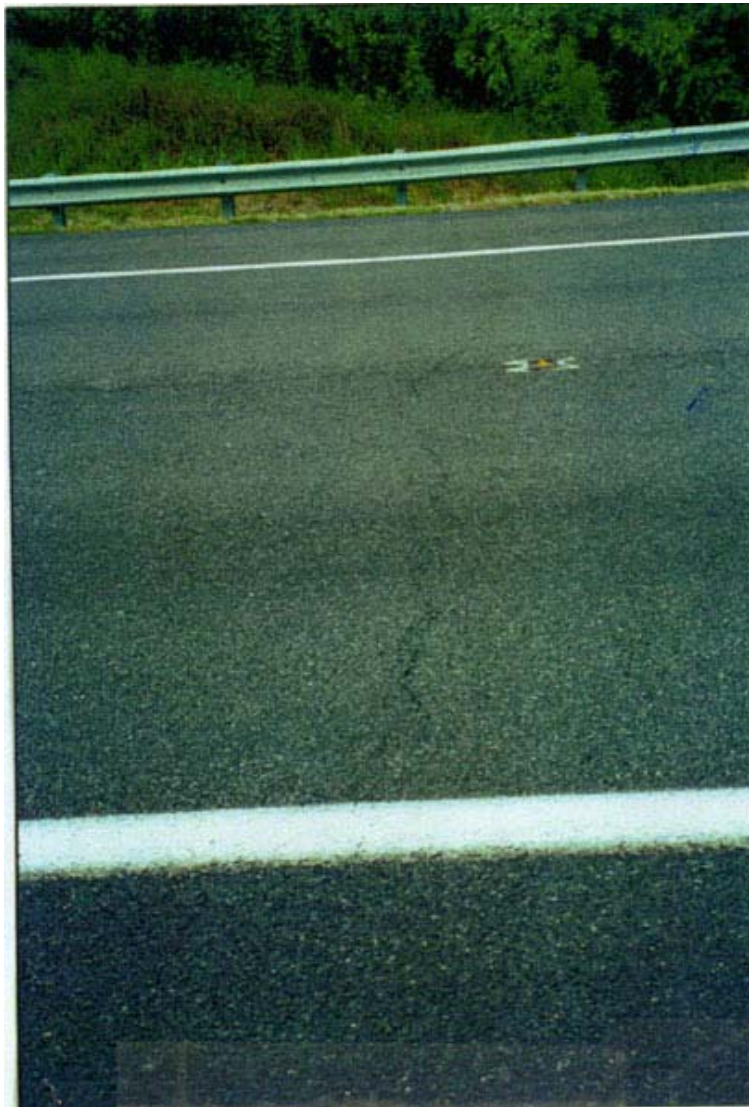
Most of the SMA mixtures that have been placed have been overlays on high volume interstates. Many of these mixes were placed over old existing pavements that had joints or cracks. During the inspection there was very little cracking in the SMA mixtures. The small amount of cracking that was observed on a few projects appeared to be reflective cracks. These few cracks have remained tight and were not raveling (Figure 20). The high asphalt content in these mixtures and the use of polymers will likely result in the SMA remaining intact adjacent to the crack. So at the time of inspection, there was no significant thermal cracking problem.

Figure 20. Typical Transverse Crack in SMA Mixture

- C Cracking (thermal and reflective) has not been a significant problem. SMA mixtures appear to be more resistant to cracking than dense mixtures. This is likely due to the relatively high asphalt content resulting in high film thickness.
- C There was no evidence of raveling on the SMA projects.
- C Fat spots appear to be the biggest performance problem. These are caused by segregation, draindown, high asphalt content, or improper type or amount of stabilizer.
- C Based on findings in the study, SMA mixtures should continue to provide good performance in high volume traffic areas. The extra cost for construction should be more than offset by the increased performance.

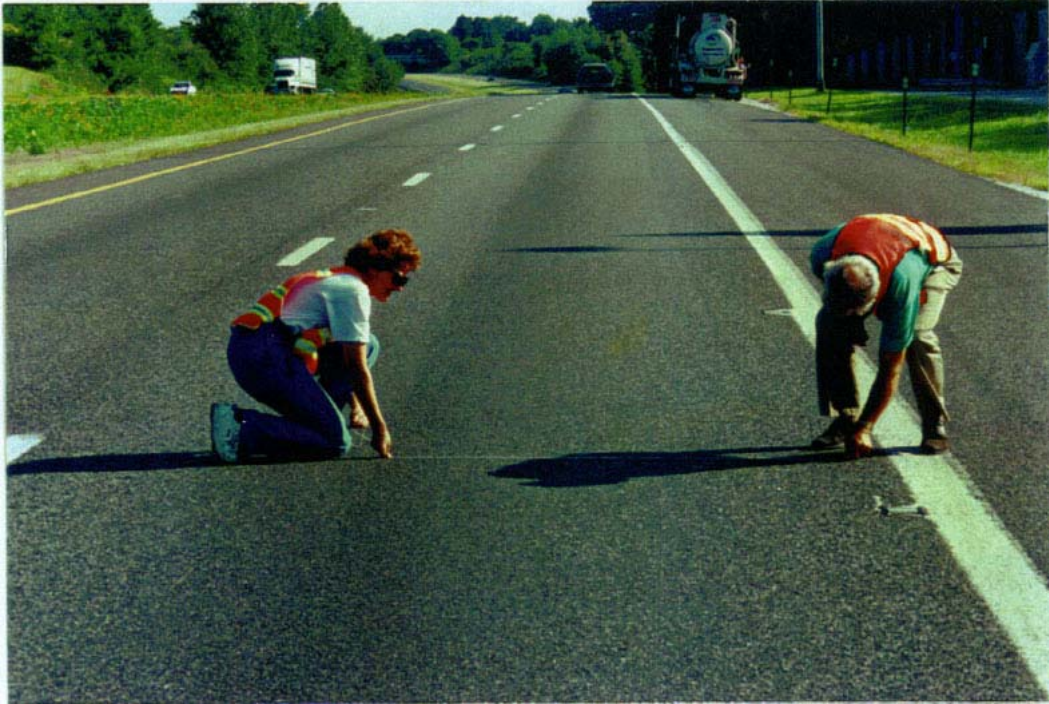
Rutting was measured on most of the SMA sections (Figure 21). A few pavements could not be measured for rutting due to the high rate of traffic. It was obvious that these few sections had no significant rutting since they were inspected from the shoulder but an exact measurement of rutting was not made on these sections. The rutting distribution is shown in Figure 22. It is clear from this figure that approximately 90% of the pavements evaluated had less than 4 mm average rutting. Approximately 70% of the pavements had less than 2 mm of rutting. Over 25% of the SMA pavements had no measurable rutting. There were six projects at the higher rutting rates (more than 6 mm) in which the rutting could be attributed to the SMA mixture. Although most of these SMA pavements are not very old, most have been exposed to a significant amount of traffic. So from a rutting point of view the SMA mixtures are providing excellent performance.

Figure 21. Rut Depth Measurement

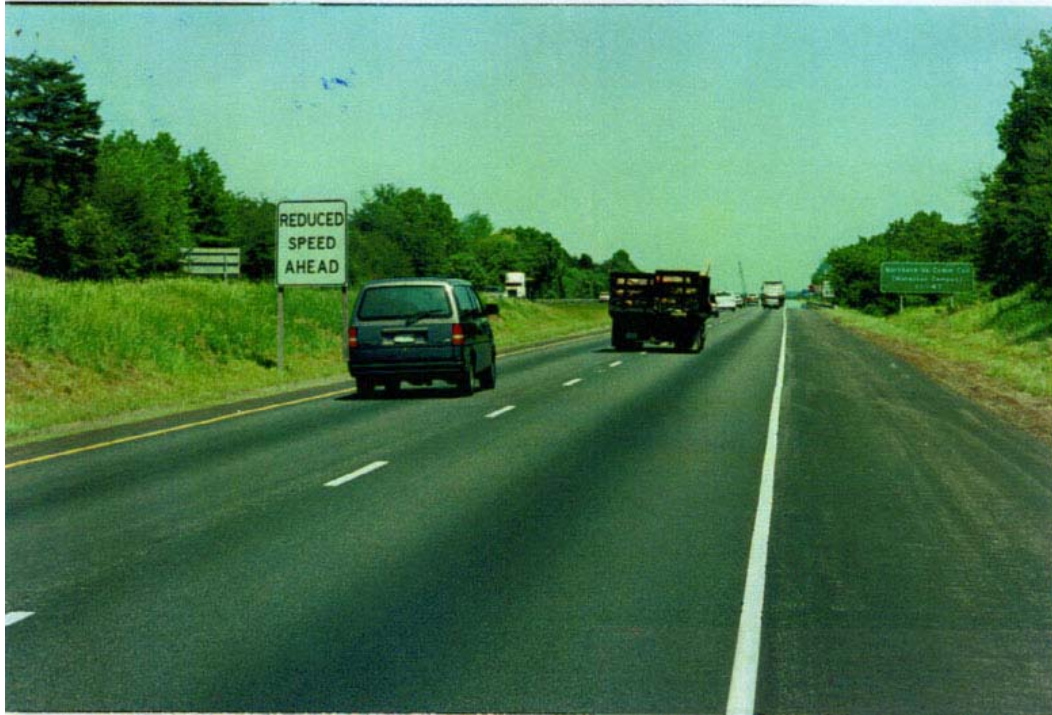
Typically, the performance of the SMA mixtures has been excellent in very high traffic areas (Figure 23). The surface uniformity of most projects has been very good.

Figure 23. Typical Good Performing SMA
