A STUDY OF IN-PLACE RUTTING OF ASPHALT PAVEMENTS

National Center for
Asphalt Technology

E.R. Brown
Stephen A. Cross

NCAT Report 89-02

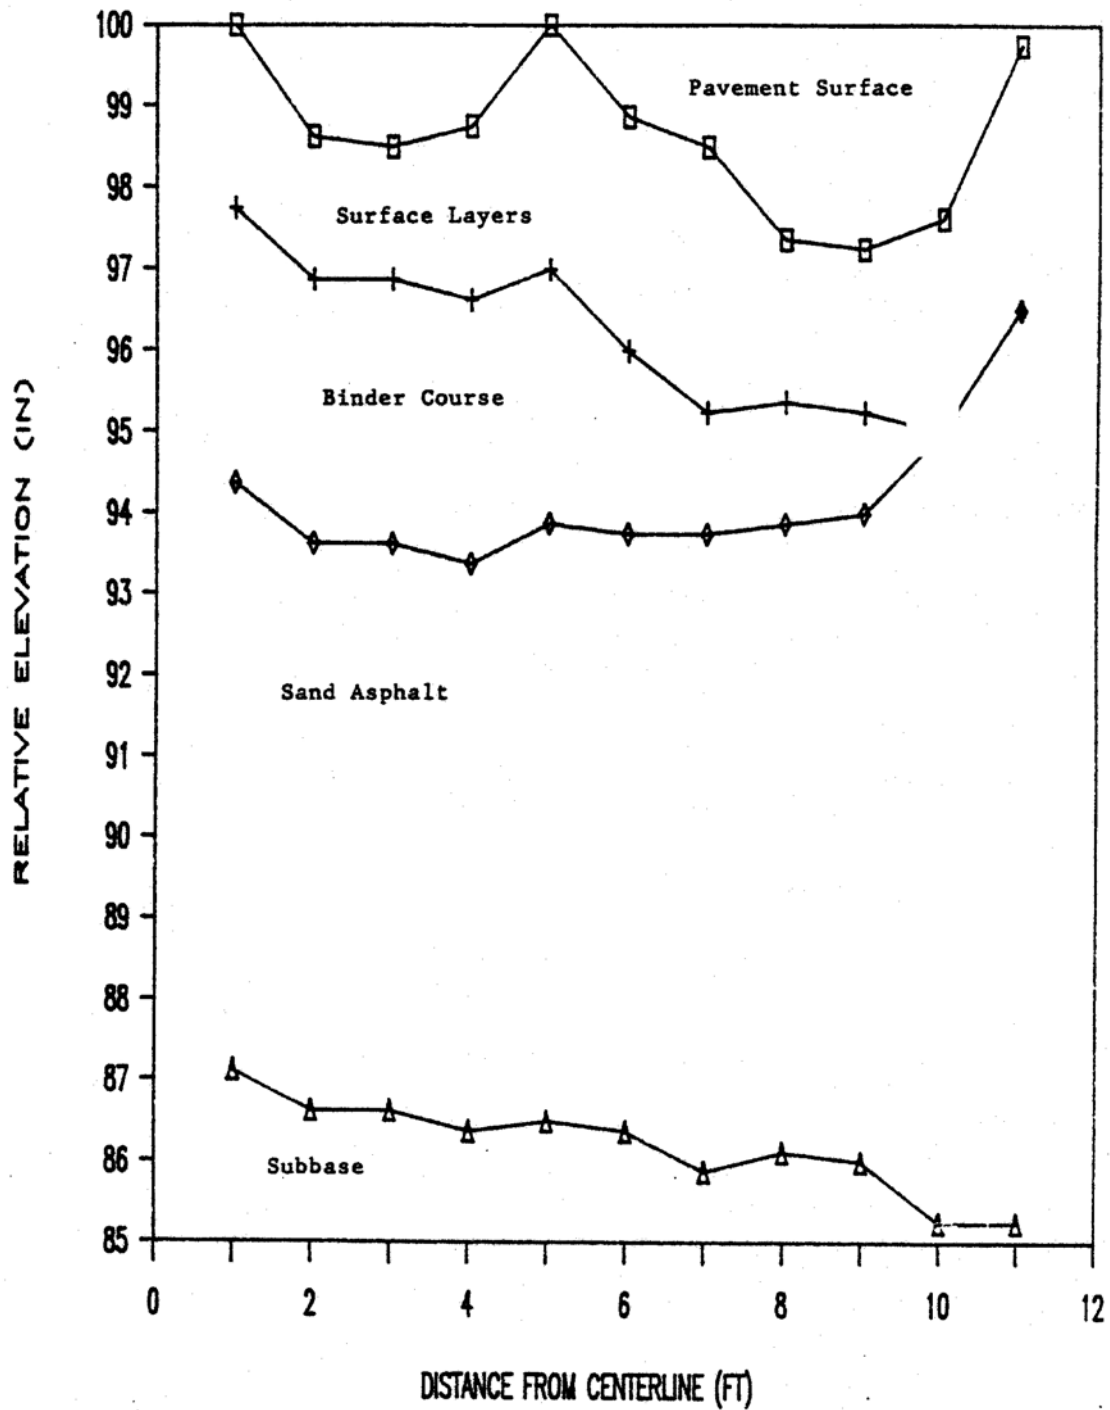
Figure 6. Relative Layer Elevation vs. Distance from Centerline for Site #1

It is clear from Figures 5, 6, and 7 that a significant amount of rutting had occurred in the surface of the pavement at site 1. This particular pavement had experienced rutting in the past and had been milled, patched, and overlaid at various times to alleviate the rutting problem. The large amount of maintenance work explains why the various layers vary in thickness and grade. After observing the trench for site 1 and closely reviewing Figure 6 it is apparent that most of the rutting had occurred in the surface layers (the surface layers consisted of three thin layers of asphalt mix).

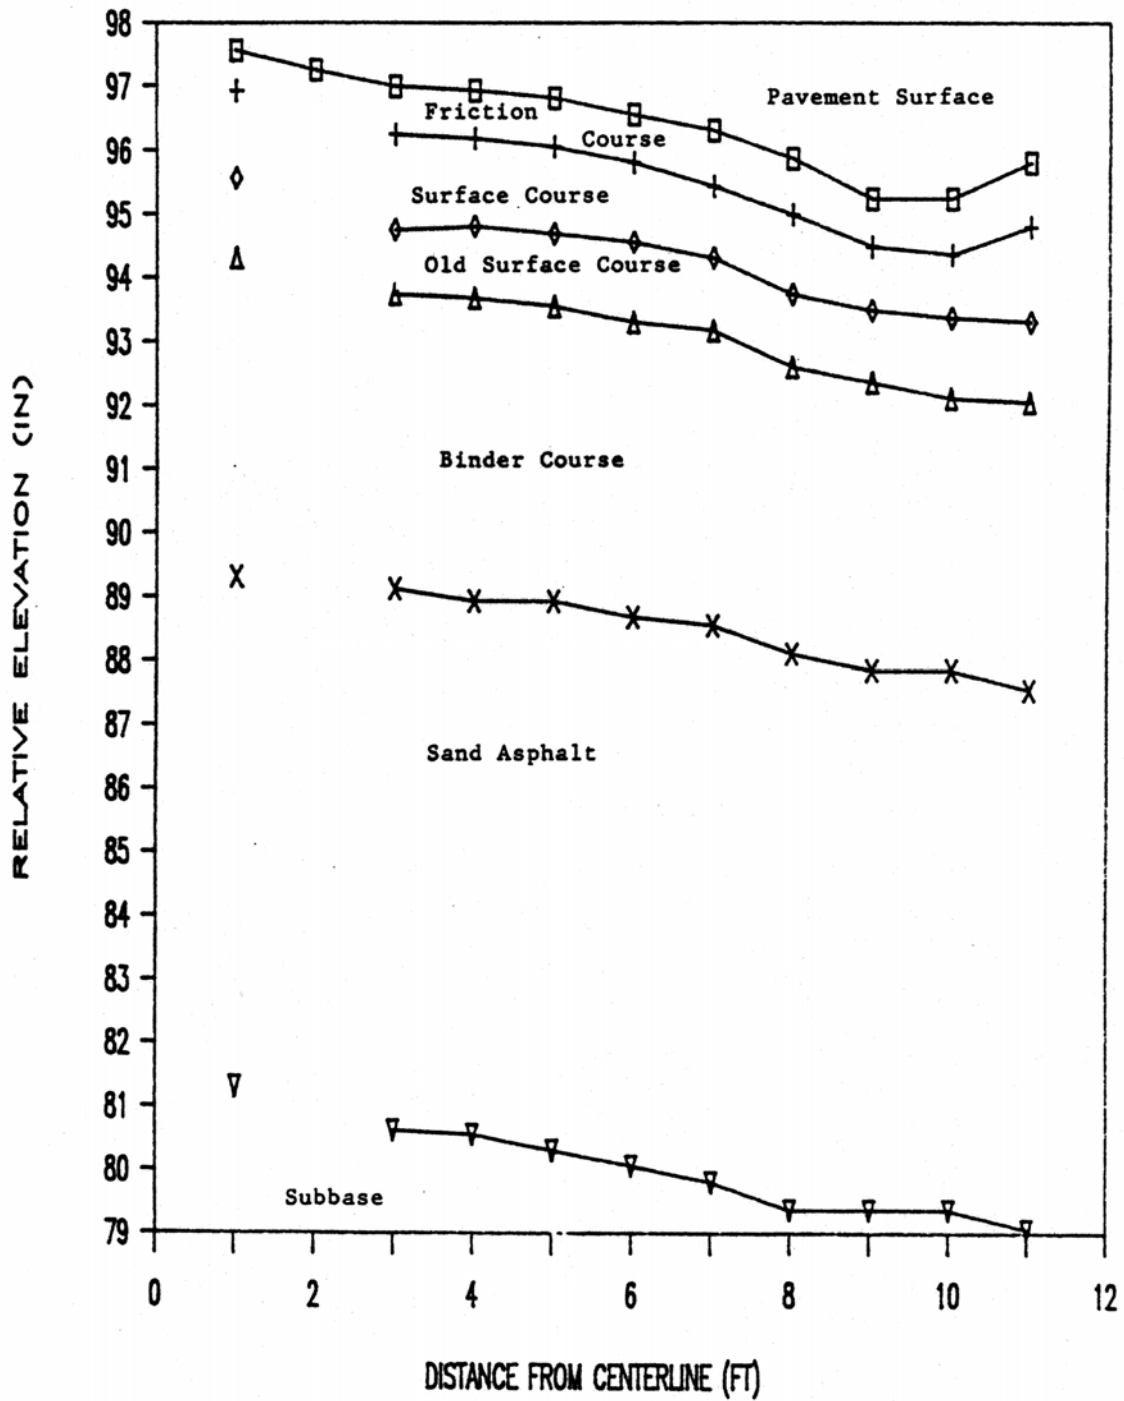
Figure 8. Relative Layer Elevation vs. Distance from Centerline for Site #2

Figures 8 and 9 show that a small rut had occurred adjacent to the shoulder for the pavement at site 2. Very little rutting was obsemed adjacent to the centerline. The shoulder paint stripe had moved in some locations which is often a result of stripping. The rutting at this site appeared to be partially related to stripping which explains why the rut is adjacent to the shoulder (source of water). Observations while cutting the trench and during the laboratory testing operation showed a significant amount of uncoated aggregate which was concluded to be stripping. Measurements taken at site 3 showed very little rutting (Figures 10 and 11) however there were locations where the material had shoved outward adjacent to the shoulder. These were localized areas and did not

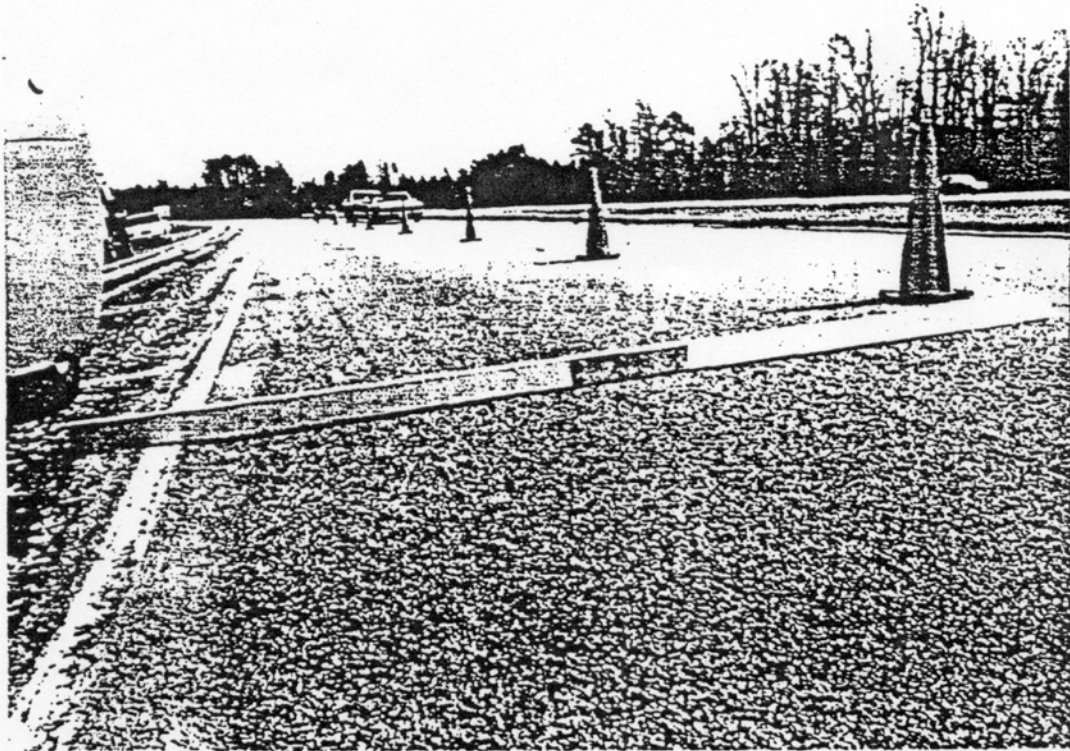
Figure 11. Typical Rutting at Site #3

result in significant rutting. Site 3 consisted of an old PCC pavement which had been overlaid with asphalt concrete. The asphalt mix contained primarily uncrushed aggregate and had clearly stripped. During the trenching operation many aggregate particles were observed that had been completely stripped of asphalt. It is anticipated that the high amount of stripping and the localized shoving that has begun will very rapidly lead to a significant rutting problem.

The rutting at site 3 was likely the result of stripping of the asphalt from the aggregate. The amount of rutting was small but the roughness caused by the rutting had resulted in loss of ride quality. This stripping and rutting would have been prevented or minimized if a high quality crushed aggregate had been used (*5*).

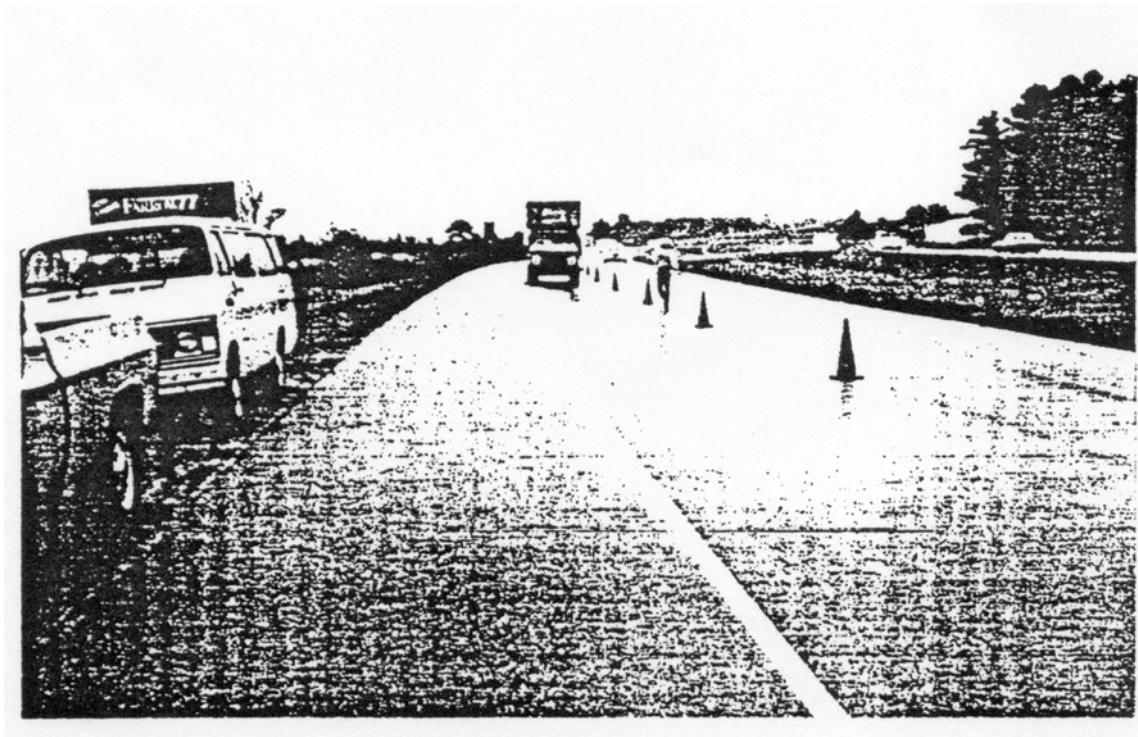
Figure 12. Asphalt Mix with Excellent Performance at Site #4

Site 4 was selected as a pavement that had performed over ten years with no major performance problems (Figure 12). The plot in Figure 13 shows that this asphalt mix has a small rut but this did not appear to be a typical rut. The surface was perfectly straight except for a slight dip at 8 feet from the centerline. This depression was well within the allowable tolerance of construction variation and obviously had no effect on the traffic using the roadway.
Site 5 had experienced some rutting primarily adjacent to the centerline. Figures 14 and 15 show that most of the rutting here had occurred in the friction and surface course. Cores were obtained during rain and it was clear that the rut adjacent to the centerline held water.

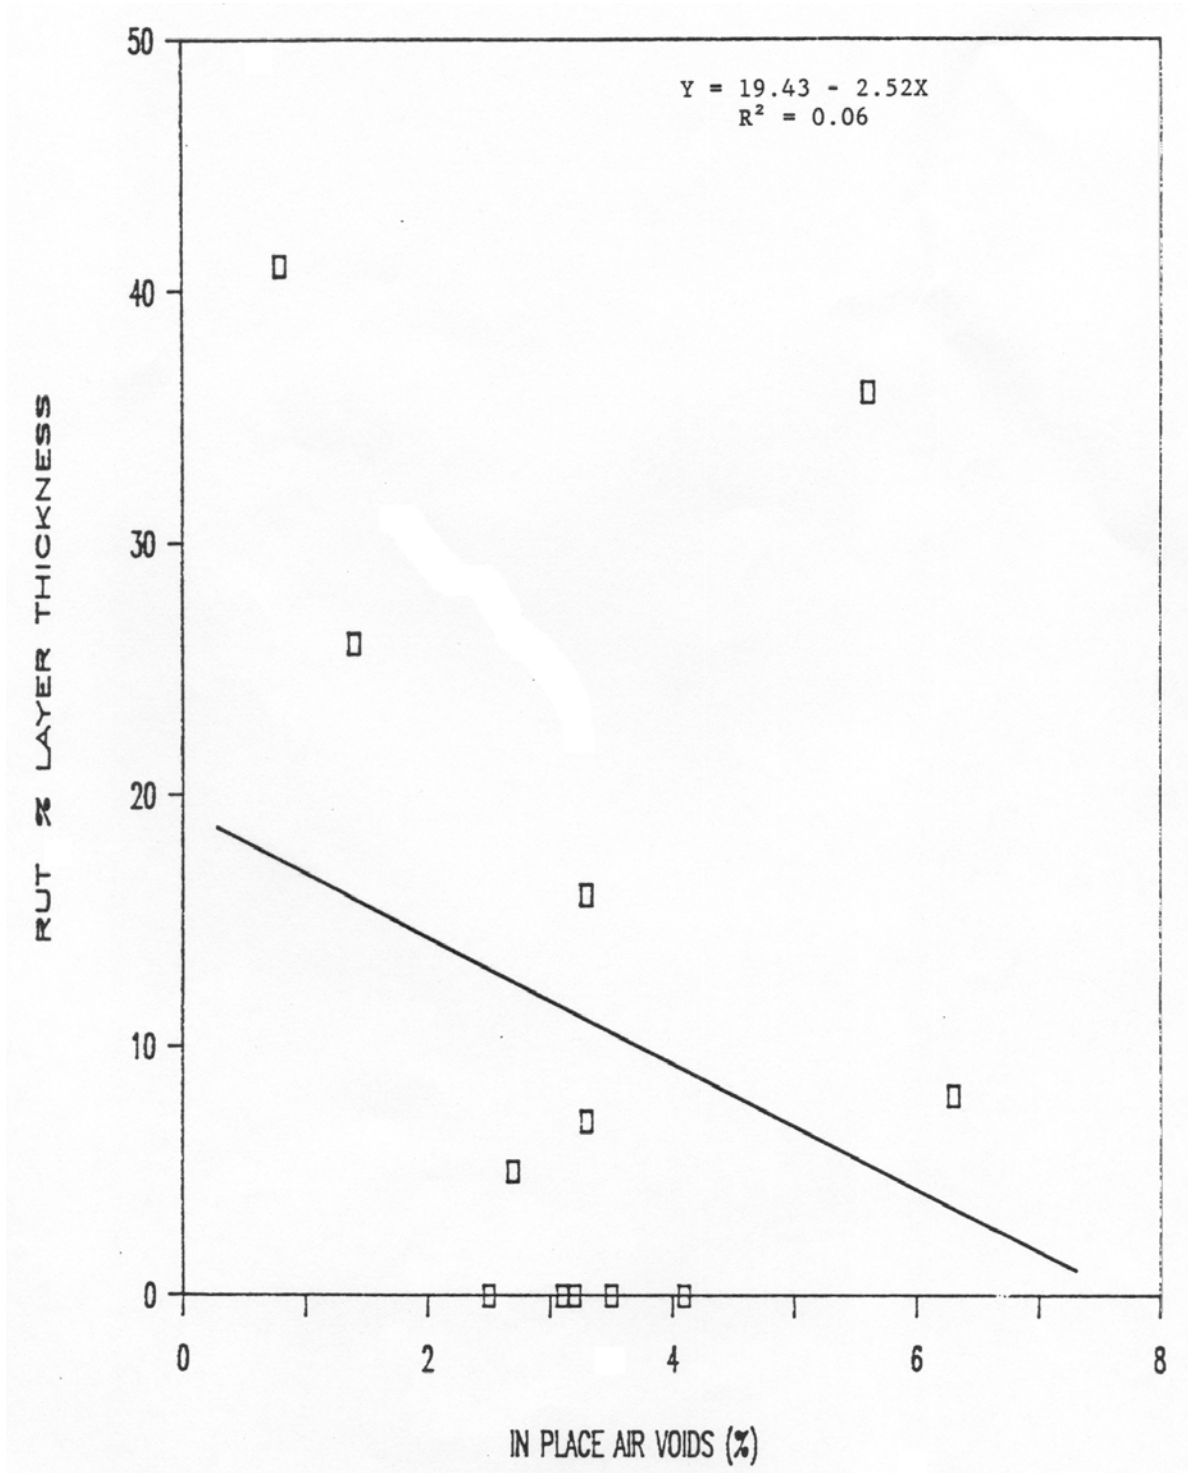
**Figure 16. In-Place Air Voids vs. Layer Rutting**

One of the primary causes of rutting is well-documented in the literature to be low air voids (3,4). A look at the relationship between rutting and minimum in-place air voids shows that the relationship between the two parameters has an $R^2 = 0.06$ (Figure 16). The data does show a trend of more rutting at lower air voids but the correlation coefficient is too low to be useful. It is possible the relationship between rutting and air voids is affected by an increase in air voids once the pavement begins to rut and shove. There is a good possibility that the void level decreases under compaction to some point at which rutting begins to occur and at which time the void level begins to increase due to shoving of the mixture.

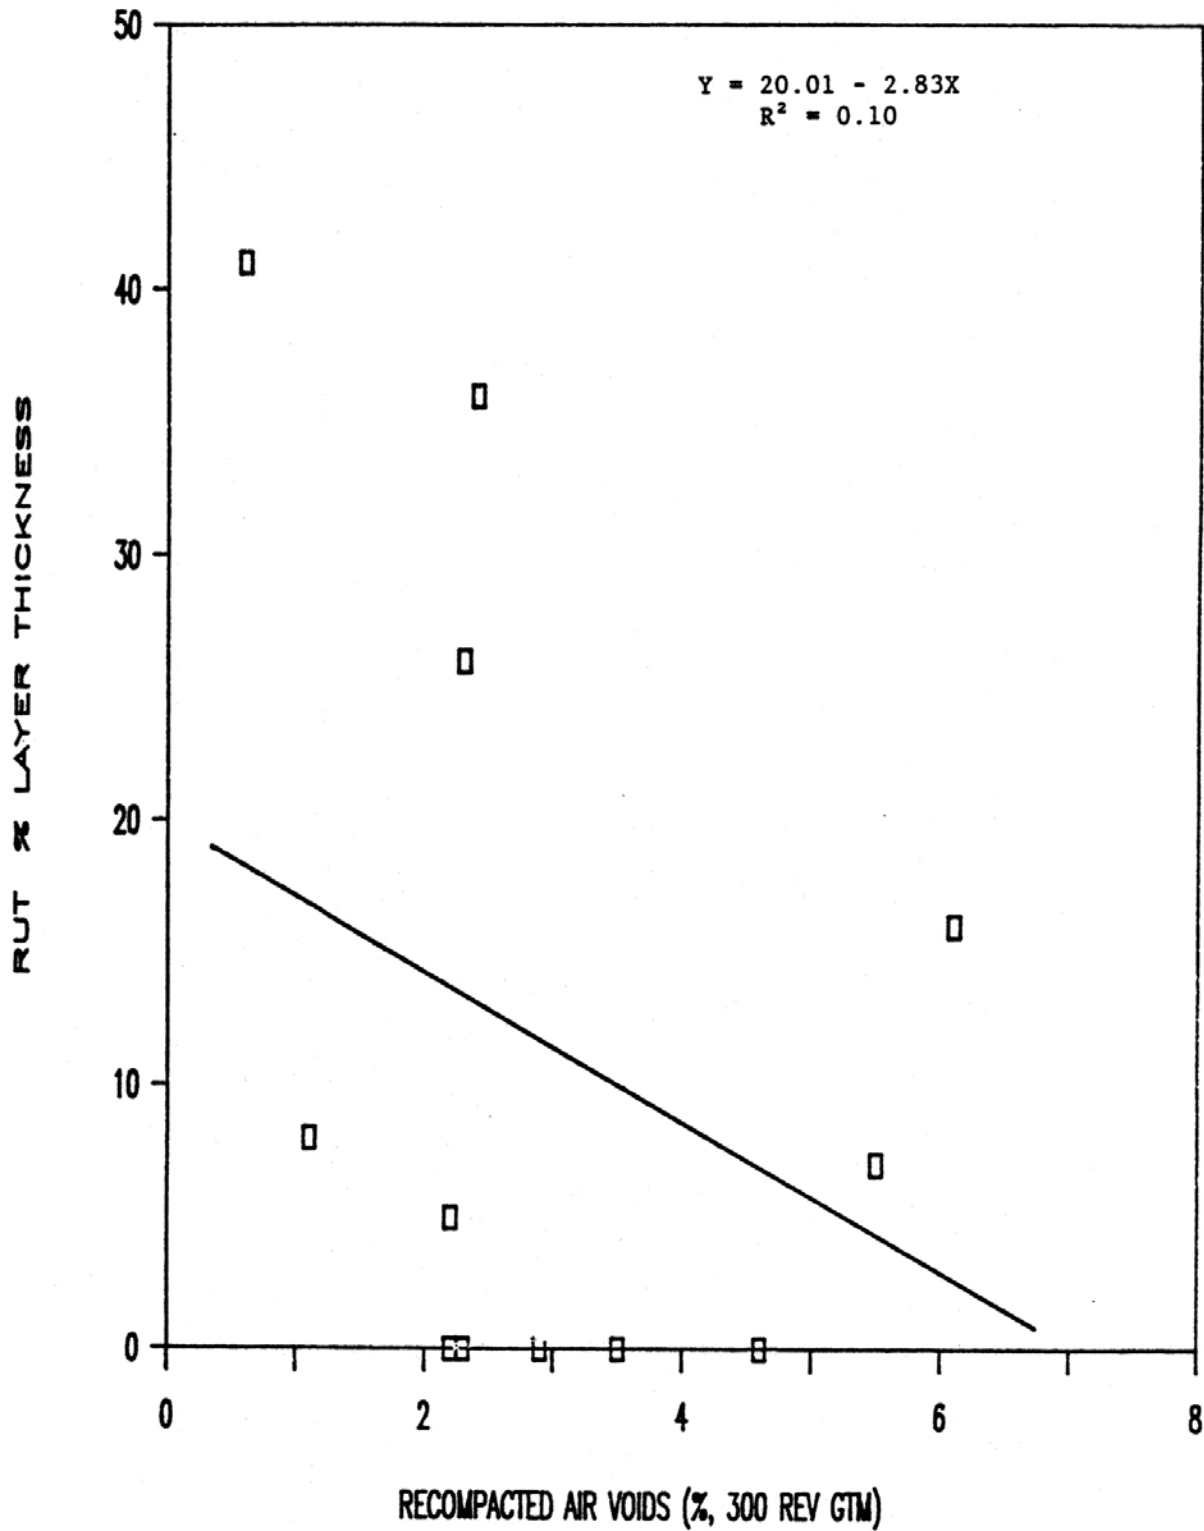
Figure 17. Recompacted Air Voids vs. Layer Rutting

The relationship between layer rutting and recompacted air voids which has an $R^2 = 0.10$ is shown in Figure 17. This information clearly shows for the pavements tested that very little rutting occurs when the recompacted air voids are 3.0 percent or higher for compactive efforts of 75 blow Marshall and Gyratory with 120 psi, 1 degree and 300 revolutions. The voids data in Figure 17 was determined with the GTM. Three of the four mixes with more than 3 percent air voids have no rutting while the other mix has only 10 percent rutting. Significant rutting occurs

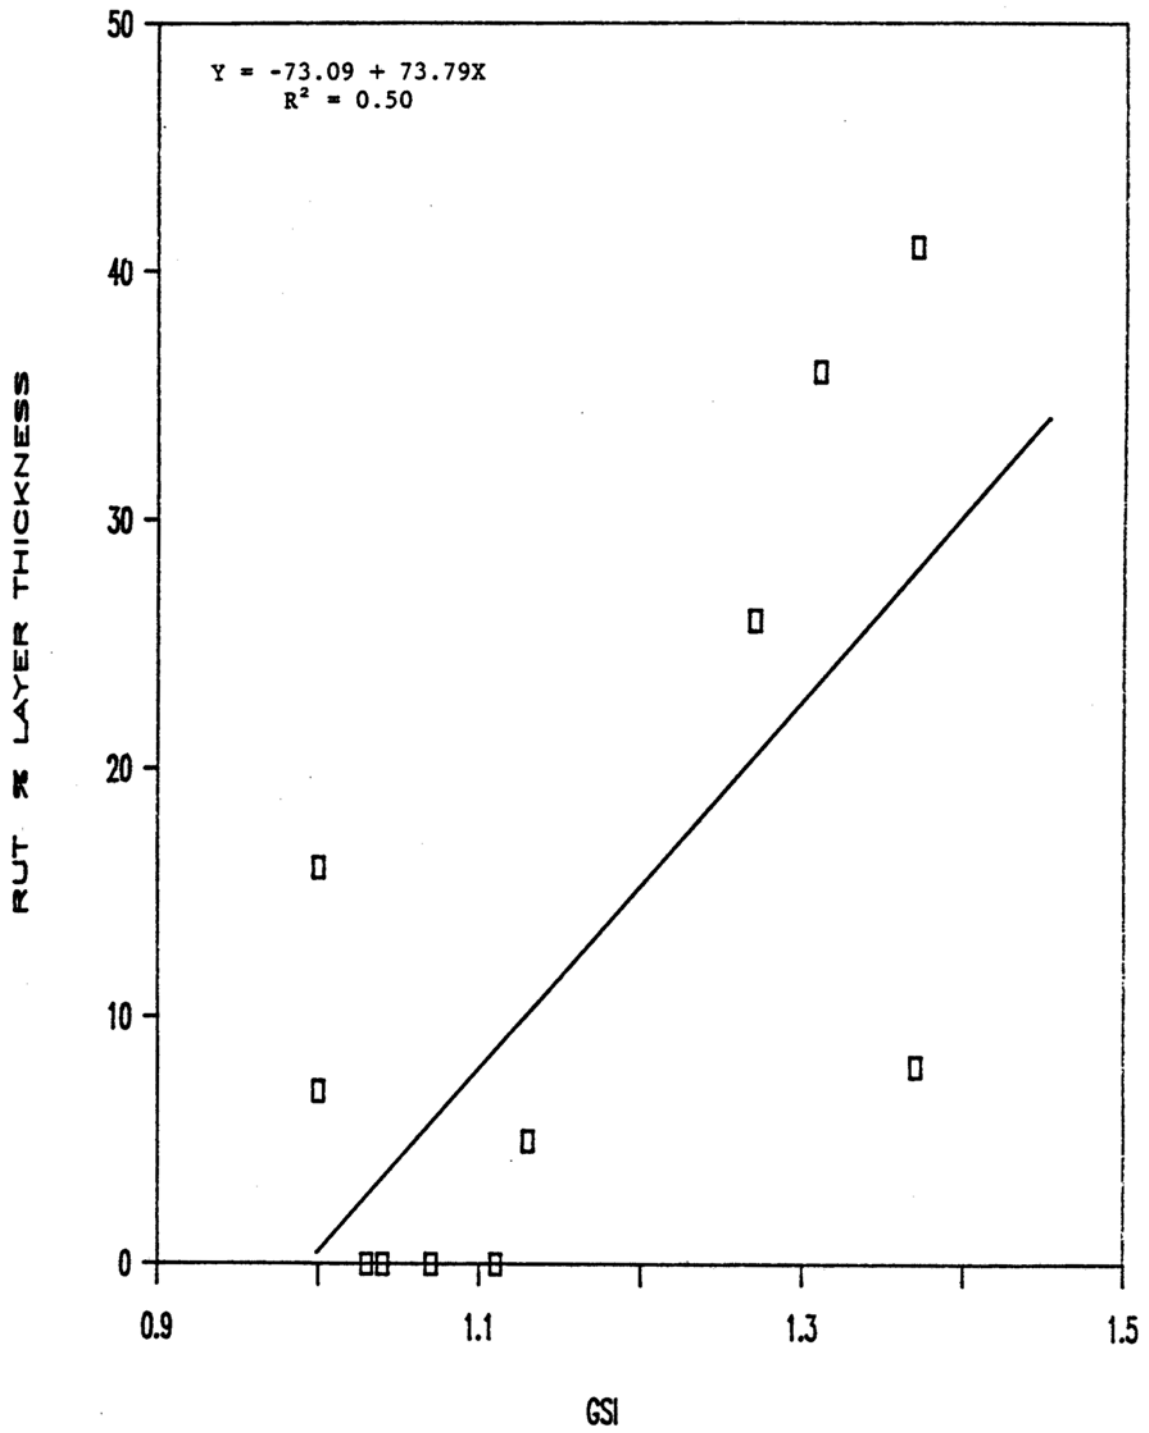
Figure 18. GSI vs. Layer Rutting

Another parameter that appears to relate weIl with layer rutting is the GSI which has an $R^2 = 0.50$ (Figure 18). When the GSI exceeds 1.1 the data shows that significant rutting can be expected. Only one of the five pavement layers that had GSI values less than 1.1 had experienced significant rutting.

The GSI determined during compaction with the Gyratory Testing Machine was shown to be a good indicator of mixes that had rutted under traffic. Based on the results of this study, a maximum GSI value of 1.1 is recommended when compacting samples with 1 degree angle, 120 psi, and 300 revolutions.

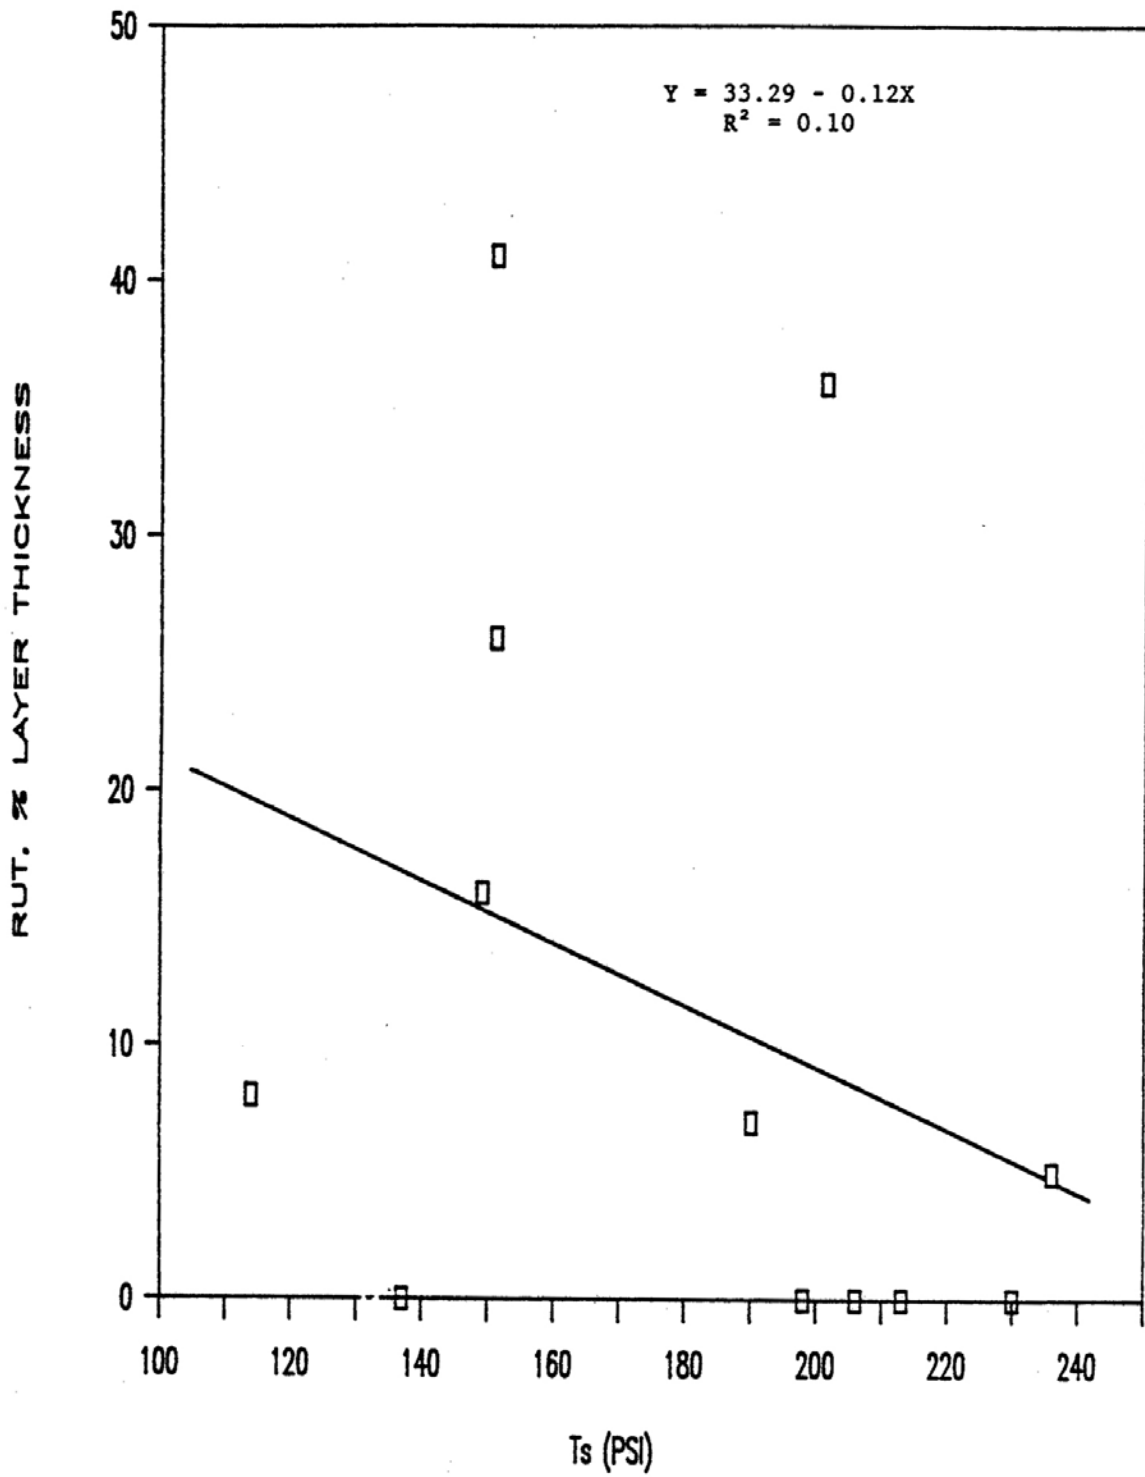
**Figure 19. Resilient Modulus vs. Layer Rutting**

Plots of resilient modulus and indirect tensile strength versus layer rutting are shown in Figure 19 and 20 ($R^2 = 0.01$ and 0.10, respectively). It is obvious from these plots that there is no good relationship between layer rutting and these two parameters. There is no reason to expect a good relationship to exist between these parameters and rutting since rutting is due to compressive stresses and both of these tests measure tensile properties of the mixes.

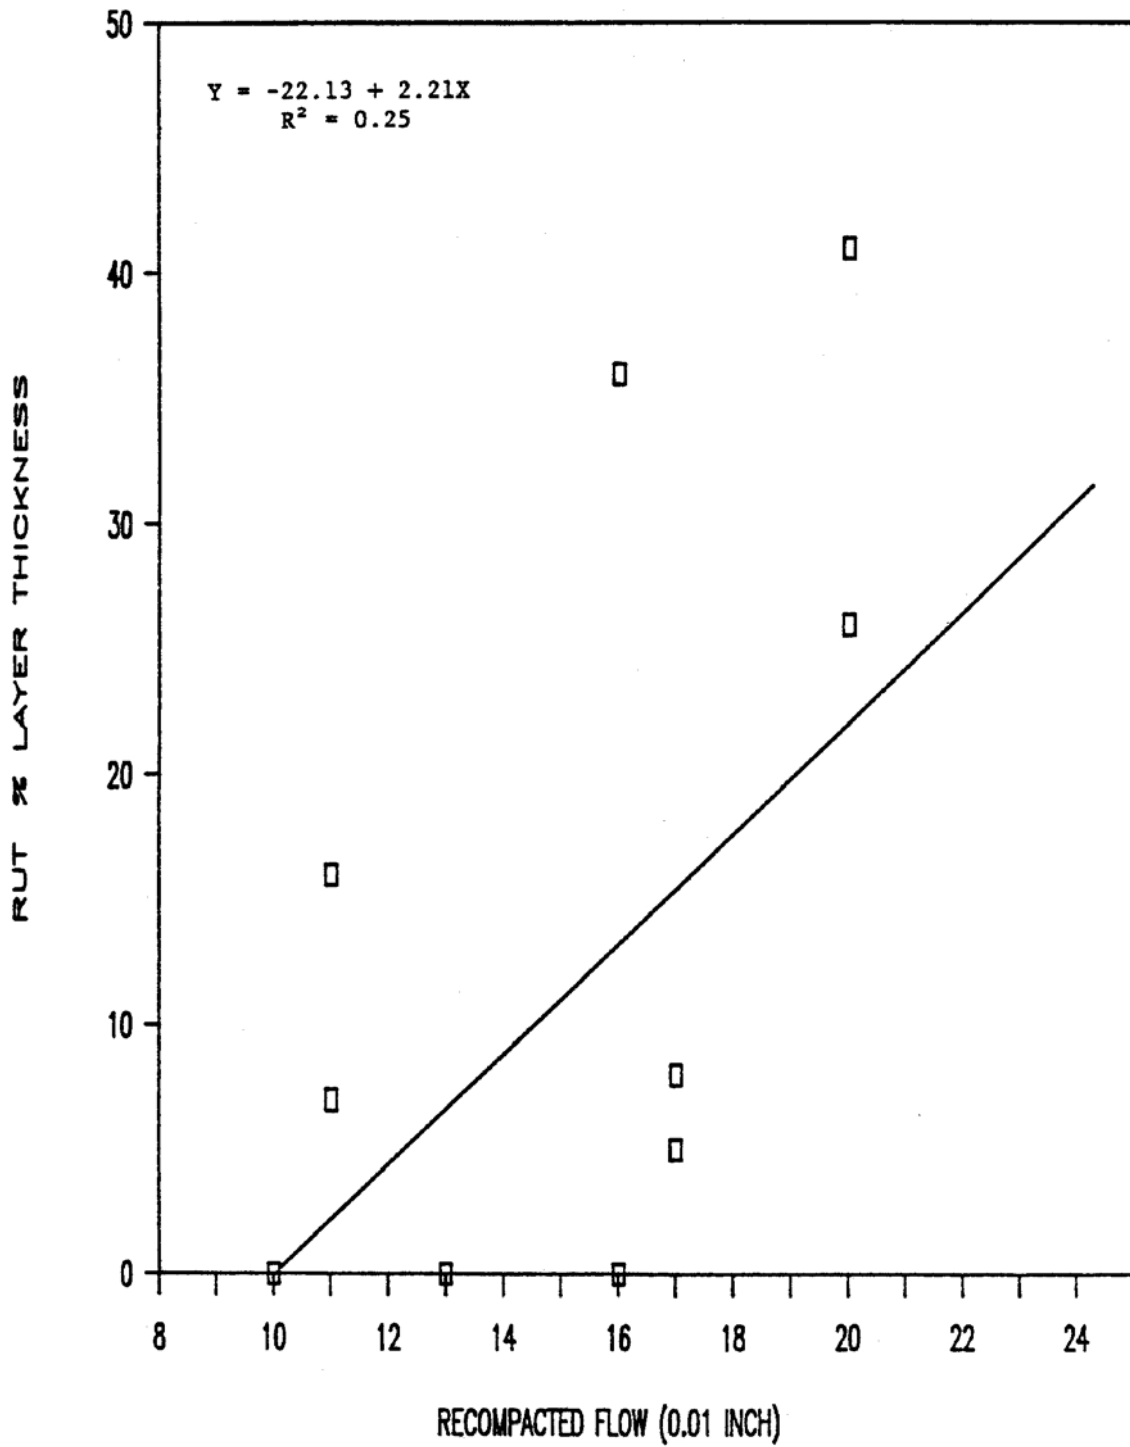
Figure 21. Marshall Flow vs. Layer Rutting

The Marshall flow in the recompacted samples appears to be an indicator of rutting potential with an $R^2 = 0.25$ (Figure 21). A flow above 16 for the pavements tested resulted in rutting equal to approximately 10-40 percent of layer thickness. A flow below 16 resulted in only one of the mixes having more rutting than 10 percent of layer thickness.

One of the biggest causes of rutting is excessive asphalt content in asphalt mixtures. Steps should be taken to insure proper asphalt content is selected and provided during mix production. Compactive effort should be selected to provide a density equal to that which will be obtained under traffic (75 blow with manual hammer or Gyratory Testing Machine have been shown to be sufficient). The asphalt content should be selected to provide a void content of 4-5 percent in laboratory compacted mixtures for high traffic volume roads. Asphalt content should not arbitrarily be increased to facilitate compaction, to minimize segregation, or for any other reason except to provide satisfactory voids in the laboratory compacted asphalt mixture. The maximum Marshall flow should be specified to be 16. If a Gyratory Testing Machine is used the GSI should not exceed 1.1.
